Historic Preservation Board Staff Report

Author: Anya Grahn, Historic Preservation Planner
Subject: Material Deconstruction and Reconstruction Review
Address: 803 Norfolk Avenue
Project Number: PL-15-02923
Date: November 11, 2016
Type of Item: Administrative – Material Deconstruction and Reconstruction

Address: 803 Norfolk Avenue
Designation: Significant
Applicant: Jim Hewitson (Architect Jon DeGray)
Proposal:
1. Reconstruction of c.1938 corrugated metal garage along Crescent
2. Material Deconstruction of stacked stone retaining walls, historic roof and dormers, chimney, demolition of historic and non-historic foundation elements, historic and non-historic porch elements on the front and side porches, historic doors, replacement of historic and non-historic windows; removal of portions of historic walls in order to accommodate a new addition on the northwest corner of the historic house.

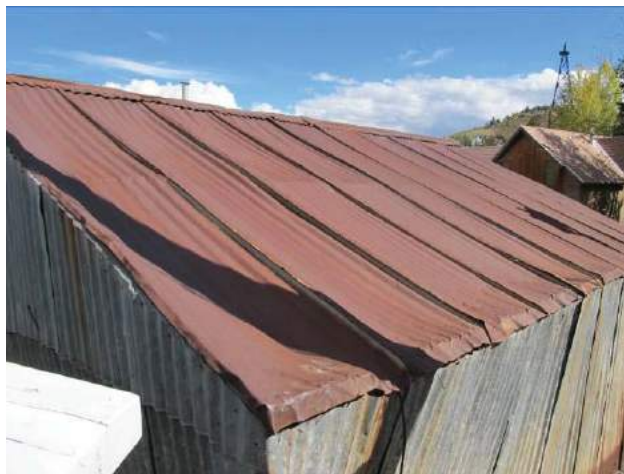
Chad Root, Chief Building Official, toured the site with staff on September 29th and found that the garage was hazardous and dangerous, pursuant to Section 116.1 of the International Building Code. His comments are attached as Exhibit F. Staff has found that the garage is settling in different directions, causing the garage to settle towards the house as well as the street. The garage has settled askew in such a way that the panels have become warped and may not be salvageable. The roof has corroded, and

there are holes where the galvanized corrugated metal panels have rested on the dirt floor. The garage has no foundation, a dirt floor, and minimal wood frame structure.

This image shows how the garage is settling in different directions.

Chief Building Official (CBO) Chad Root inspected the site on September 29, 2016 and has found reconstruction is necessary due to the deteriorated condition of the building's materials and structure (Exhibit F). The garage structure is wood frame and sits directly on the dirt in most places. While the dirt is largely packed down, it has eroded away from the exterior walls in some areas. There are a few places where a makeshift concrete foundation wall has been poured to prevent erosion and stabilize the garage. As noted in the CBO's observations, the building has settled both towards the house to the east as well as Crescent Tramway to the northwest. This settlement has pulled the structural members in two directions, causing many to detach from the roof and wall structure.

Chad Root concluded that the structure is in poor condition and should be considered for reconstruction based on the deficiencies. He found that the material of the garage has deteriorated to a condition that it cannot be reasonably repaired, nor was it reasonable to attempt to move the structure or dismantle it for panelization.

#4. Any corrugated metal wall panel that can be made safe and serviceable through repair shall be salvaged and reused on the reconstructed garage. The applicant shall replace any deteriorated wall panels in-kind with new corrugated steel panels that match the existing in design, dimension, texture, material, and finish. The new corrugated metal panels shall resemble the corroded appearance of the historic panels in order to not detract from the historic materials.

#5. Any corroded steel roof panels that can be made safe and serviceable through repair shall be salvaged and reused on the reconstructed garage. The applicant shall replace any deteriorated roof panels in-kind with new steel panels that match the existing in design, dimension, texture, material, and finish. The new metal roof panels shall resemble the corroded appearance of the historic panels in order to not detract from the historic materials. These panels shall not be reflective. Special attention shall be paid to duplicate the architectural detailing of the ridge cap.

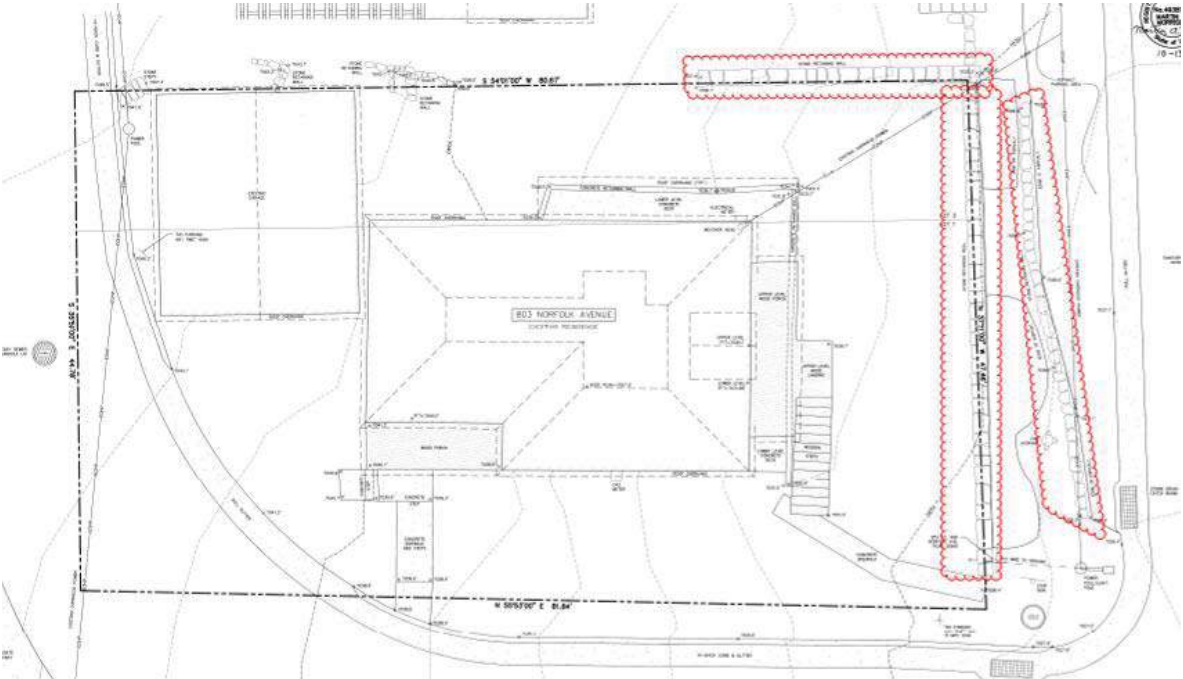
The site has a moderate uphill slope of approximately 18 feet from the east side of the property along Norfolk Avenue to the west side along Crescent Tram. There are existing stone retaining walls along the east and north property lines. These walls are in poor condition and the Engineer’s report notes that they are moving 5 to 12 inches horizontally at the top of the walls, creating a dangerous situation. The applicant proposes to reconstruct these walls with new stacked stone walls that are in keeping with the historic character of the district. A new stacked stone wall will also be constructed along the south property line, adjacent to 8th Street to help retain grade.

Site Plan showing the location of the existing retaining walls.

Staff finds that the proposed work to reconstruct the retaining walls mitigates any impact that will occur to the visual character of the neighborhood and any impact to the architectural integrity of the site’s buildings.

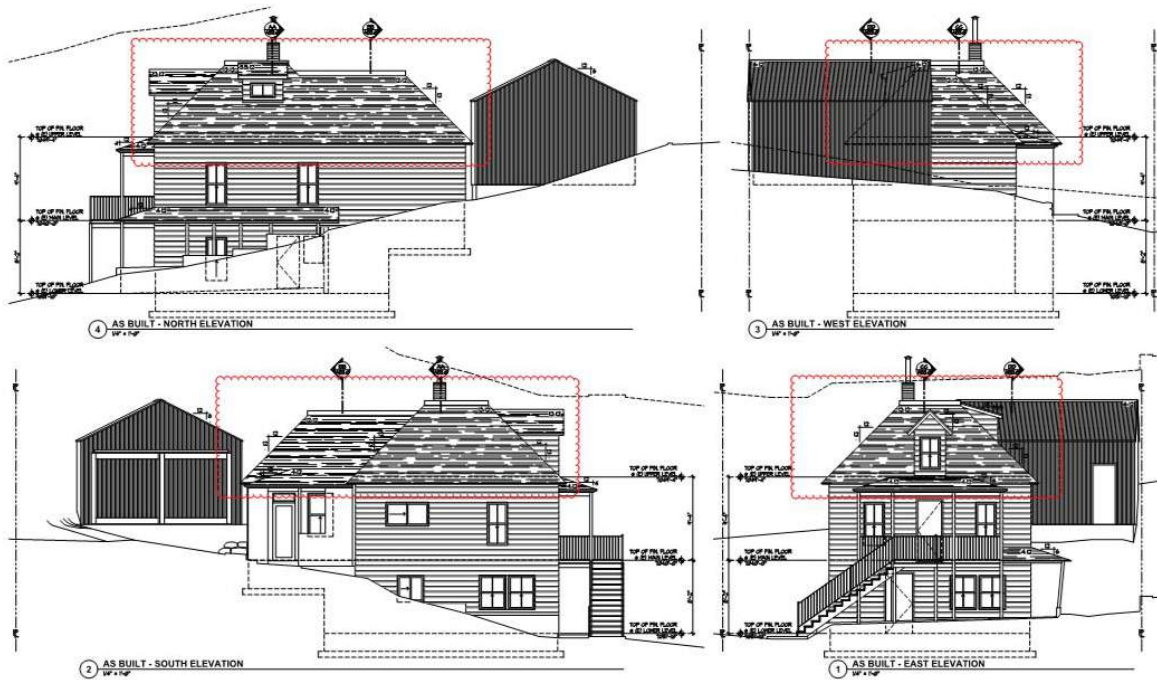
The Engineer's Report notes that the existing roof structure is not structurally sound. The existing 2x4 roof joists are at 24" on center on a sloped roof spanning 8 to 12 feet. The 12 foot roof joists are at 12% capacity of the code and the 8 foot roof joists are 16% capacity of the code. The existing roof deck consists of 1x wood plank installed perpendicular to the existing joists and does not have any capacity of the shear diaphragm value. The addition to the west was found to be in poor condition.

Removal of the roof.

The applicant is proposing to remove the entire roof structure and reconstruct the roof. Due to the close proximity of the roof joists and the shape of the roof, the applicant has found that sistering the existing structural members with new roof joists is nearly impossible as the roof framing is very cut up with dormer framing and short rafters. The applicant finds that it would be near impossible to sister alongside the short rafter pieces and new hip beams. The proposed reconstruction will match the original in design, dimension, and material. The new roof will be sheathed in architectural grade asphalt shingles.

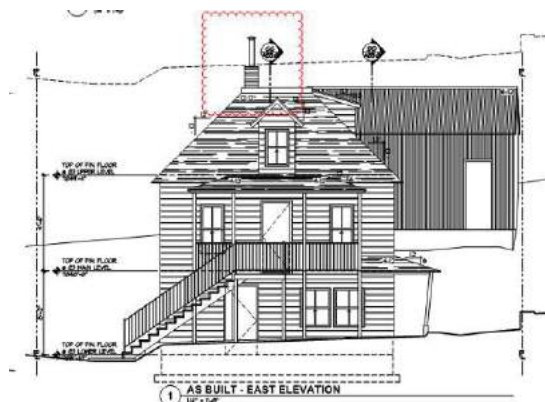
The brick chimney is visible in the c.1940 tax photo. The chimney appears to have been shortened after 1940 and there is evidence of Portland Cement repairs. The applicant is proposing to remove the entire stack of the historic chimney. Salvaged bricks from the interior and exterior portions of the stack will be reused to reconstruct the chimney above the roofline of the historic house.

Chimney proposed to be reconstructed.

Staff finds that the proposed material deconstruction is necessary for the restoration and reconstruction of the chimney.

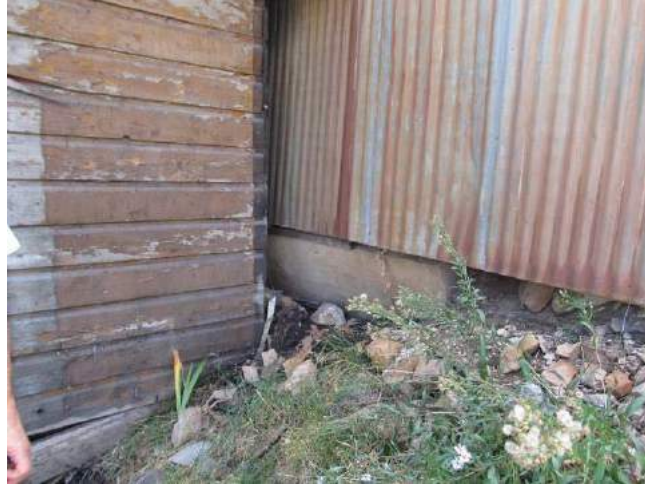
On the north elevation of the rear addition, the exterior wall consists of painted vertical boards that sit directly on the dirt. This wall had previous been an interior wall between the house and the 10 foot by 10 foot sleeping porch documented on the 1968 tax card. The applicant is proposing to remove and reconstruct this wall as an IBC-compliant framed wall. The new sleeping porch addition will be constructed along this wall and attach to the garage wall to the west.

The wall on the left is the original wall between the house and sleeping porch. Note how the garage is pulling away from the wall of the house.

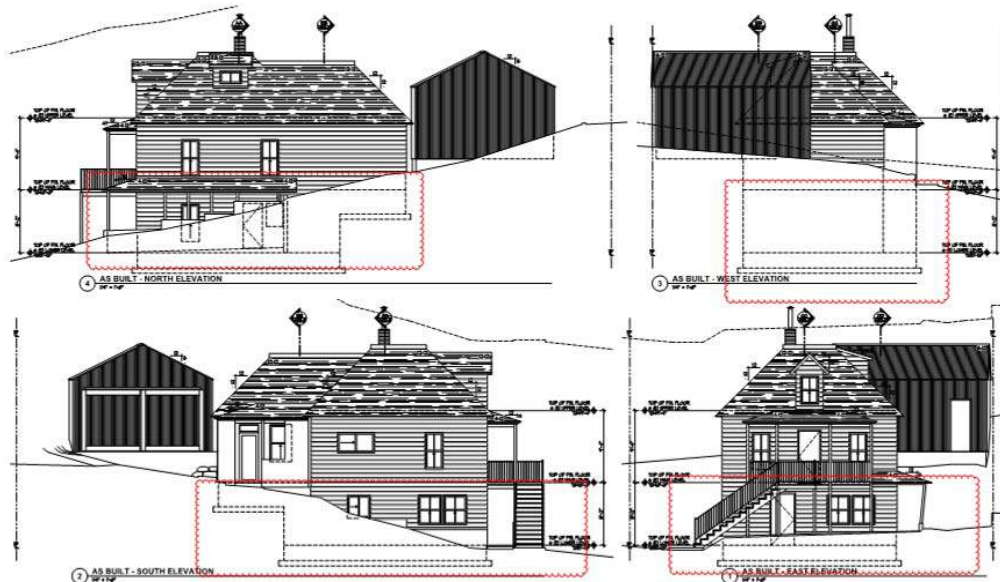
The historic photograph from c.1900 shows that the main level of the house was elevated above grade, revealing a walkout basement level that was constructed into the hillside. It is unclear when the existing basement level was constructed or if it is the same basement addition that was built before the 1891 addition. The 1949 and 1958 tax cards note that there is no foundation. This level is largely constructed of framed walls with some limited concrete walls along the south wall. This is the only portion of the house that features framed walls and not single-wall construction. The Engineer's Report (Exhibit H) notes that the existing building has sandstone footings but the footings are so deteriorated that they can be removed by hand and are no longer holding up the house.

Foundation level proposed to be removed.

The applicant is proposing to raise the house two feet (2') in order to pour a new concrete foundation beneath the house and the garage. On the Norfolk façade (east elevation), the new foundation will not be visible. The foundation will be re-clad with salvaged historic siding on the 8th Street (south) façade in order to conceal the new foundation. In order to complete this work, the existing foundation sections will be demolished.

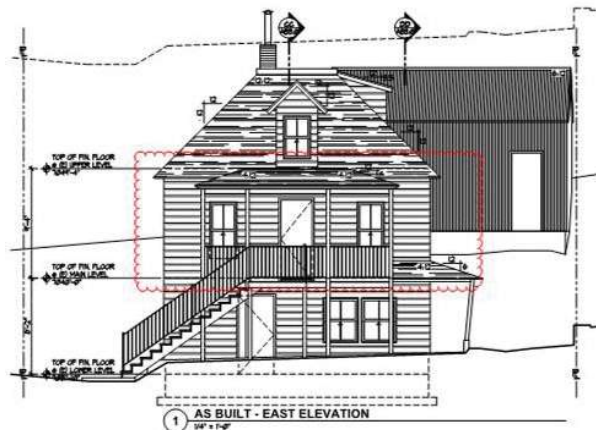
The porch is largely deteriorated. The wood stair structure has deteriorated and the structural members have detached from the original structure. The porch floor shows sign of wood rot and the porch railings and posts are not historic. The applicant proposes to completely reconstruct the porch.

Upper level front porch proposed to be reconstructed.

Staff finds that the reconstruction of the porch and the entailed material deconstruction is necessary for the restoration and rehabilitation of the building and the reconstruction of this element.

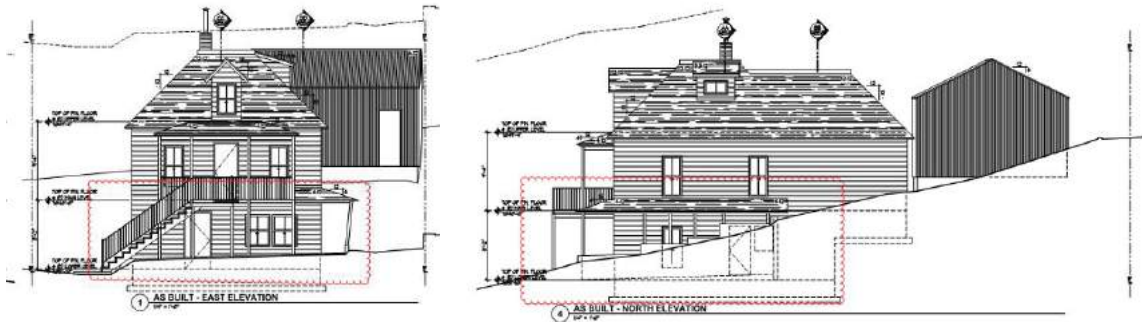
The lower level of the porch was constructed at the same time as the upper level; however, the porch was extended to wrap around the north elevation of the house sometime after 1907. The door openings on the north elevation of the house appear original, so it is likely that there was an overhang above this side entrance. Because of the grade change, the porch floor is at grade on the east (Norfolk) side but is below grade along the north elevation. There is a failing poured concrete wall along the north side that retains the soil and supports the simple wood posts holding up the shed roof along the north side of the house. Due to the settling of the concrete wall, the porch posts have become detached from the roof and concrete wall.

Lower level wood and concrete porch proposed to be reconstructed.

The applicant is proposing to reconstruct this porch. The porch roof will be reconstructed and a new concrete retaining wall will be poured along the north side. New drains will be added to address water issues.

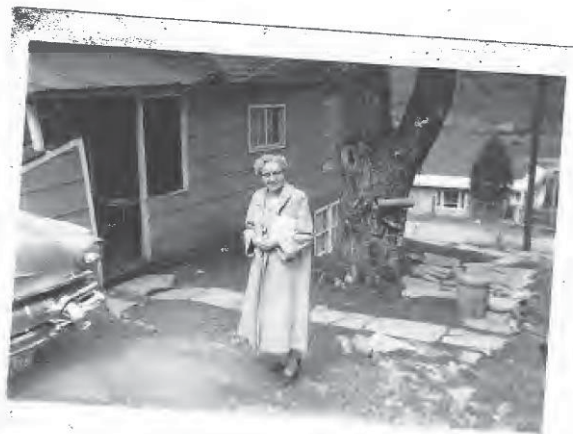
C.1950 photorgraph showing the wood shed on the left side of the porch.

The porch is in poor condition. The wood floor sits directly on the dirt and is largely rotted through. The plywood walls of the porch are not original and the wood shed has been lost. The applicant is proposing to reconstruct this side porch as an

enclosed porch. The porch will retain its original size and scale; however, new windows will be installed to enclose the porch.

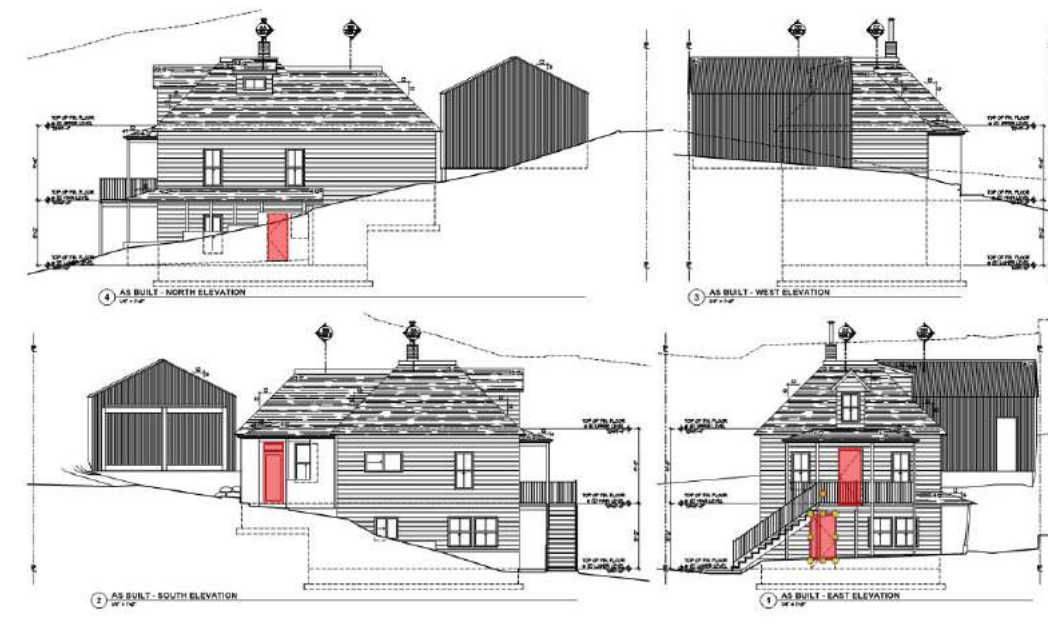
Per the applicant’s Physical Conditions Report, there are four doors on the historic house. These doors are all over 50 years old and in fair to poor condition. Three of the doors have door frames that are no longer square with the door, the paint has deteriorated, and the hardware is loose.

The applicant is proposing to replace all of the doors with new wood doors. The doors on the Norfolk façade will match the historic doors. The door on lower level of the north elevation, below grade, will be expanded to a patio door. Staff finds that this is a minimal change and will not be visible from the primary right-of-way.

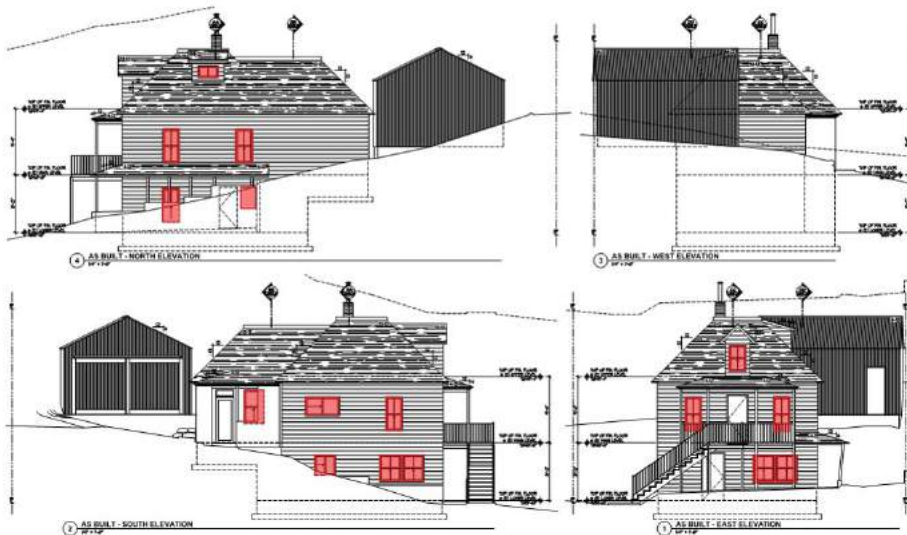
There are sixteen (16) existing window openings on the exterior of the structure. Of these, fourteen of the existing windows are believed to be historic wood windows and two non-historic aluminum windows. The historic wood windows vary from fair to poor condition. They are experiencing wood rot, warping, paint deterioration, and many are no longer operable.

Red indicates the existing windows to be replaced.
