AGENDA

Historic Preservation Board Staff Report

Subject: 334 Marsac Avenue
John P. Nimmo House
Author: Francisco Astorga, Planner
Date: July 18, 2012
Type of Item: Historic District Grant Application
Project Number: PL-12-01559

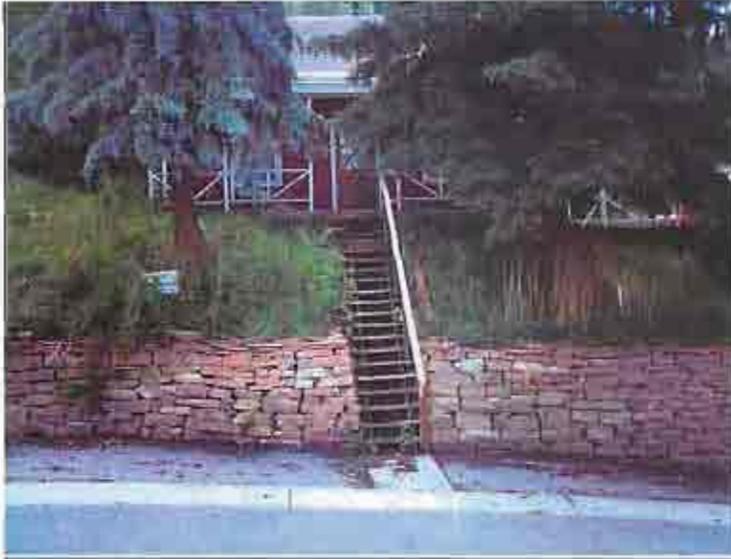
A.3 Retaining Wall

Street View

Across the front of the property, as described in the Topography section, there exists a very nice hand stacked stone retaining wall (2' to 6' in height). The wall is in very good condition. Another retaining wall exists, also described in the Topography section, high upon the site to the rear. It is built of railroad ties and is in poor condition.

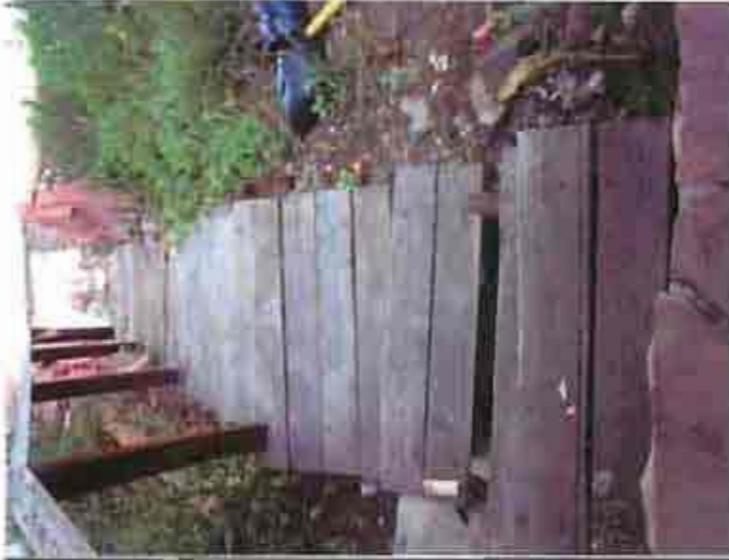
A. 4 Exterior Steps

Broken Steps

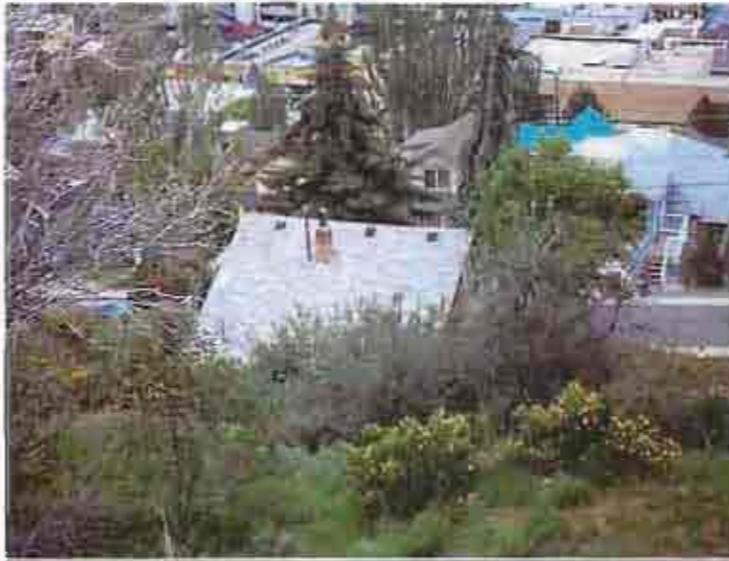
B.1 Roof

Rear View

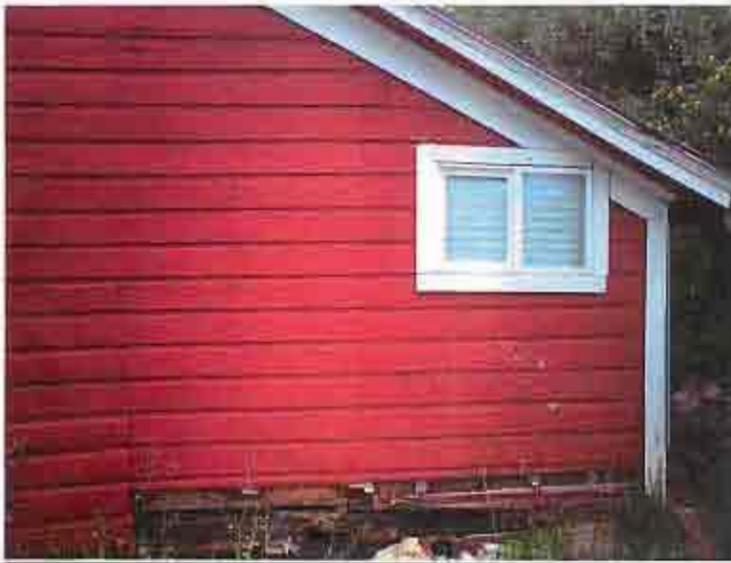
B. 2 – B.5 Exterior Wall

Northwest Corner

Exterior walls- The exterior walls will be reused and will form the correct heights, lengths, window and door sizes and locations for the rehabilitated house. A good portion of the existing siding and trim can be reused. There are some boards close to the ground that are rotten and warped and will have to be replaced. Any new siding will be milled to the exact profile of the existing. All exterior walls will be straightened and plumbed and will be re-structured from the inside with 2"x6" studs at 16" o.c. and plywood sheathing. The existing Historic wall will be attached to the interior stud wall and proper insulation and air barrier will be added to the system.

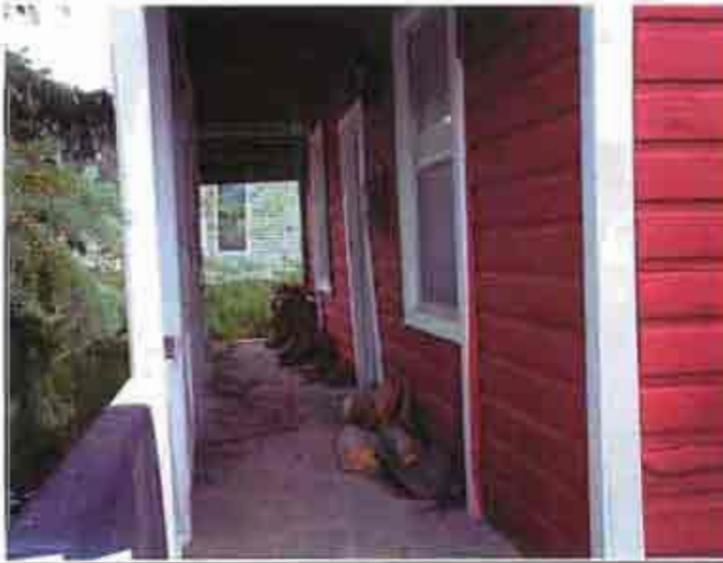
Northeast Corner Showing Porch, Front Door Window Trims

All trim is judged to be in fair condition, possible for rehabilitation and reuse.

Trim- Much of the door and window trim on the existing house can be reused. The trim is very simple flat square-cut pieces. If any of the pieces need to be replaced, it will be a very simple match. See details provided of the window and door trim and the porch and stair railing.

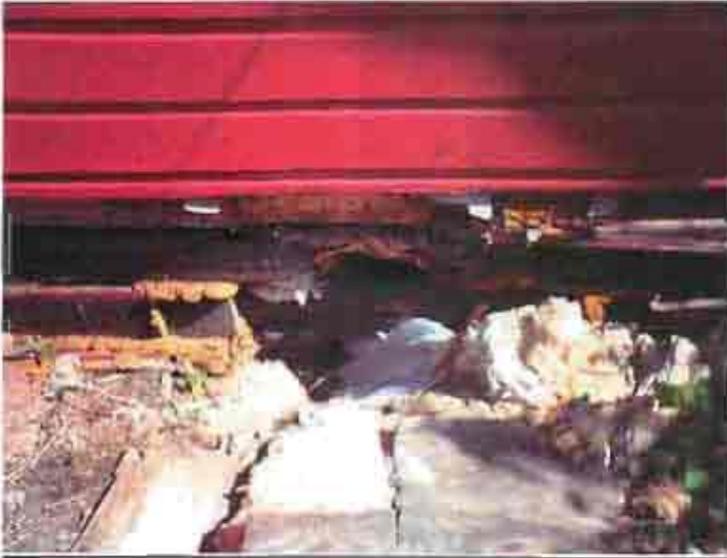
B.6 Foundation

North Wall Showing Rotten Foundation and Rotting Siding

The foundation is wood on dirt that is totally rotted.

Foundation- The project is proposing a new basement with garage under the Historic house. The house will have to be raised above its present location in order to facilitate the excavation, forming and pouring of the new concrete foundation. The main floor of the house will also receive a new floor system. The old system is resting on dirt and is rotted. When the new foundation and floor system are in place, the house will be lowered back to its original position and elevation.

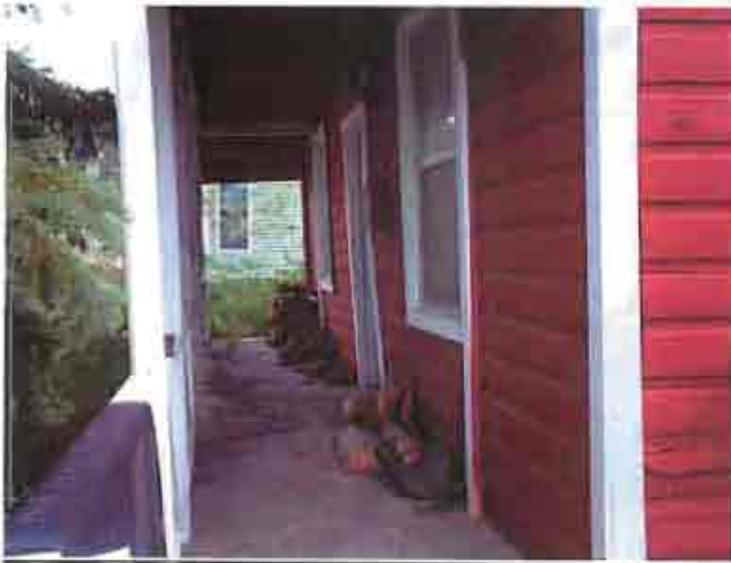
B.7 Porch(s)

Front Porch Showing Flagstone Floor
