HISTORIC SITE FORM - HISTORIC SITES INVENTORY

PARK CITY MUNICIPAL CORPORATION (10-08)

Address: 1108 Park Avenue

City, County: Park City, Summit County, Utah

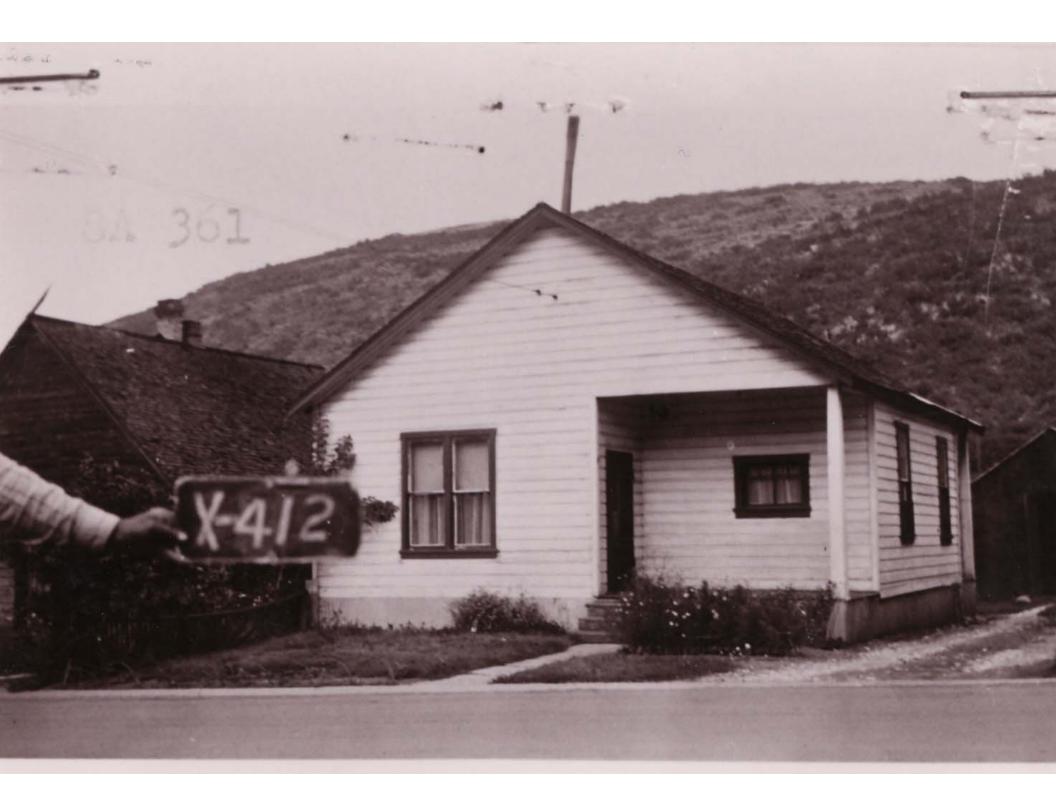
Photo No. 1: West elevation (primary façade). Camera facing east, 2006.
Photo No. 2: Southwest oblique. Camera facing northeast, 1995.
Photo No. 3: West elevation (primary façade). Camera facing east, tax photo.
