# HISTORIC SITE FORM -- HISTORIC SITE INVENTORY

Name of Property: **John Matson House**

Address: 147 Ridge Avenue

Building Type and/or Style: Early 21<sup>st</sup> c. type / Neo-Eclectic style

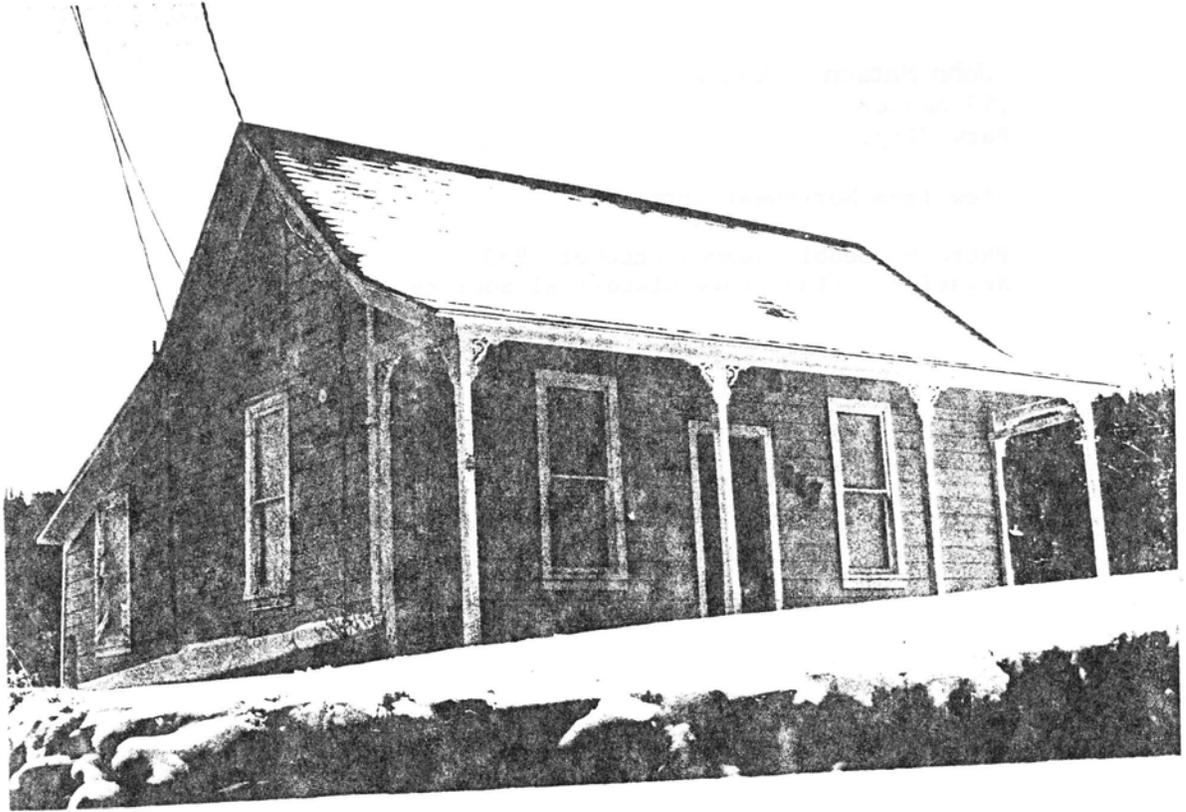
- Photo No. 1: Southeast oblique. Camera facing northwest, 2011.
- Photo No. 2: East elevation. Camera facing west, 2011.
- Photo No. 3: North elevation. Camera facing south, 2011.
- Photo No. 4: West elevation (primary façade). Camera facing east, 2011.
- Photo No. 5: West elevation (primary façade). Camera facing east, 2008.
- Photo No. 6: Northwest oblique. Camera facing southeast, 2008.
- Photo No. 7: Northwest oblique. Camera facing southeast, 2008.
- Photo No. 8: North elevation. Camera facing south, 2008.
- Photo No. 9: Northwest oblique. Camera facing southeast, 2006.
- Photo No. 10: North elevation. Camera facing south, 2006.
- Photo No. 11: Southeast oblique (accessory building). Camera facing northwest, 2006.
- Photo No. 12: West elevation (primary façade). Camera facing east, 1995.
- Photo No. 13: West elevation (primary façade). Camera facing east, 1983 Site Form PDF file.
