HISTORIC SITE FORM - HISTORIC SITES INVENTORY

PARK CITY MUNICIPAL CORPORATION (10-08)

Address: 802 NORFOLK AVE

Building Type and/or Style: Bungalow type / Prairie School vernacular style No. Stories: 1

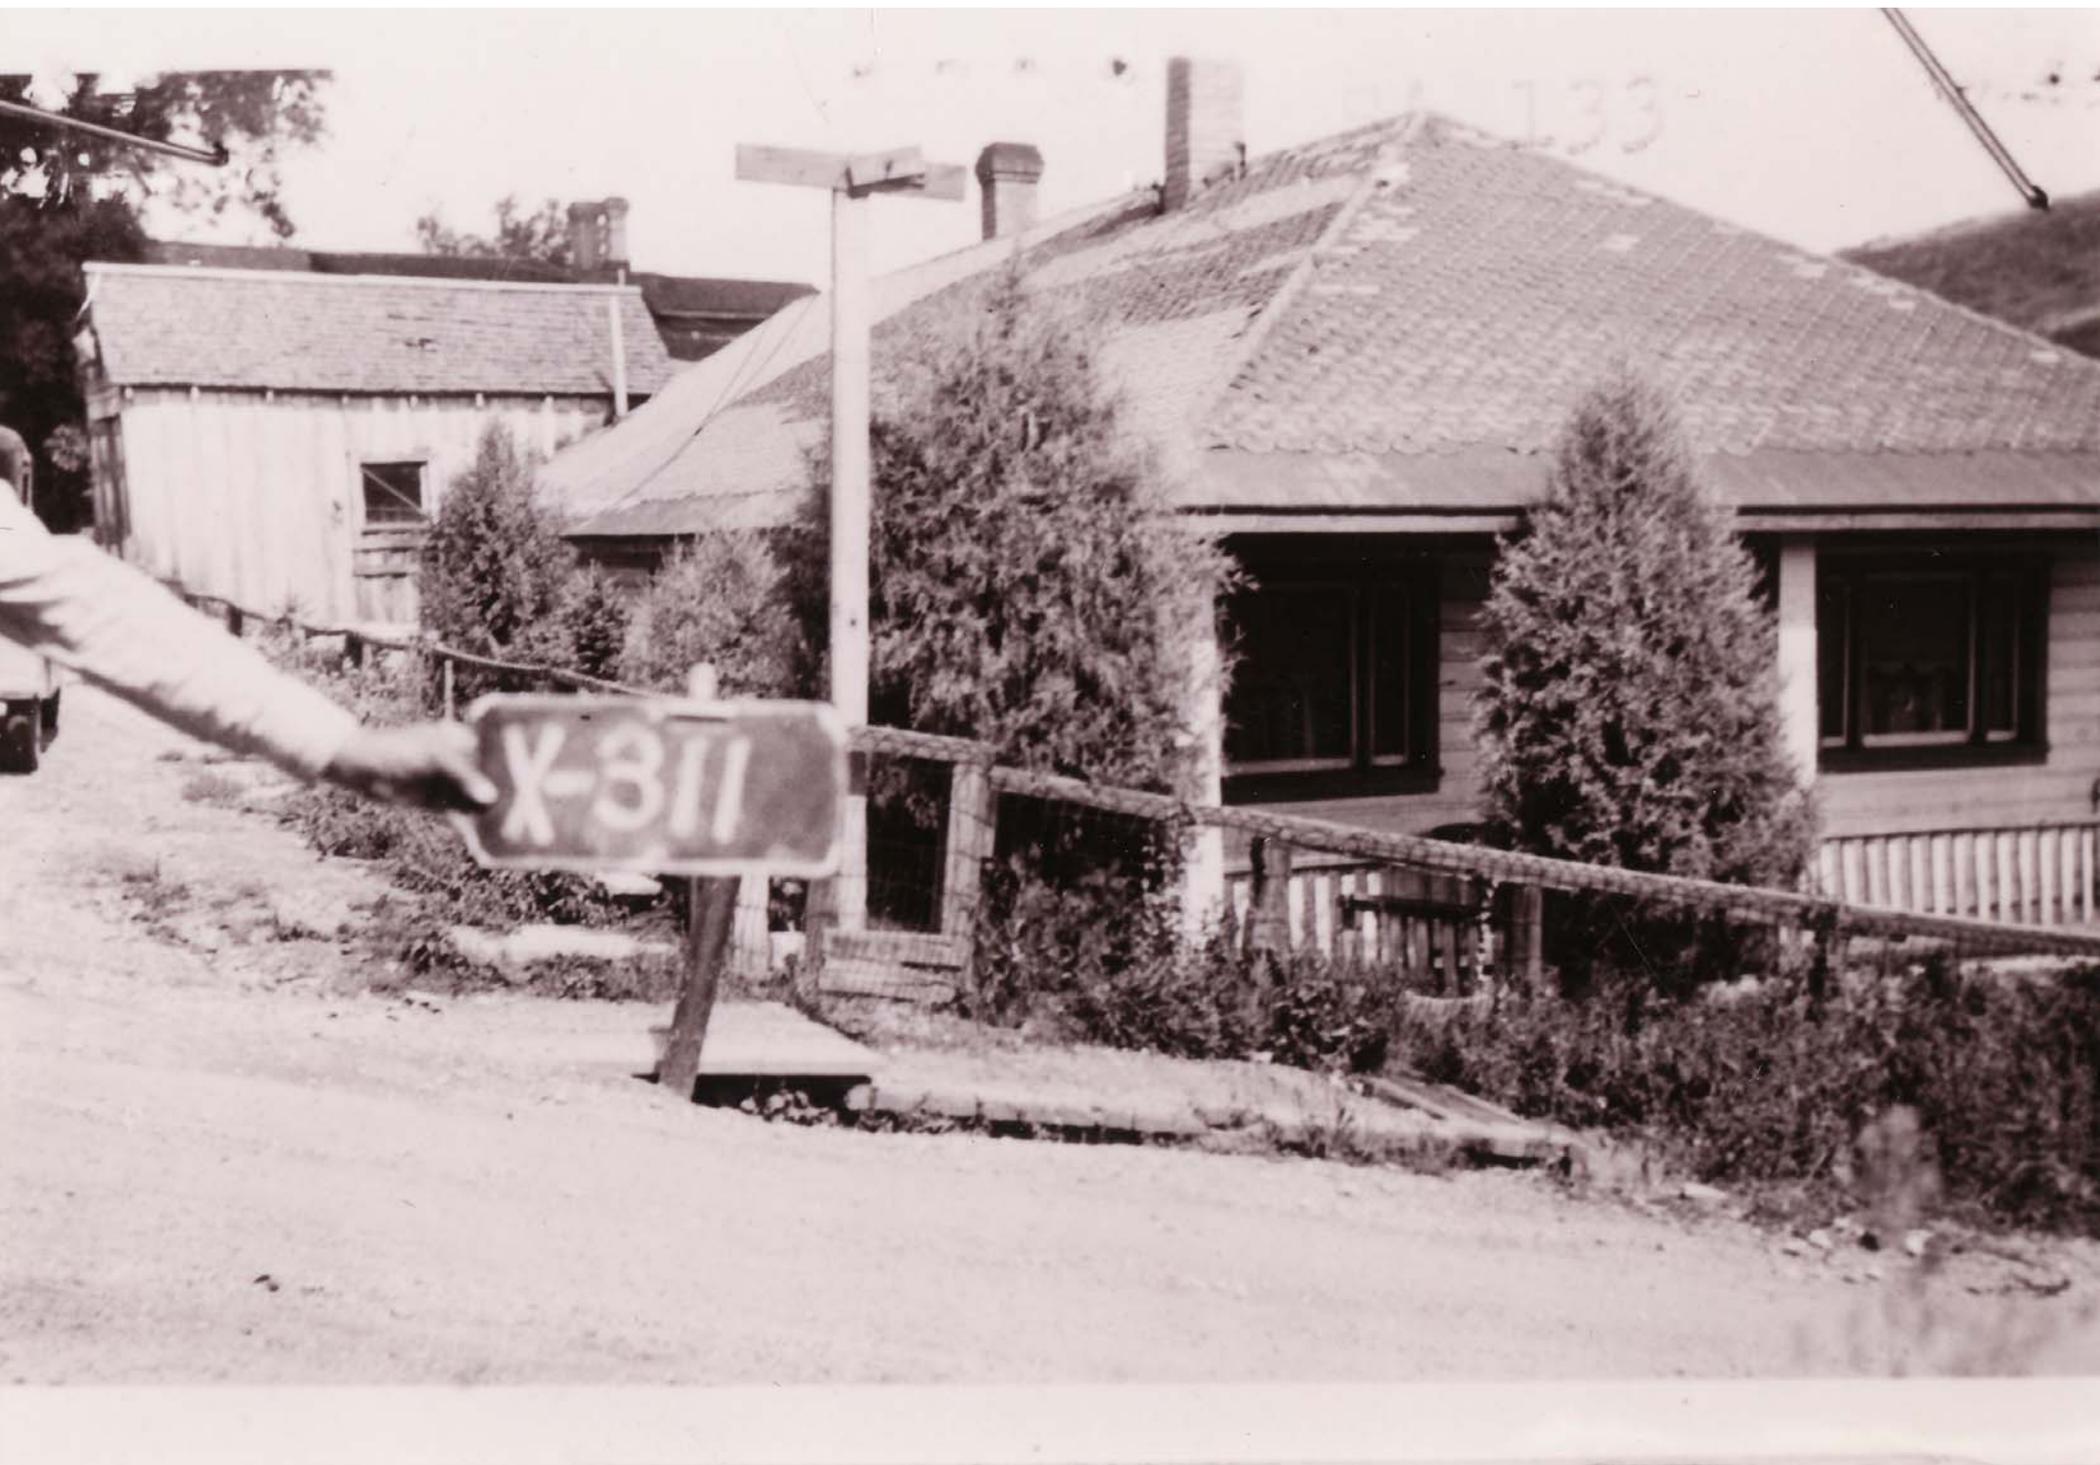
Photo No. 1: West elevation (primary façade). Camera facing east, 2006.

Walls: The walls of the house are clad in wooden drop siding.

Windows/Doors: The façade entry door has two panels and a single window opening with smaller lights enclosing a single larger light. Neither the material nor the age of the door cannot be determined from the available 2006 photograph. The façade windows have a large central fixed pane flanked by two vertical panes.

Setting (The physical environment--natural or manmade--of a historic site. Describe the setting and how it has changed over time.): The front yard was landscaped with lawn, small shrubs and a small pine tree in the 2006 photograph. The entrance is set at street level with a short gravel path leading to the wooden porch floor. The lot appears to slope down from the finished road grade behind the house.
