HISTORIC SITE FORM - HISTORIC SITES INVENTORY

PARK CITY MUNICIPAL CORPORATION (10-08)

Address: 359 Woodside Avenue

Building Type and/or Style: Foursquare type / Vernacular style

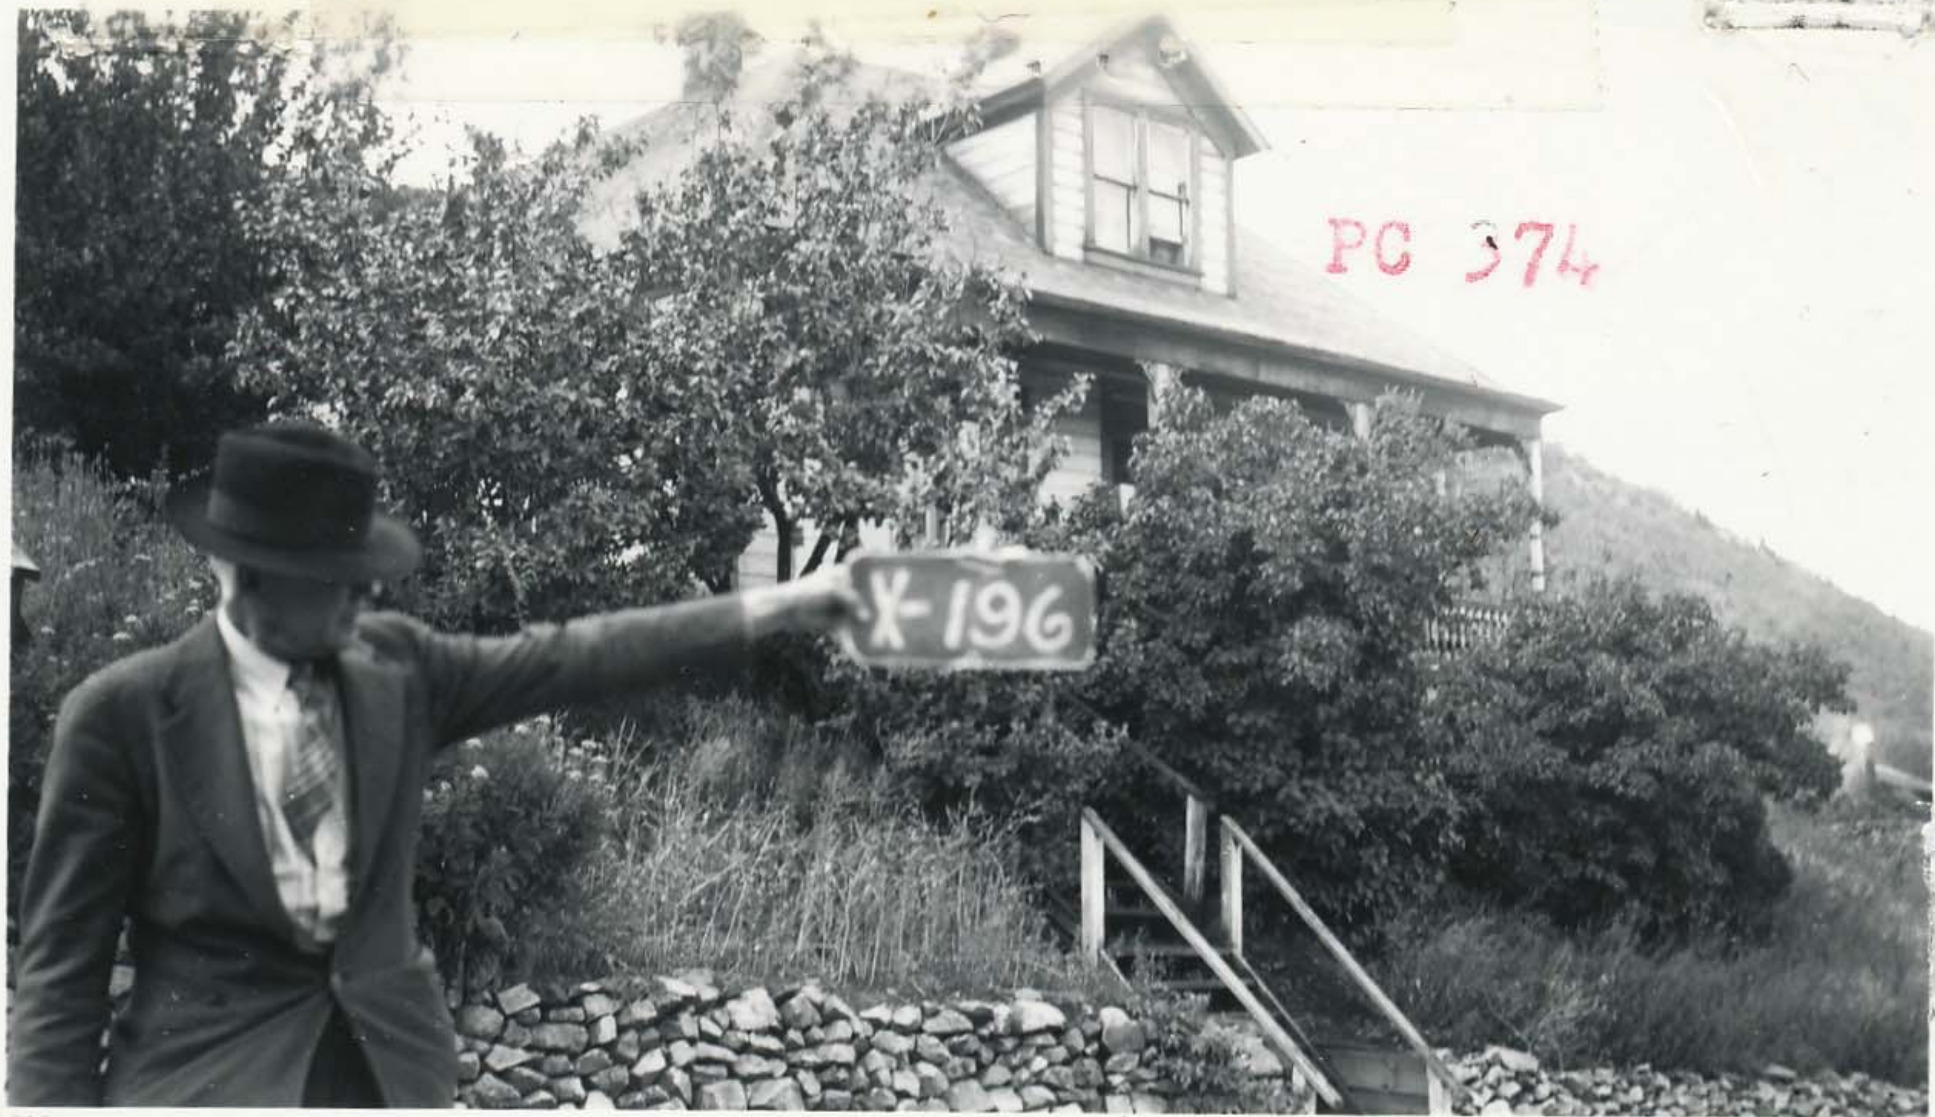
PC 374

One-and-a-half story frame home with hip roof, aluminum siding, and aluminum window frames. Two medium roof dormers remain, and the general shape of the structure has also apparently remained close to the original. The decorative front porch has been replaced with iron.
