HISTORIC SITE FORM - HISTORIC SITES INVENTORY

PARK CITY MUNICIPAL CORPORATION (10-08)

Name of Property: James Cassidy House

Address: 33 KING RD

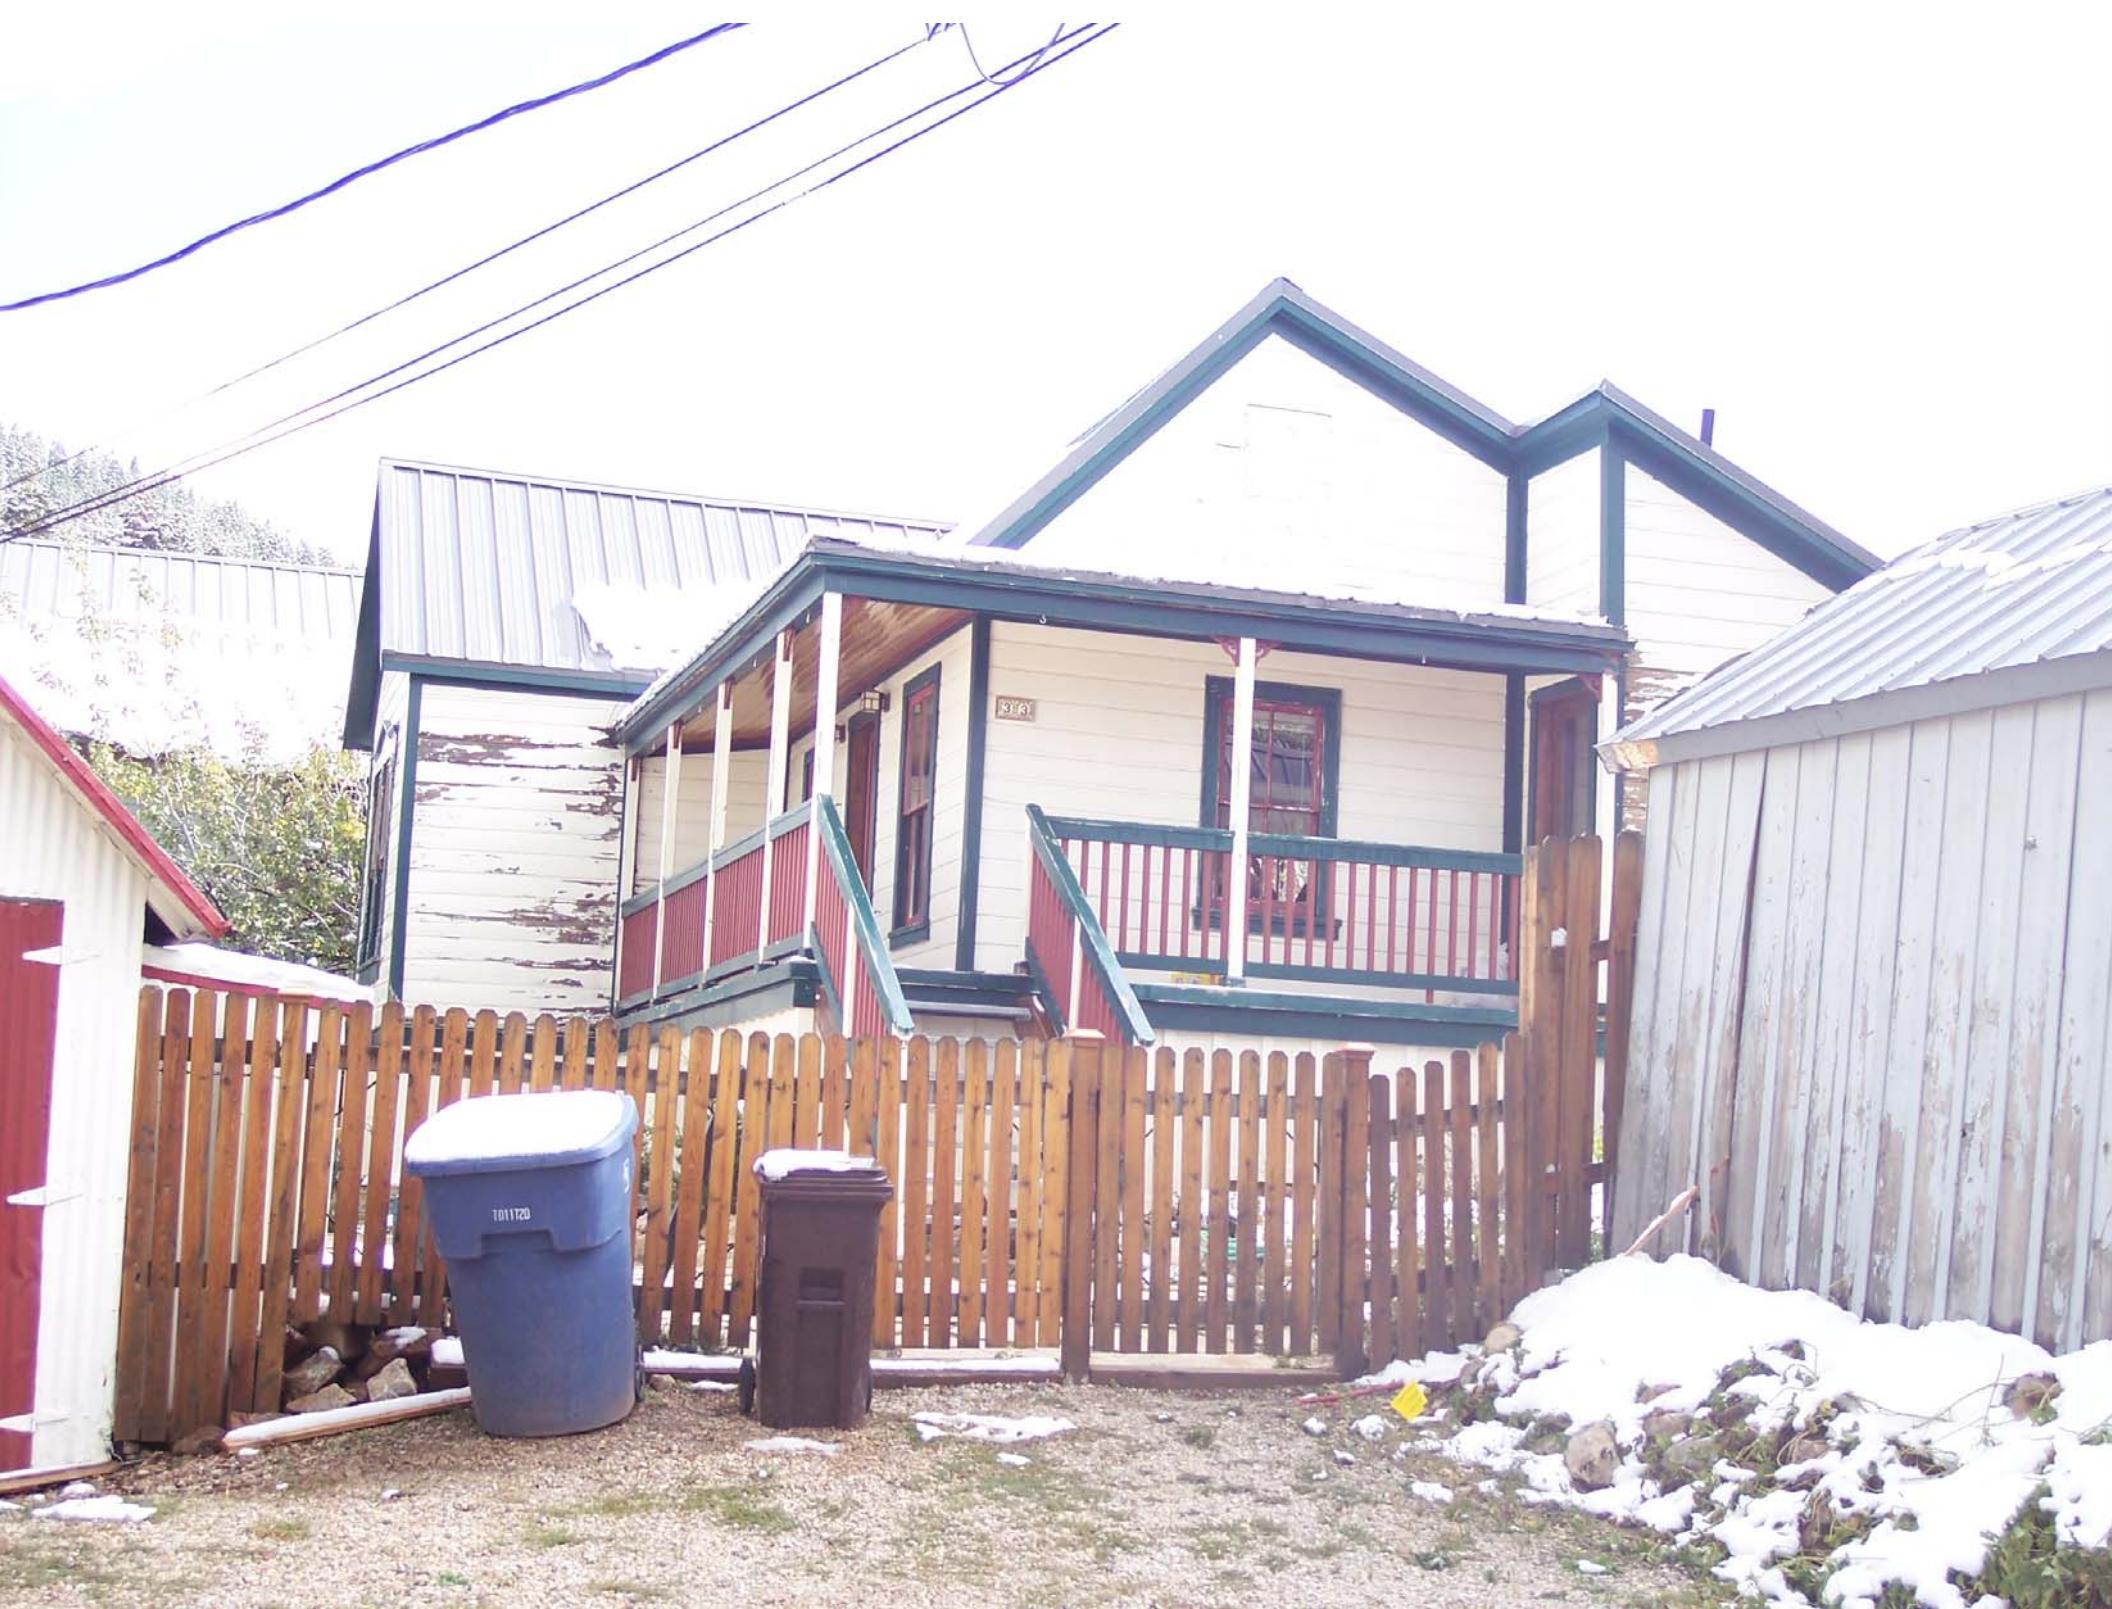
Photo No. 2: Accessory building. Camera facing south, 2006.

Site: The house sits back off the road (King Road). Wooden fence, small frame accessory building, and parking area between the fence and road. The accessory building is sheathed in metal corrugated materials--walls and roof--and is noted in the tax cards as having a wooden floor.
