HISTORIC SITE FORM - HISTORIC SITES INVENTORY

PARK CITY MUNICIPAL CORPORATION (10-08)

Address: 304 GRANT AVE

Building Type and/or Style: Hall-Parlor variant / Vernacular style

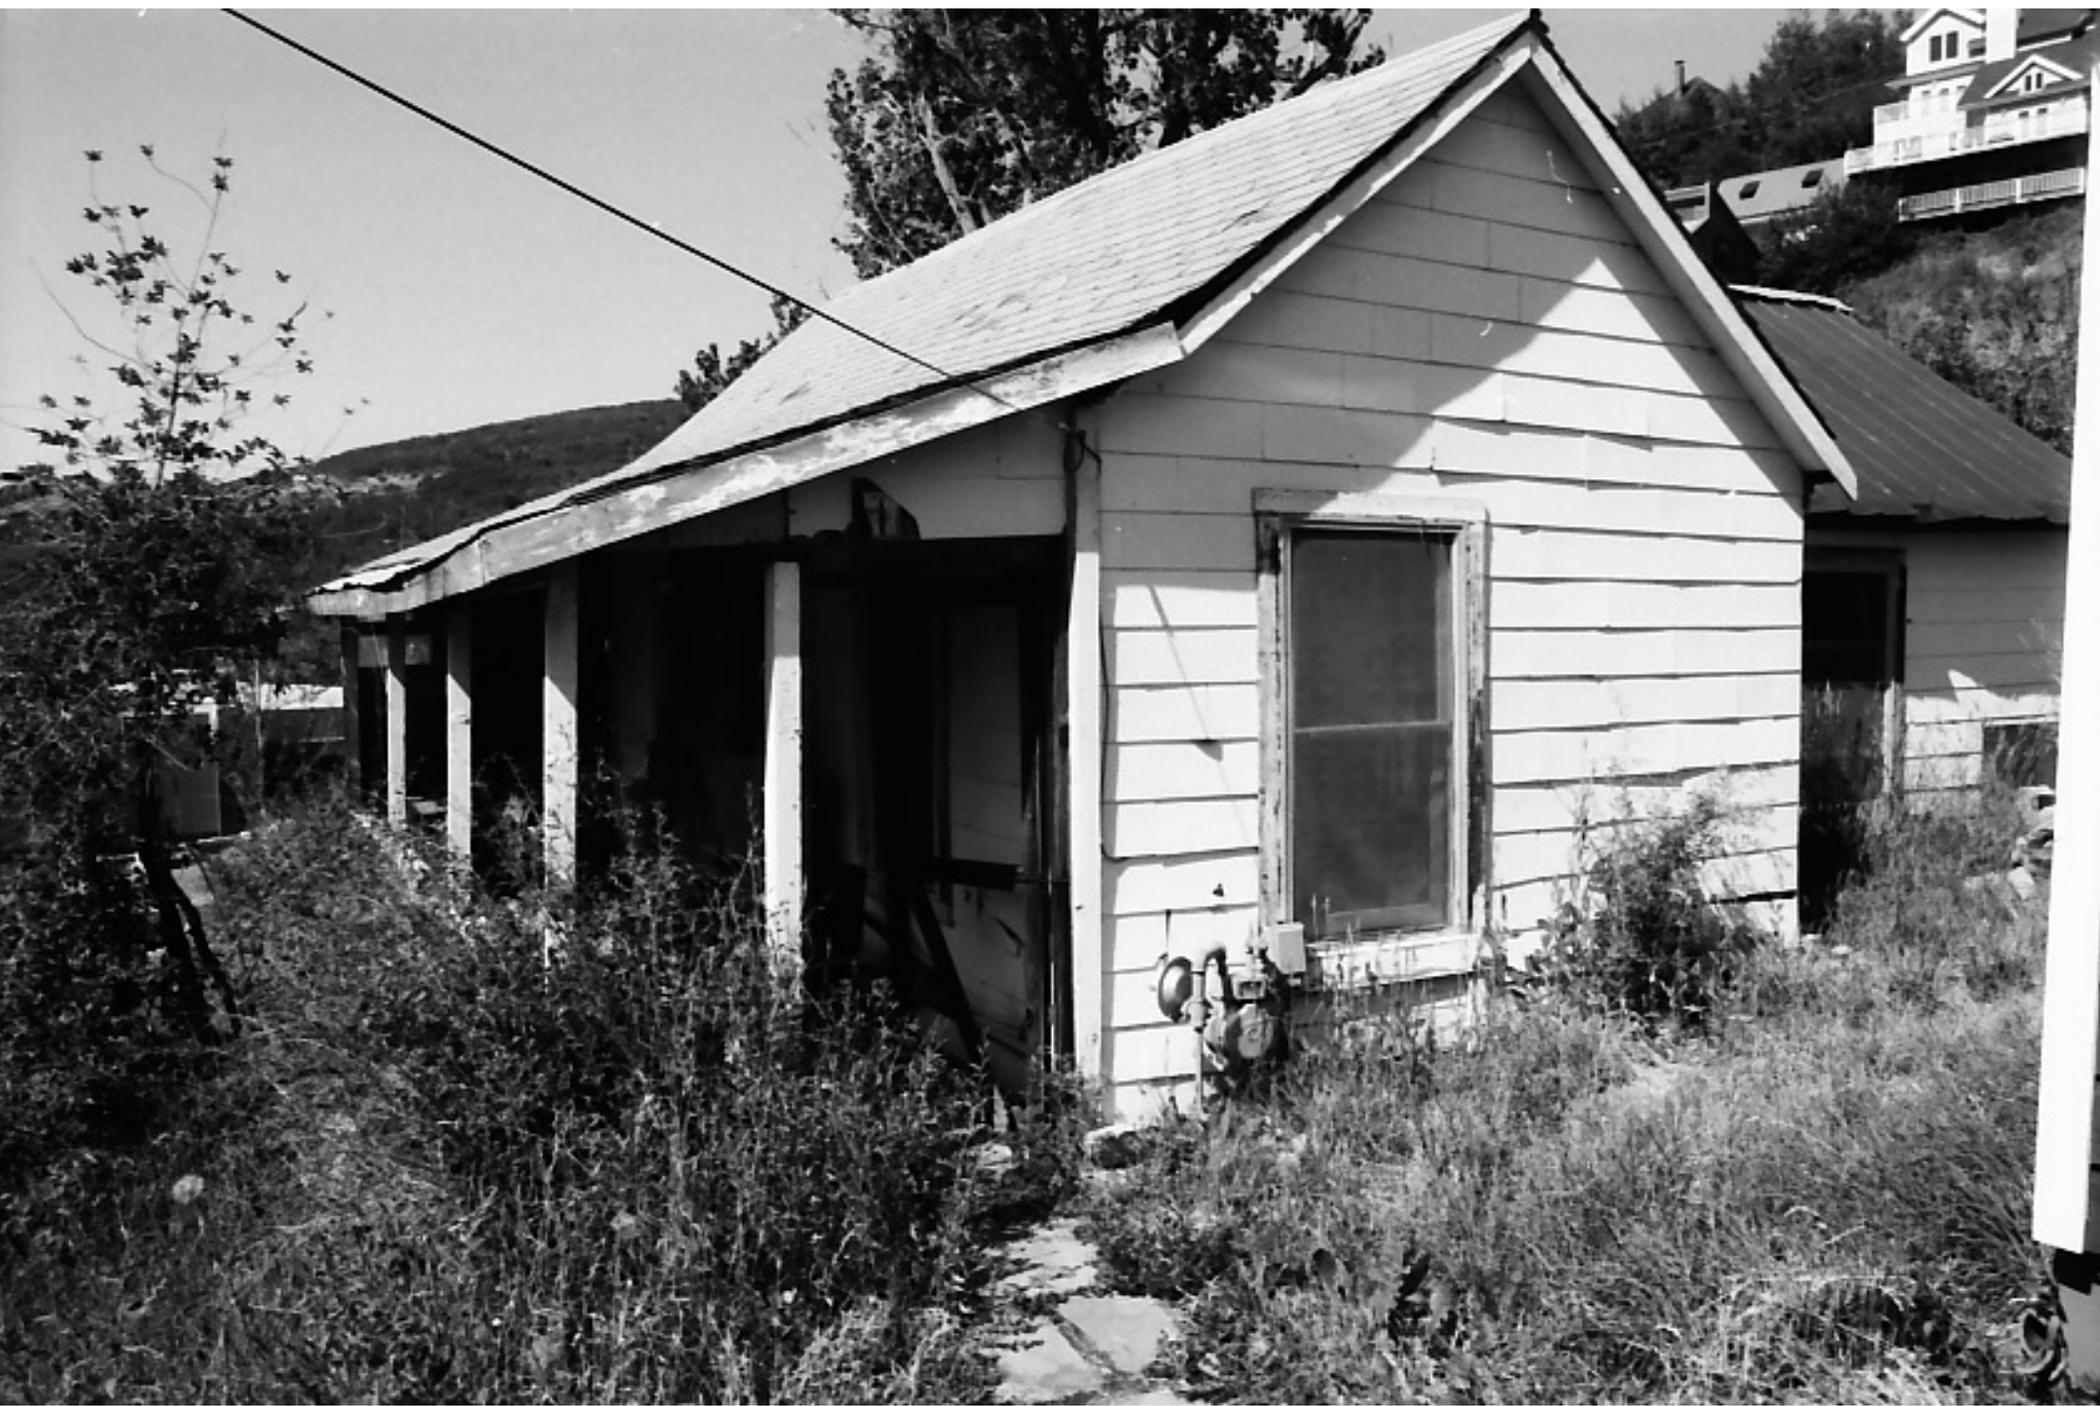
Photo No. 1: North elevation. Camera facing south, 2006.

Poor (Major problems are apparent and constitute an imminent threat. Describe the problems.): Complete disrepair, asbestos shingles cover most of the façade, yet areas of exposed wood siding are significantly deteriorated; roof appears to lack proper flashing and appears to be causing water damage throughout; windows and doors are in poor condition; paint is peeling or missing causing underlying wood to weather.
