# HISTORIC SITE FORM - HISTORIC SITES INVENTORY

PARK CITY MUNICIPAL CORPORATION (10-08)

Address: 187 Daly Avenue

Building Type and/or Style: T/L cottage

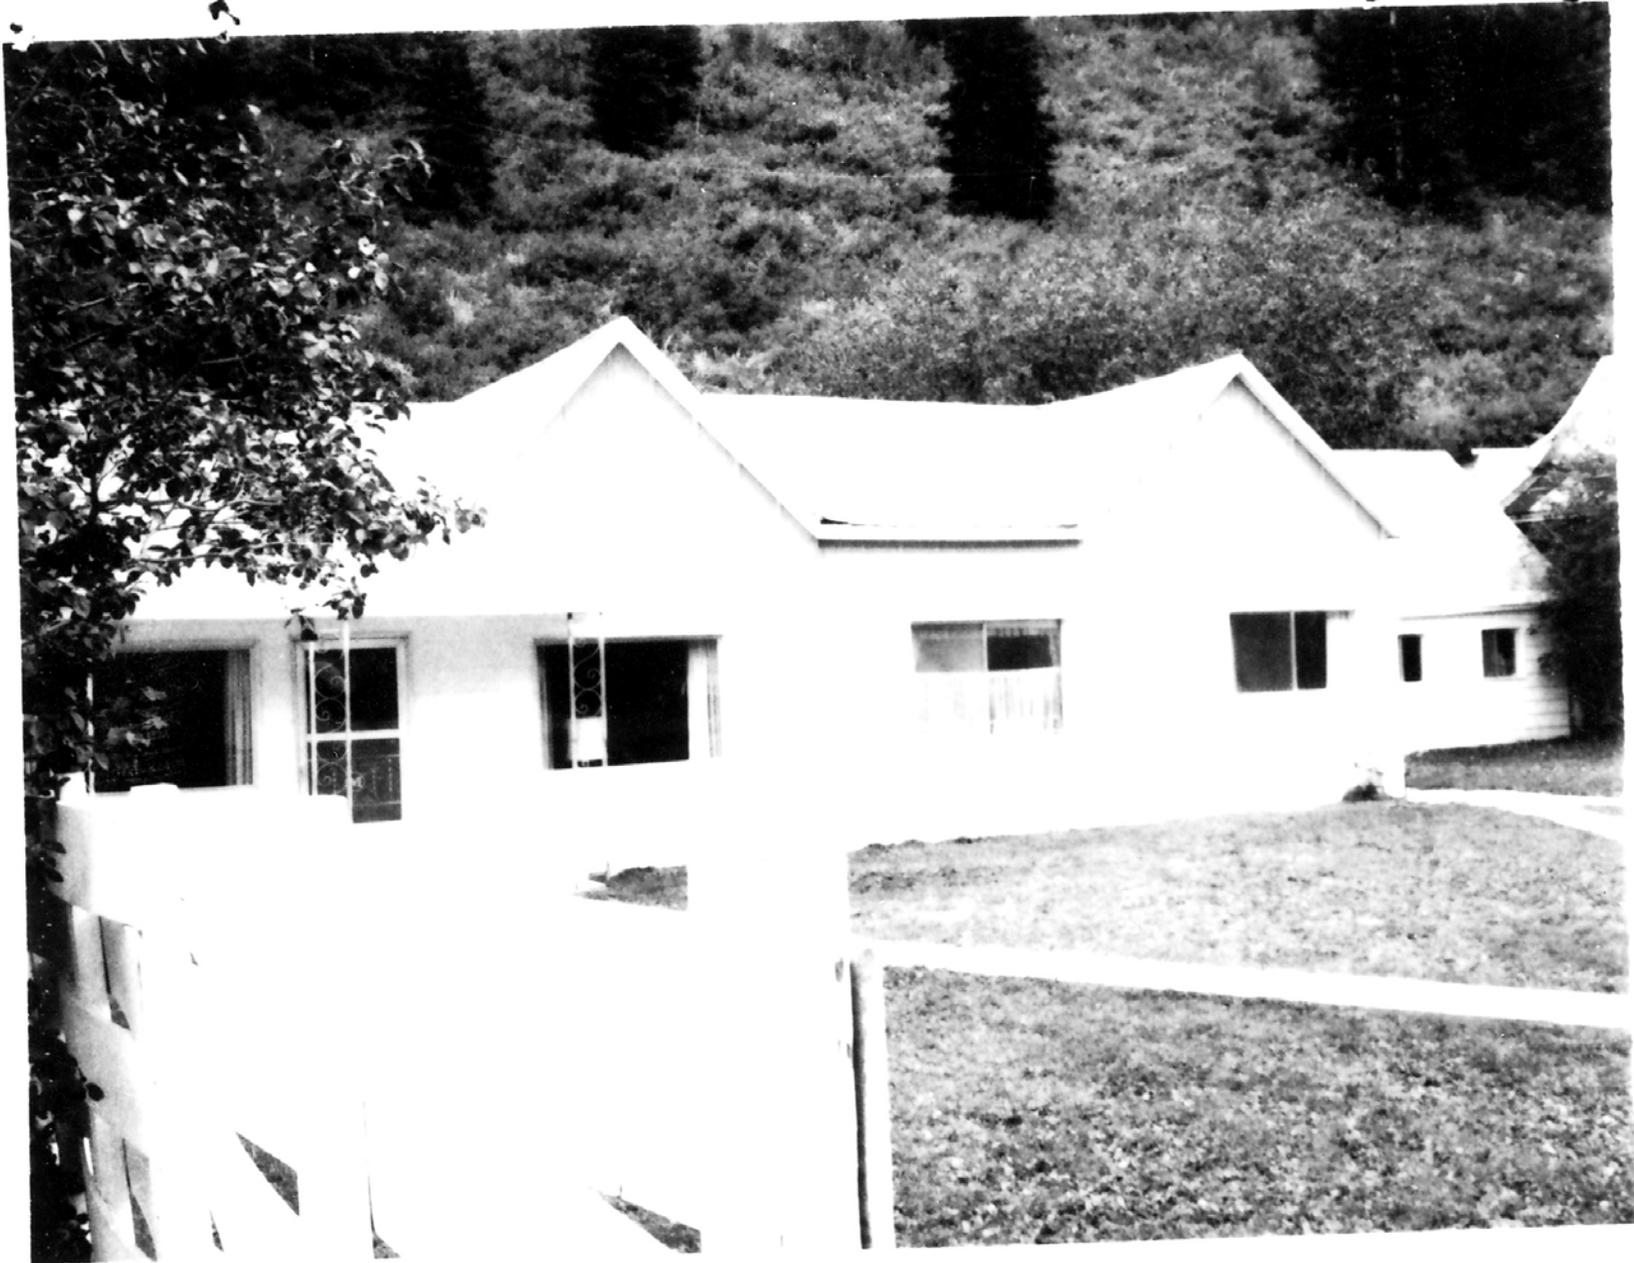
**Photo No. 1:** Northwest oblique. Camera facing southeast, 2006.

**Design** (The combination of physical elements that create the form, plan, space, structure, and style. Describe additions and/or alterations from the original design, including dates--known or estimated--when alterations were made): The one-story frame T/L cottage has been modified significantly over time. Based on earlier photographs, this house may have been moved closer to the roadway than it appears in 1995 and c. 1960 photographs; though it may be a reconstruction rather than the original house. Also, the earlier photographs suggest a duplex or side-by-side dwellings that at one time were connected. The current house appears to be the T/L cottage façade of one of the original houses with extensive rear additions. The additions spring from the ridgeline of the original house form. The house was raised to accommodate a concrete foundation and basement. The windows in the gable end are paired double-hung sash type windows, but are not vertically oriented as is typical on mining era homes. The tax photo shows a horizontal window with aluminum frame units. Also, the tax photo and 1995 photos show the house clad in aluminum siding. The modifications to the site are extensive and affect the site's historic character.
