HISTORIC SITE FORM - HISTORIC SITES INVENTORY

PARK CITY MUNICIPAL CORPORATION (10-08)

1 IDENTIFICATION			
Name of Property:			
Address: 305 Park Ave		AKA:	
City, County: Park City, Summi	t County, Utah	Tax Numb	per: PC-37
Current Owner Name: MARTZ Current Owner Address:PO BC Legal Description (include acre	X 1963 PARK CITY, U	IT 84060-1963	
2 STATUS/USE			
Property Category ☑ building(s), main ☐ building(s), attached ☐ building(s), detached ☐ building(s), public ☐ building(s), accessory ☐ structure(s)	Evaluation* □ Landmark Site ☑ Significant Site □ Not Historic *National Register of □ listed (date:)	Reconstruction Date: unknown Permit #: □ Full ☑ Partial Historic Places: ☑ ineligi	<u>Use</u> Original Use: Residential Current Use: Residential
3 DOCUMENTATION			
Blaes, Dina & Beatrice Lufkin. "Fin. Carter, Thomas and Goss, Peter. University of Utah Graduate S McAlester, Virginia and Lee. <i>A Fie</i> Roberts, Allen. "Final Report." Park	□ abstract of □ tax card □ original bui □ sewer pern □ Sanborn M □ obituary ind □ city directo vey □ census red □ biographica □ newspaper boks, articles, interviews al Report." Park City Histo Utah's Historic Architecture chool of Architecture and

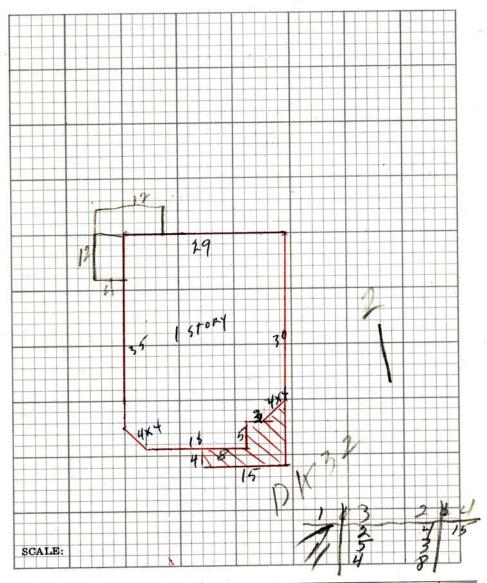
Gne-story frame dwelling with gable roof, having an aluminum covering. A front porch, with gable roof, exists on the northeast section. Ornate woodwork remains on the porch. In addition, decorative woodwork remians around a corner window in the southeast corner. Wood framing around the windows appears to have remained the same as in a 1940's tax photo.

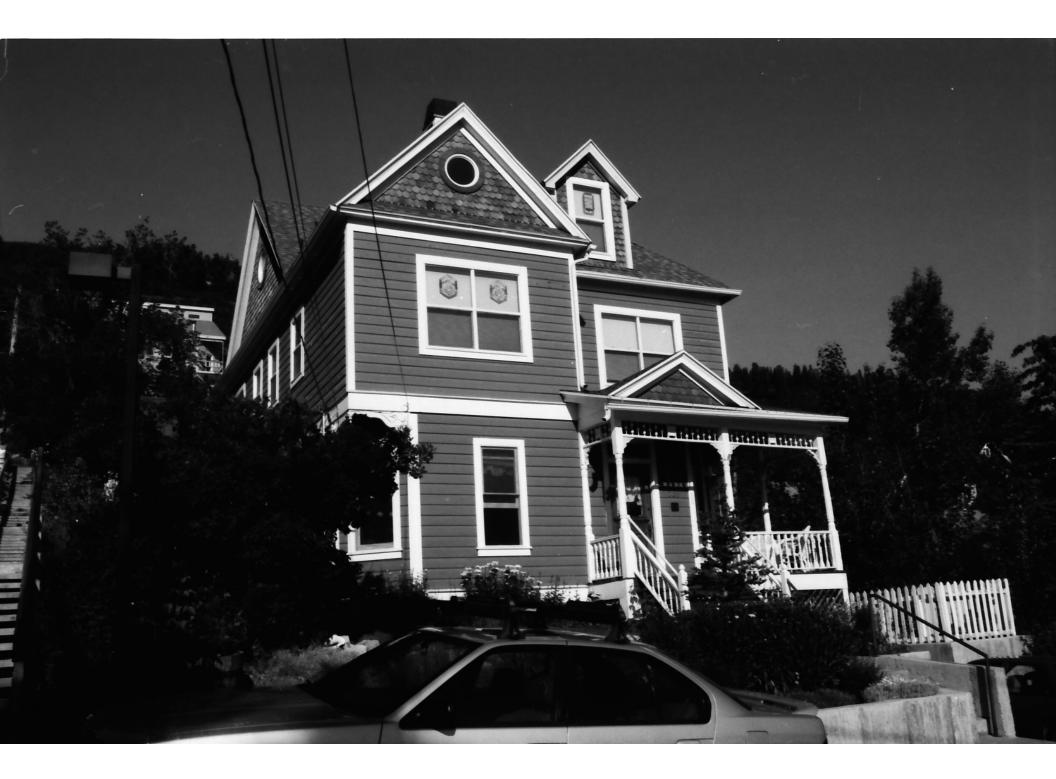
Photo No. 1: East elevation (primary façade). Camera facing west, 2006.

☑ Good (Well maintained with no serious problems apparent.)
☐ Fair (Some problems are apparent. Describe the problems.):
☐ Poor (Major problems are apparent and constitute an imminent threat. Describe the problems.):
☐ Uninhabitable/Ruin
Materials (The physical elements that were combined or deposited during a particular period of time in a particular pattern or configuration. Describe the materials.): Foundation: The foundation is not visible in the available photographs and therefore its material or existence cannot be verified. Tax records note that it was stone in 1949 and 1957.
Walls: The exterior walls are clad in wooden drop/novelty siding.
Roof: The hipped roof is sheathed in composition shingles. A siding-clad chimney shaft is visible on the façade.
Windows/Doors: Windows include one-over-one double-hung sash in simple casing with slightly projecting sills. The second floor façade windows are placed in pairs in horizontal openings. The front-facing gable end has a round window in the attic level.

Essential Historical Form: ☑ Retains ☐ Does Not Retain, due to:
Location: ☑ Original Location ☐ Moved (date) Original Location:
Design (The combination of physical elements that create the form, plan, space, structure, and style. Describe additions and/or alterations from the original design, including datesknown or estimatedwhen alterations were made): The original house appears on Sanborn insurance company maps in 1907 and tax records in both 1949 and 1957 as a two story house with a rectangular footprint, narrow end to the street. Both tax records noted that the house was vacant at the time of inspection. The tax record for 1968, the 1978 site form, and an undated slide in the file show a single-story frame house. Perhaps there was a fire in the 1957-1968 period. The house was capped with a full second floor and attic between 1978 and 1995, creating a Central-block-with-projecting-bay type house. No photographs are available of the original two-story house. The accuracy of the reconstruction is not evident.
