# HISTORIC SITE FORM - HISTORIC SITES INVENTORY

Name of Property: **Ellsworth J. Beggs House**

Address: 703 PARK AVE

Building Type and/or Style: House - Pyramid (2-story, foursquare) False front garage No. Stories: 2

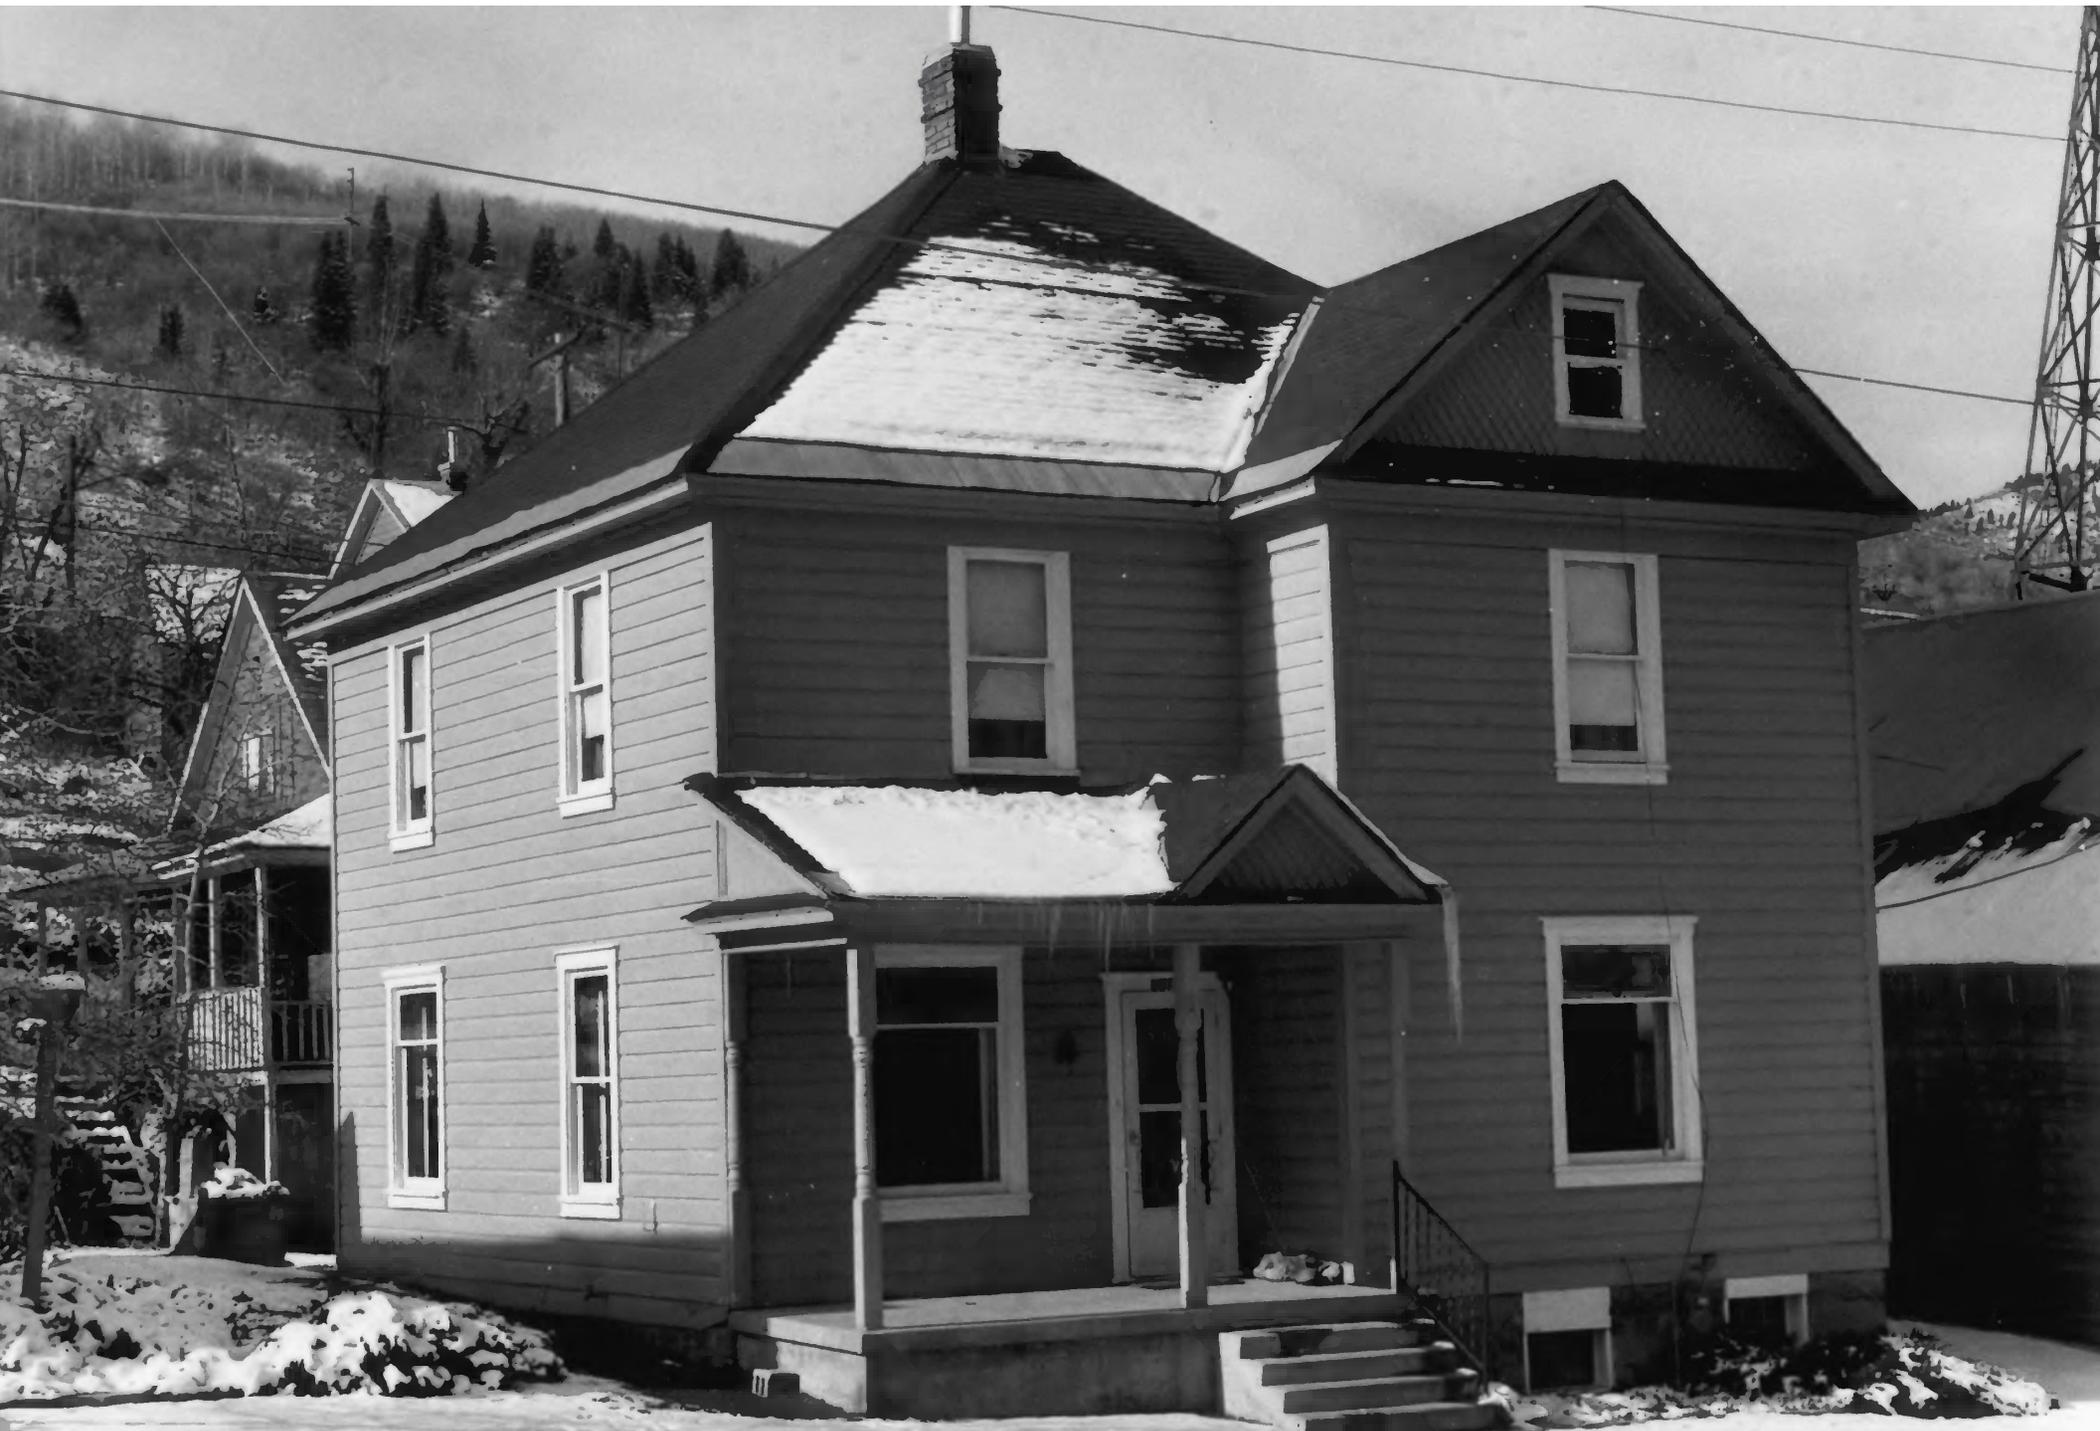
View from Southeast corner

This house is a two story frame box with a projecting cross-wing on the facade. It is a variant of the pyramid house. It has a pyramid roof over the box section, and a gable roof over the cross-wing. A small porch fills the space beside the crosswing. The porch piers are lathe turned, and a decorative pediment projects from the porch roof over the entrance area. The diamond cut shingles of the porch pediment match those of the cross-wing gable. Both first floor windows on the facade are broad single pane and transom windows. The transom windows are filled with leaded glass. One window flanks the door, and the other is set into the gable end. Most of the windows on the rest of the house are the one over one double hung sash type. There is a one story rear extension which is probably original. A small frame shed was built between this house and the garage to the north. It touches the house, but does not penetrate the wall. The shed therefore does not affect the original character of the house. This building is in excellent condition, and is essentially unaltered on the exterior. It maintains its original integrity.
