HISTORIC SITE FORM - HISTORIC SITES INVENTORY

PARK CITY MUNICIPAL CORPORATION (10-08)

1 IDENTIFICATION			,								
Name of Property:											
Address: 1266 PARK AVE		AKA: 1	AKA: ?1260 Park								
City, County: Park City, Summit	County, Utah	Tax Nu	Tax Number: ARPC-2								
Current Owner Name: ALPINE Current Owner Address: 1404 A	ANVIL DR, DRAPER, U	T 84020	Parent Parcel(s): SA-374 & SA-376								
Legal Description (include acreage): SUBD: ALPINE RETREAT @ PARK CITY CONDO UNIT: 2; 0.0 AC											
2 STATUS/USE											
Property Category ☑ building(s), main □ building(s), attached □ building(s), detached □ building(s), public □ building(s), accessory □ structure(s)	Evaluation* □ Landmark Site ☑ Significant Site □ Not Historic *National Register of H □ listed (date:)	Reconstruction Date: Permit #: □ Full □ Partial Historic Places: ☑ ine	<u>Use</u> Original Use: Residential Current Use: Residential eligible □ eligible								
3 DOCUMENTATION											
Blaes, Dina & Beatrice Lufkin. "Fina Carter, Thomas and Goss, Peter.	□ abstract of □ tax card □ original buil □ sewer perm □ Sanborn Ma □ obituary ind □ city director □ census reco □ biographica □ newspapers oks, articles, inte

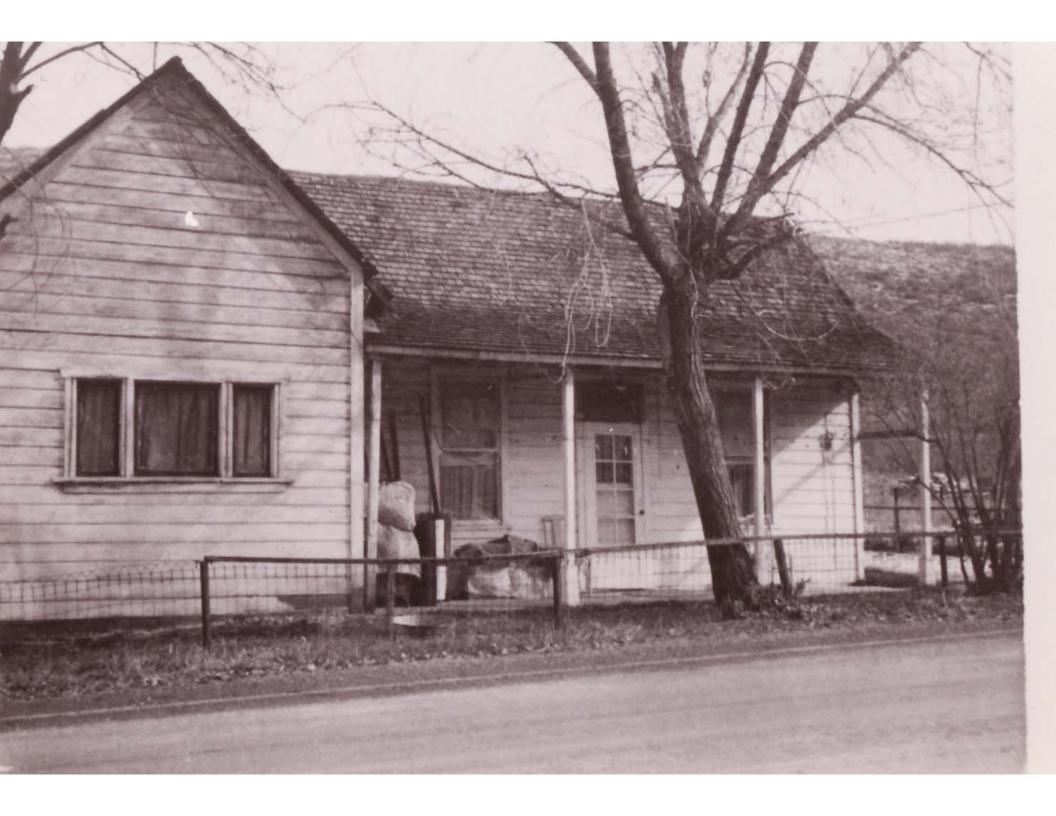
Photo No. 1: West elevation. Camera facing east, 2006.Photo No. 2: West elevation. Camera facing east, 1995.Photo No. 3: West elevation. Camera facing east, c. 1945.
