HISTORIC SITE FORM - HISTORIC SITES INVENTORY

PARK CITY MUNICIPAL CORPORATION (10-08)

Name of Property:Address: 139 Woodside AvenueAKA:City, County: Park City, Summit County, UtahTax Number: MLCH-A-AMCurrent Owner Name: Steven & Robin AltschulerParent Parcel(s): PC-402 & PC-403Current Owner Address: 210 W Rittenhouse Sq, #2703, Philadelphia, PA 19103-5777

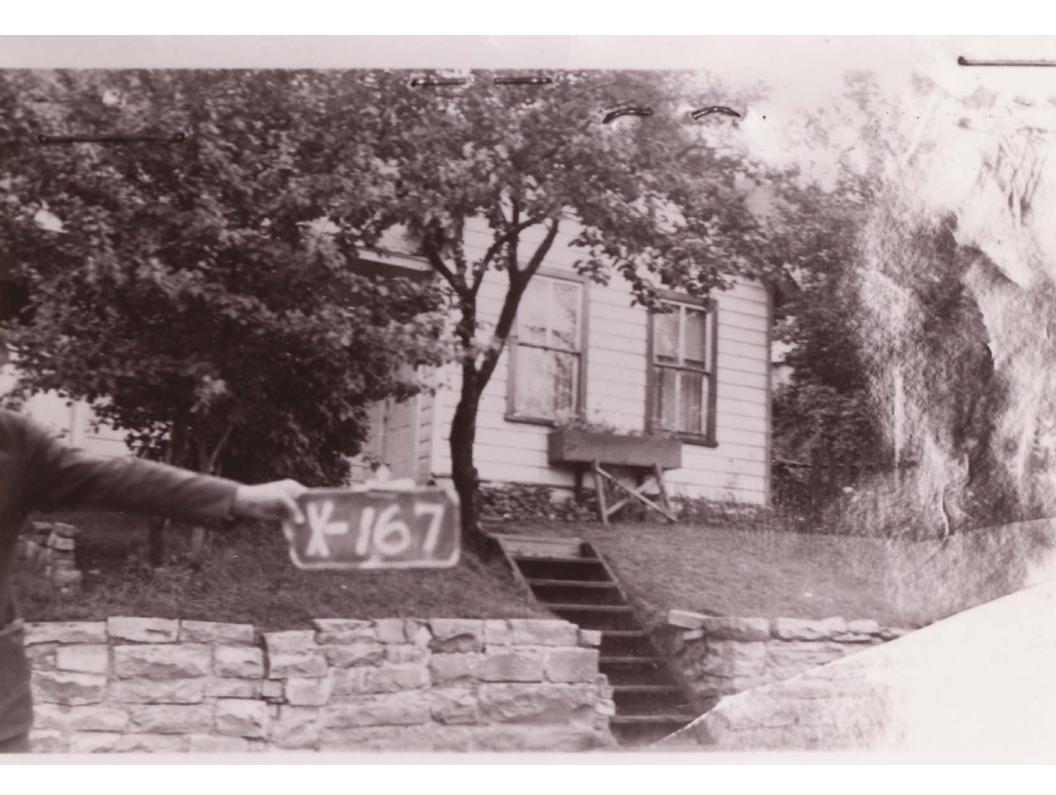
One-story frame dwelling with gable roof. The siding and window treatments are now aluminum. Window openings have been altered, as in the case of two two-overtwo double-hung windows on the front gable section having been replaced by one aluminum frame window.
