HISTORIC SITE FORM – HISTORIC SITES INVENTORY

PARK CITY MUNICIPAL CORPORATION (10-08)

Name of Property: House at 581	Park Avenue			
Address: 581 Park Avenue			A.K.A.:	
City, County: Park City, Summit County, Utah			Tax Number: 581-PA-1	
Current Owner Name: Floyd L. and Elaine E. English (H/W joint) Pa			Parent Parcel(s): PC-84	
Current Owner Address: 223 E. Maxan Street #310, Port Isabel, TX 78578				
Legal Description (include acreage): LOT 1 581 PARK AVENUE AMENDMENT; ACCORDING TO THE OFFICIAL PLAT ON FILE IN THE SUMMIT COUNTY RECORDERS OFFICE CONT 0.065 AC				
2 STATUS/USE				
building(s), main building(s), attached building(s), detached building(s), public	☐ Landmark Site Date: ☑ Significant Site Perm	it #: C III □ Partial	<u>Ise</u> Driginal Use: single dwelling Current Use: single dwelling ⊠ ineligible	
3 DOCUMENTATION				
 <u>Photos: Dates</u> ⊥ tax photo: c. 1941 ⊥ prints: Nov. 2014 (6) ⊥ historic: <u>Drawings and Plans</u> ⊥ measured floor plans ⊥ site sketch map ⊥ Historic American Bldg. Survet ⊥ original plans: ⊥ other: 	 ☑ abstract of title ☐ tax card ☐ original building p ☐ sewer permit ☑ Sanborn maps ☐ obituary index ☐ city directory/gaze Evy ☑ census records ☐ biog

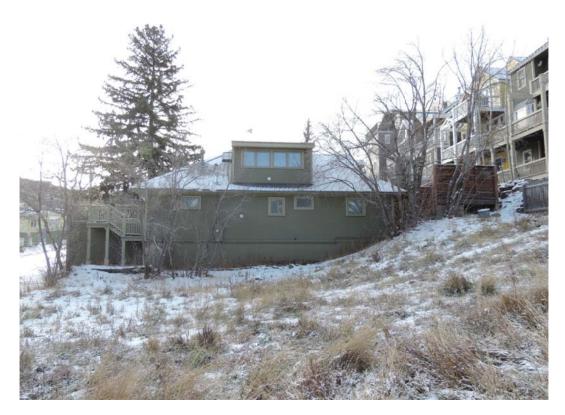
Photo No. 5: North elevation. Camera facing south. November 2014.

Feeling: The historic feel has been diluted substantially by a garage that projects from the front façade of this house and other alterations that have accumulated over the years. The historic integrity that remains in the house is visible from the north elevation, where the original pyramid house volume is apparent. The historic

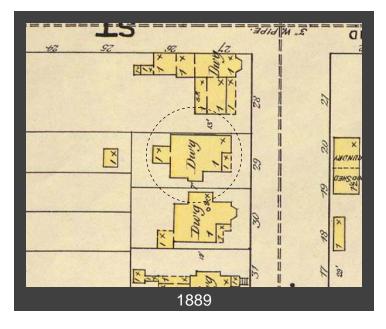
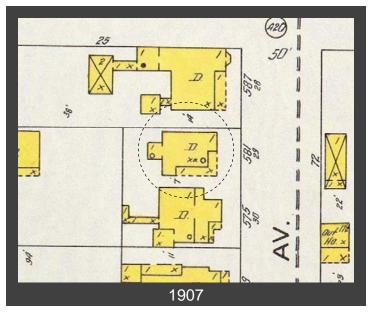
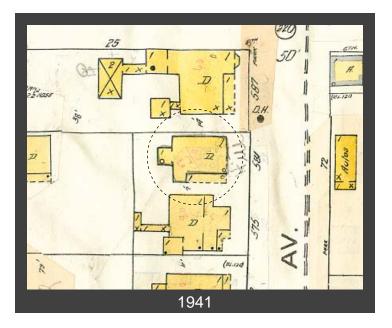
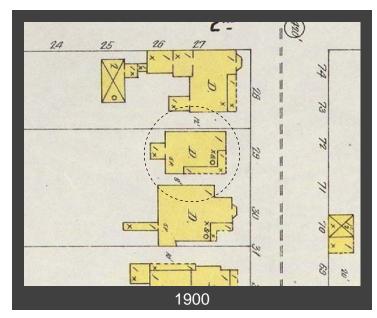
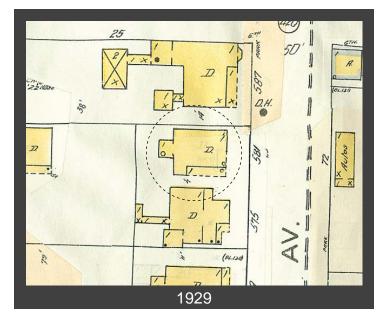
Sanborn Map History

Association: Built in the early years of Park City, the historic portion of the house is associated with the "Settlement and Mining Boom Era." However, this association has been diluted by subsequent additions and alterations to the original pyramid house, which are related to the development of the ski industry in Park City and the ensuing real estate boom. Lucien Simon was the first person to own the consolidated north half of lot 20 and all of lot 21, which he bought in 1887. Sarah and Jacob Richardson, who was an early Park City undertaker, bought it in 1892 and took out a \$1,000 mortgage on the property. The original house is shown on the 1889 Sanborn Map of Park City, so it was probably built around that time.
