HISTORIC SITE FORM - HISTORIC SITES INVENTORY

PARK CITY MUNICIPAL CORPORATION (10-08)

| 1 IDENTIFICATION | | | | | |
|---|---|--|--|--|--|
| Address: 901 NORFOLK AVE | | AKA: | | | |
| Building Type and/or Style: Cross-wing type / Vernacular style No. Stories: 1 ½ | | | | | |

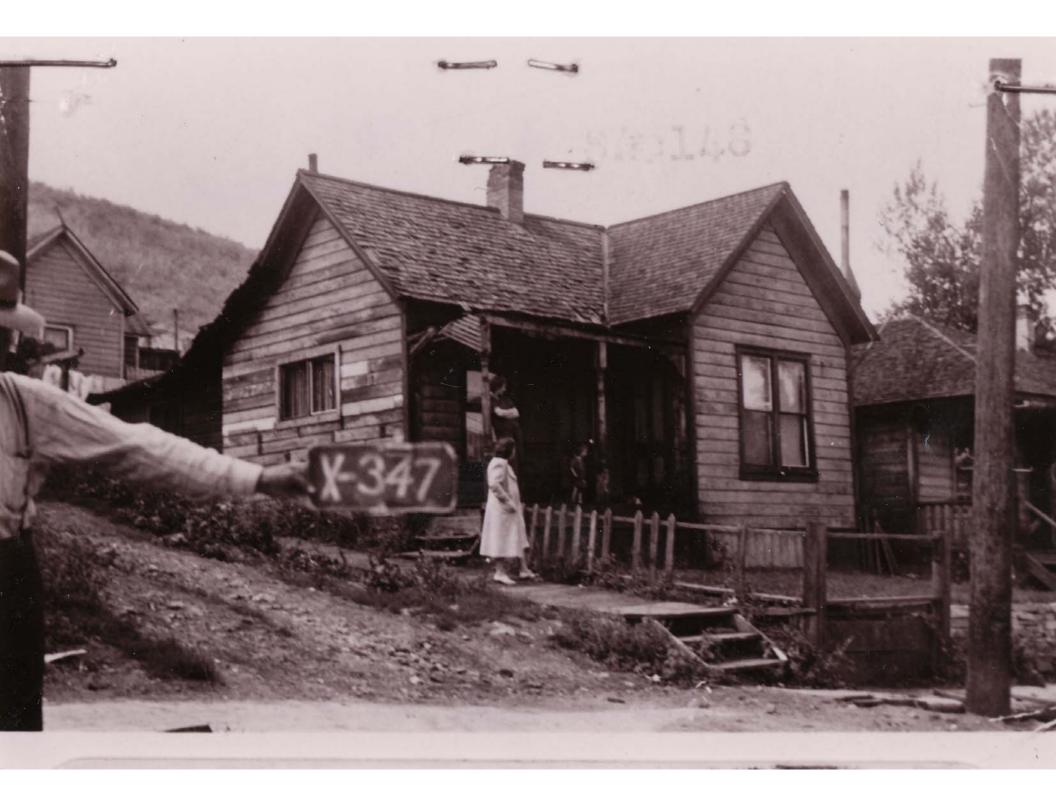
Photo No. 1: East elevation (primary façade). Camera facing west, 2006. Photo No. 2: East elevation (primary facade). Camera facing west, 1995 **Photo No. 3:** Southeast oblique. Camera facing northwest, tax photo.
