HISTORIC SITE FORM - HISTORIC SITES INVENTORY

PARK CITY MUNICIPAL CORPORATION (10-08)

Address: 1002 1/2 NORFOLK AVE

Building Type and/or Style: Cross-wing type / Vernacular type

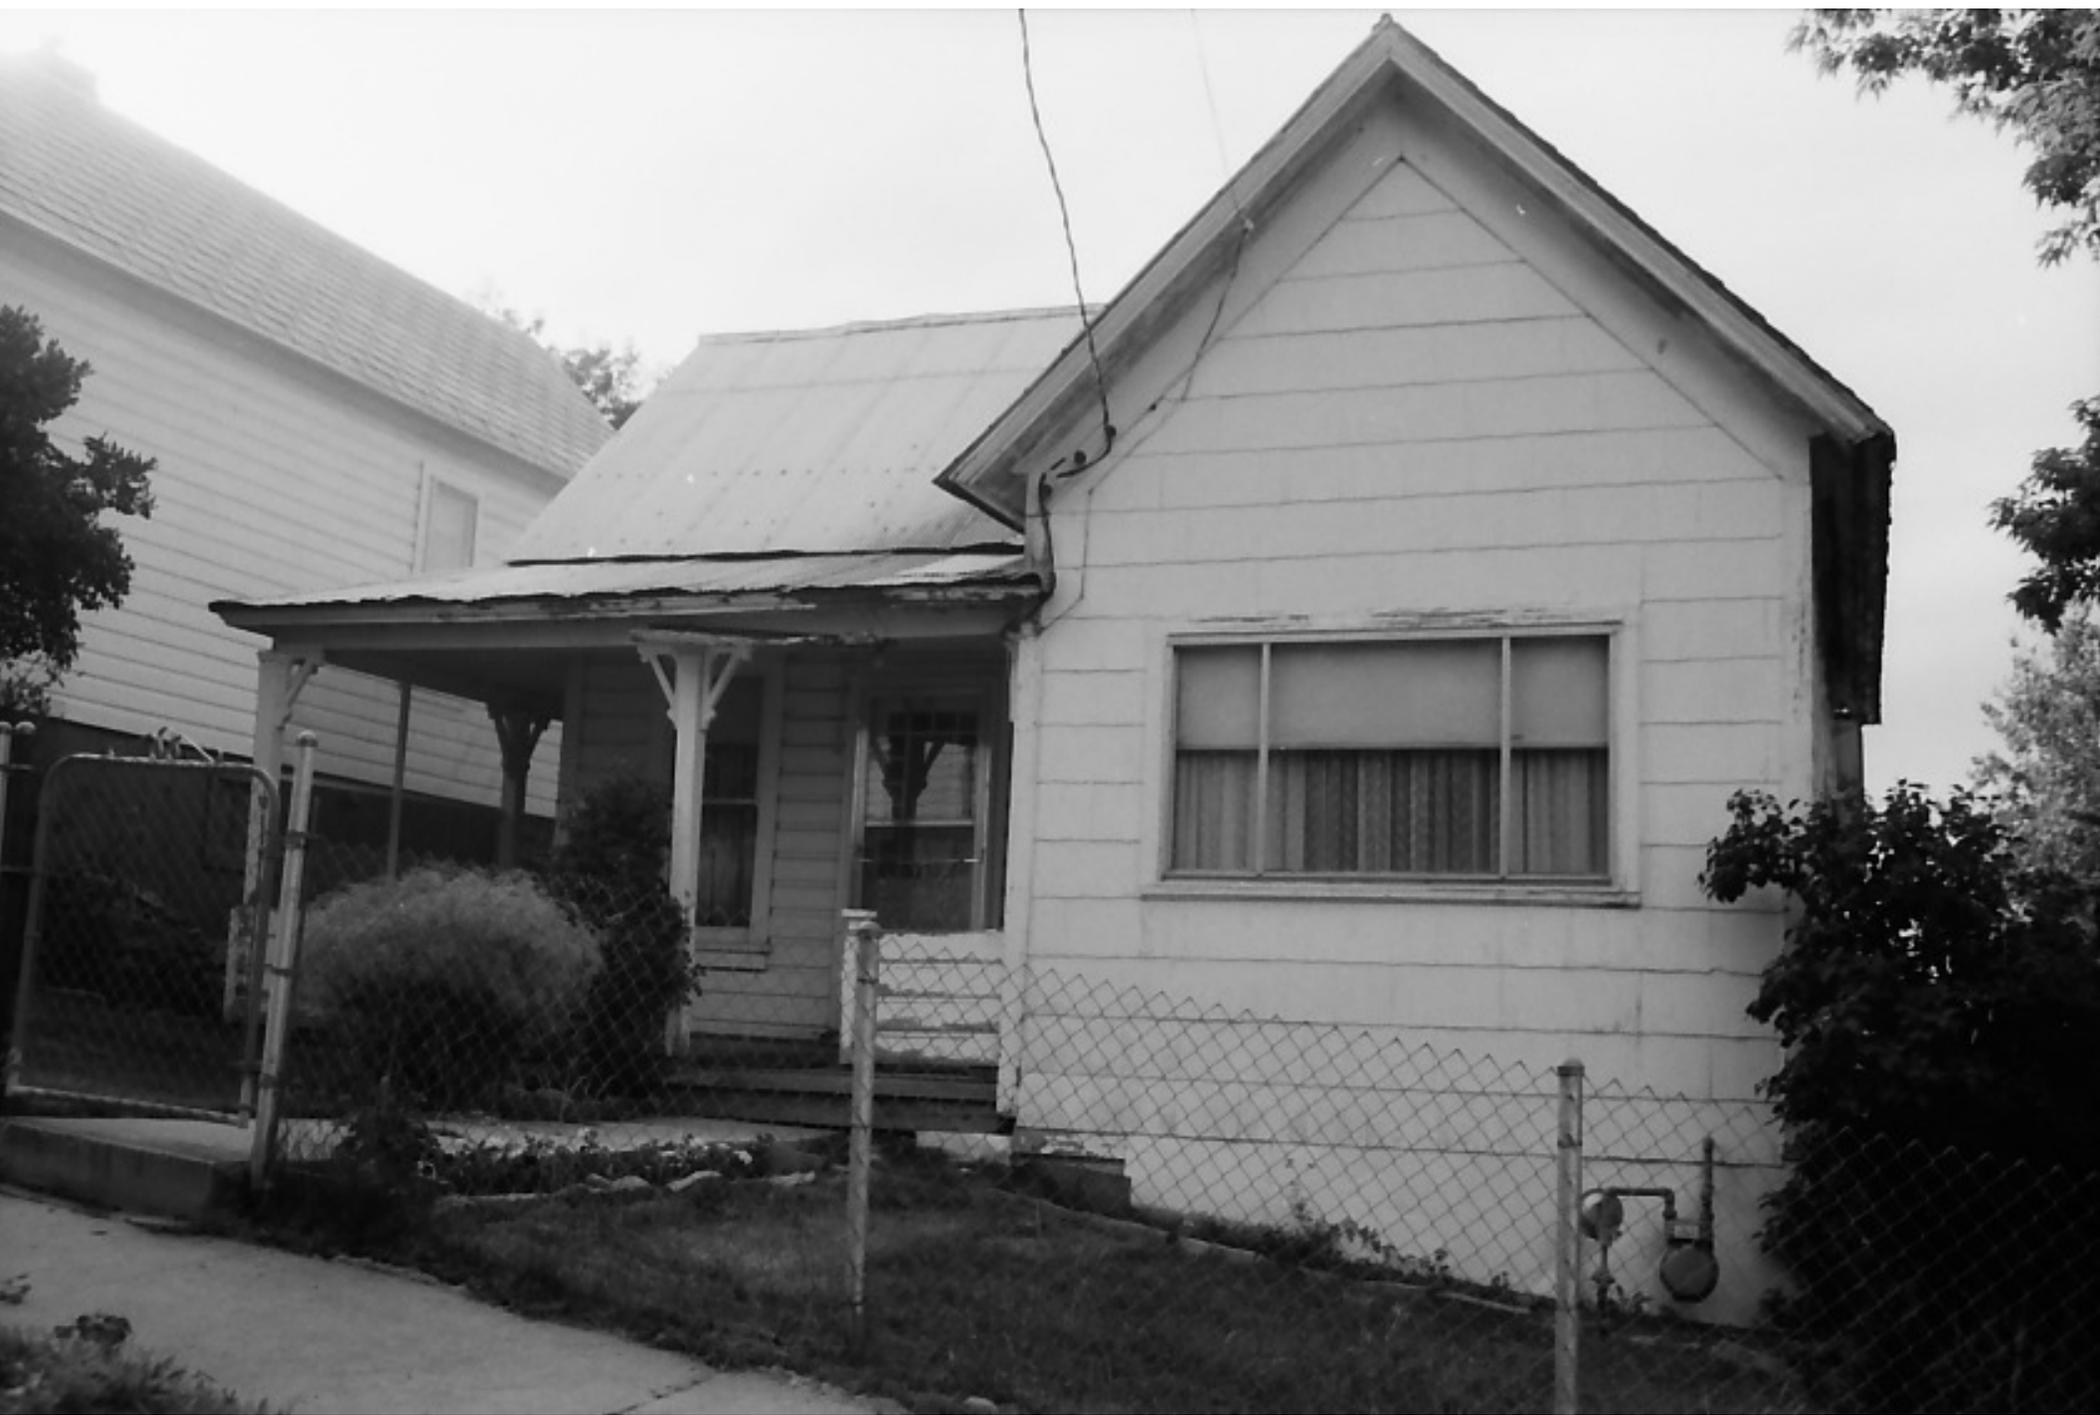
Photo No. 1: Southwest oblique. Camera facing northeast, 2006.

- Good (Well maintained with no serious problems apparent.)
- Fair (Some problems are apparent. Describe the problems.): Several spots have peeling paint and exposed wood. These include the casing around the horizontal window opening on the side gable end wall and the
- Poor (Major problems are apparent and constitute an imminent threat. Describe the problems.):
- Uninhabitable/Ruin

Walls: The exterior walls are clad in wooden drop (novelty) siding and what appears to be wooden or asbestos shingles on the side gable end wall.

Roof: The roof is sheathed in corrugated metal. The tax cards for 1958 and 1968 note that the roof is galvanized aluminum, presumably the current roof. A brick chimney is set just off the ridge line.

Windows: The visible windows include a one-over-one double-hung and a group of three set in a horizontal opening. The set of three appear to be replacements windows in possible aluminum or vinyl sash.
