HISTORIC SITE FORM - HISTORIC SITES INVENTORY

PARK CITY MUNICIPAL CORPORATION (10-08)

Address: 342 MARSAC AVE

Building Type and/or Style: Pyramid (foursquare) type / vernacular style

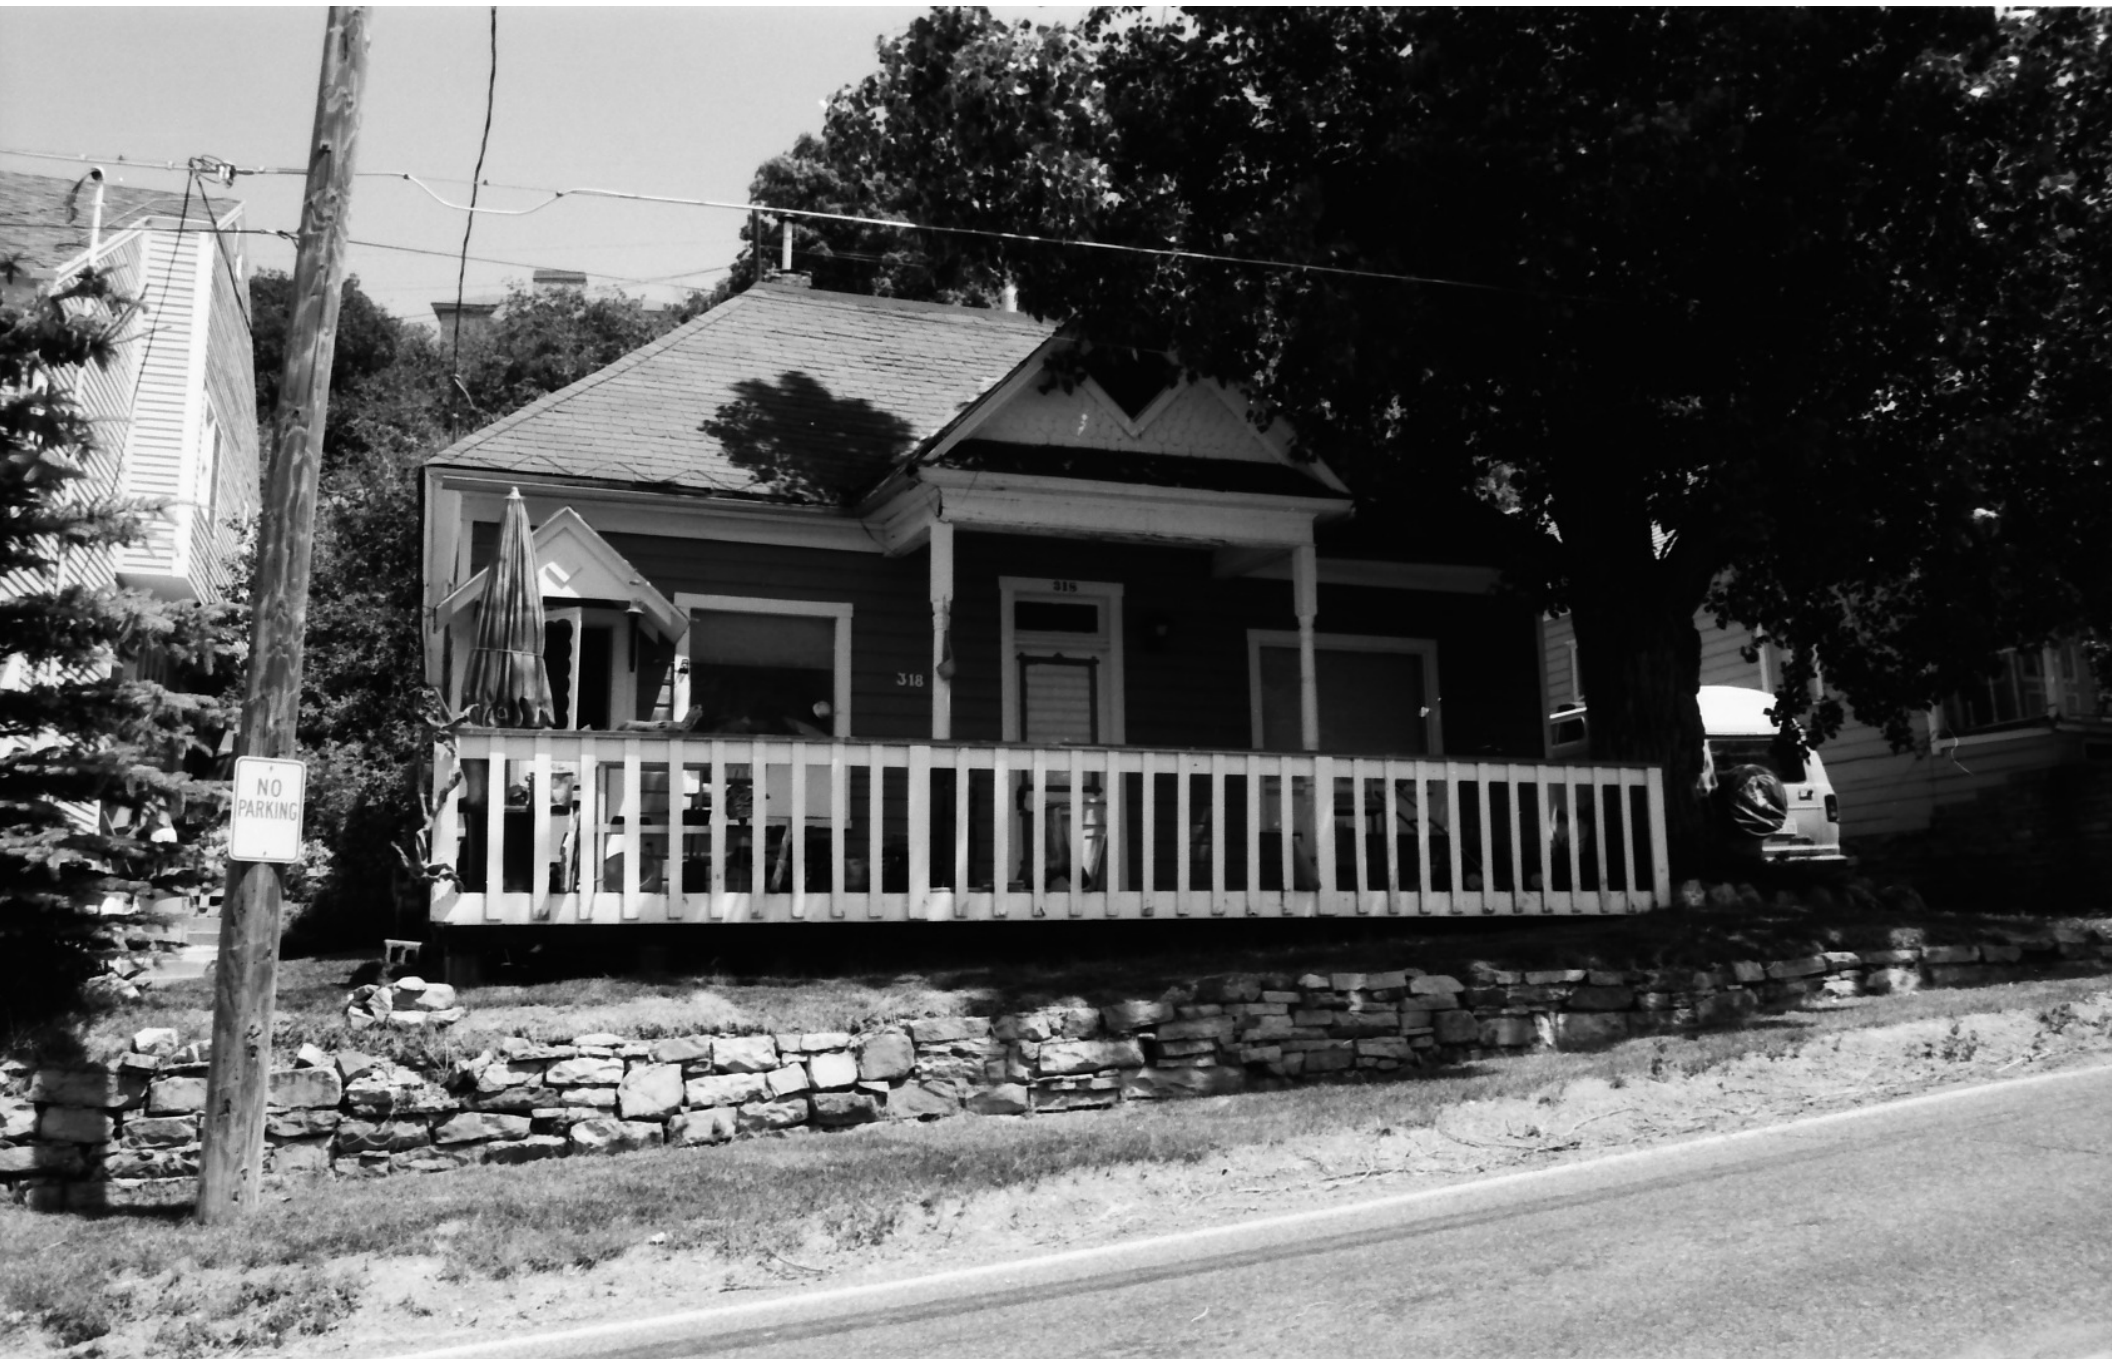
Photo No. 1: Southwest oblique. Camera facing northeast, 2006.

Walls: The exterior walls are sheathed in a drop-novelty wooden siding. The gable-end of the entrance porch roof is clad in patterned wooden shingles that are both octagonal and a varied design.

Roof: The roof is flat-topped and hipped, a "deck" roof form, clad in asphalt shingles. The two brick chimneys appear to have lost their corbelled tops but remain on the roof, topped with metal shafts.

Windows/Doors: The early windows on the facade had leaded glass transoms and a large single pane below in vertical openings visible in the c. 1940 tax photo. The current facade window has a transom-sized section in clear glass on the bottom with the larger single pane above. Simple wooden casings remain as window surrounds. The front entry door has a large single light with patterned, colored leaded glass. It appears to be of the original period.
