HISTORIC SITE FORM - HISTORIC SITES INVENTORY

PARK CITY MUNICIPAL CORPORATION (10-08)

Address: 270 GRANT AVE

Building Type and/or Style: "L" Cottage or "T" Cottage

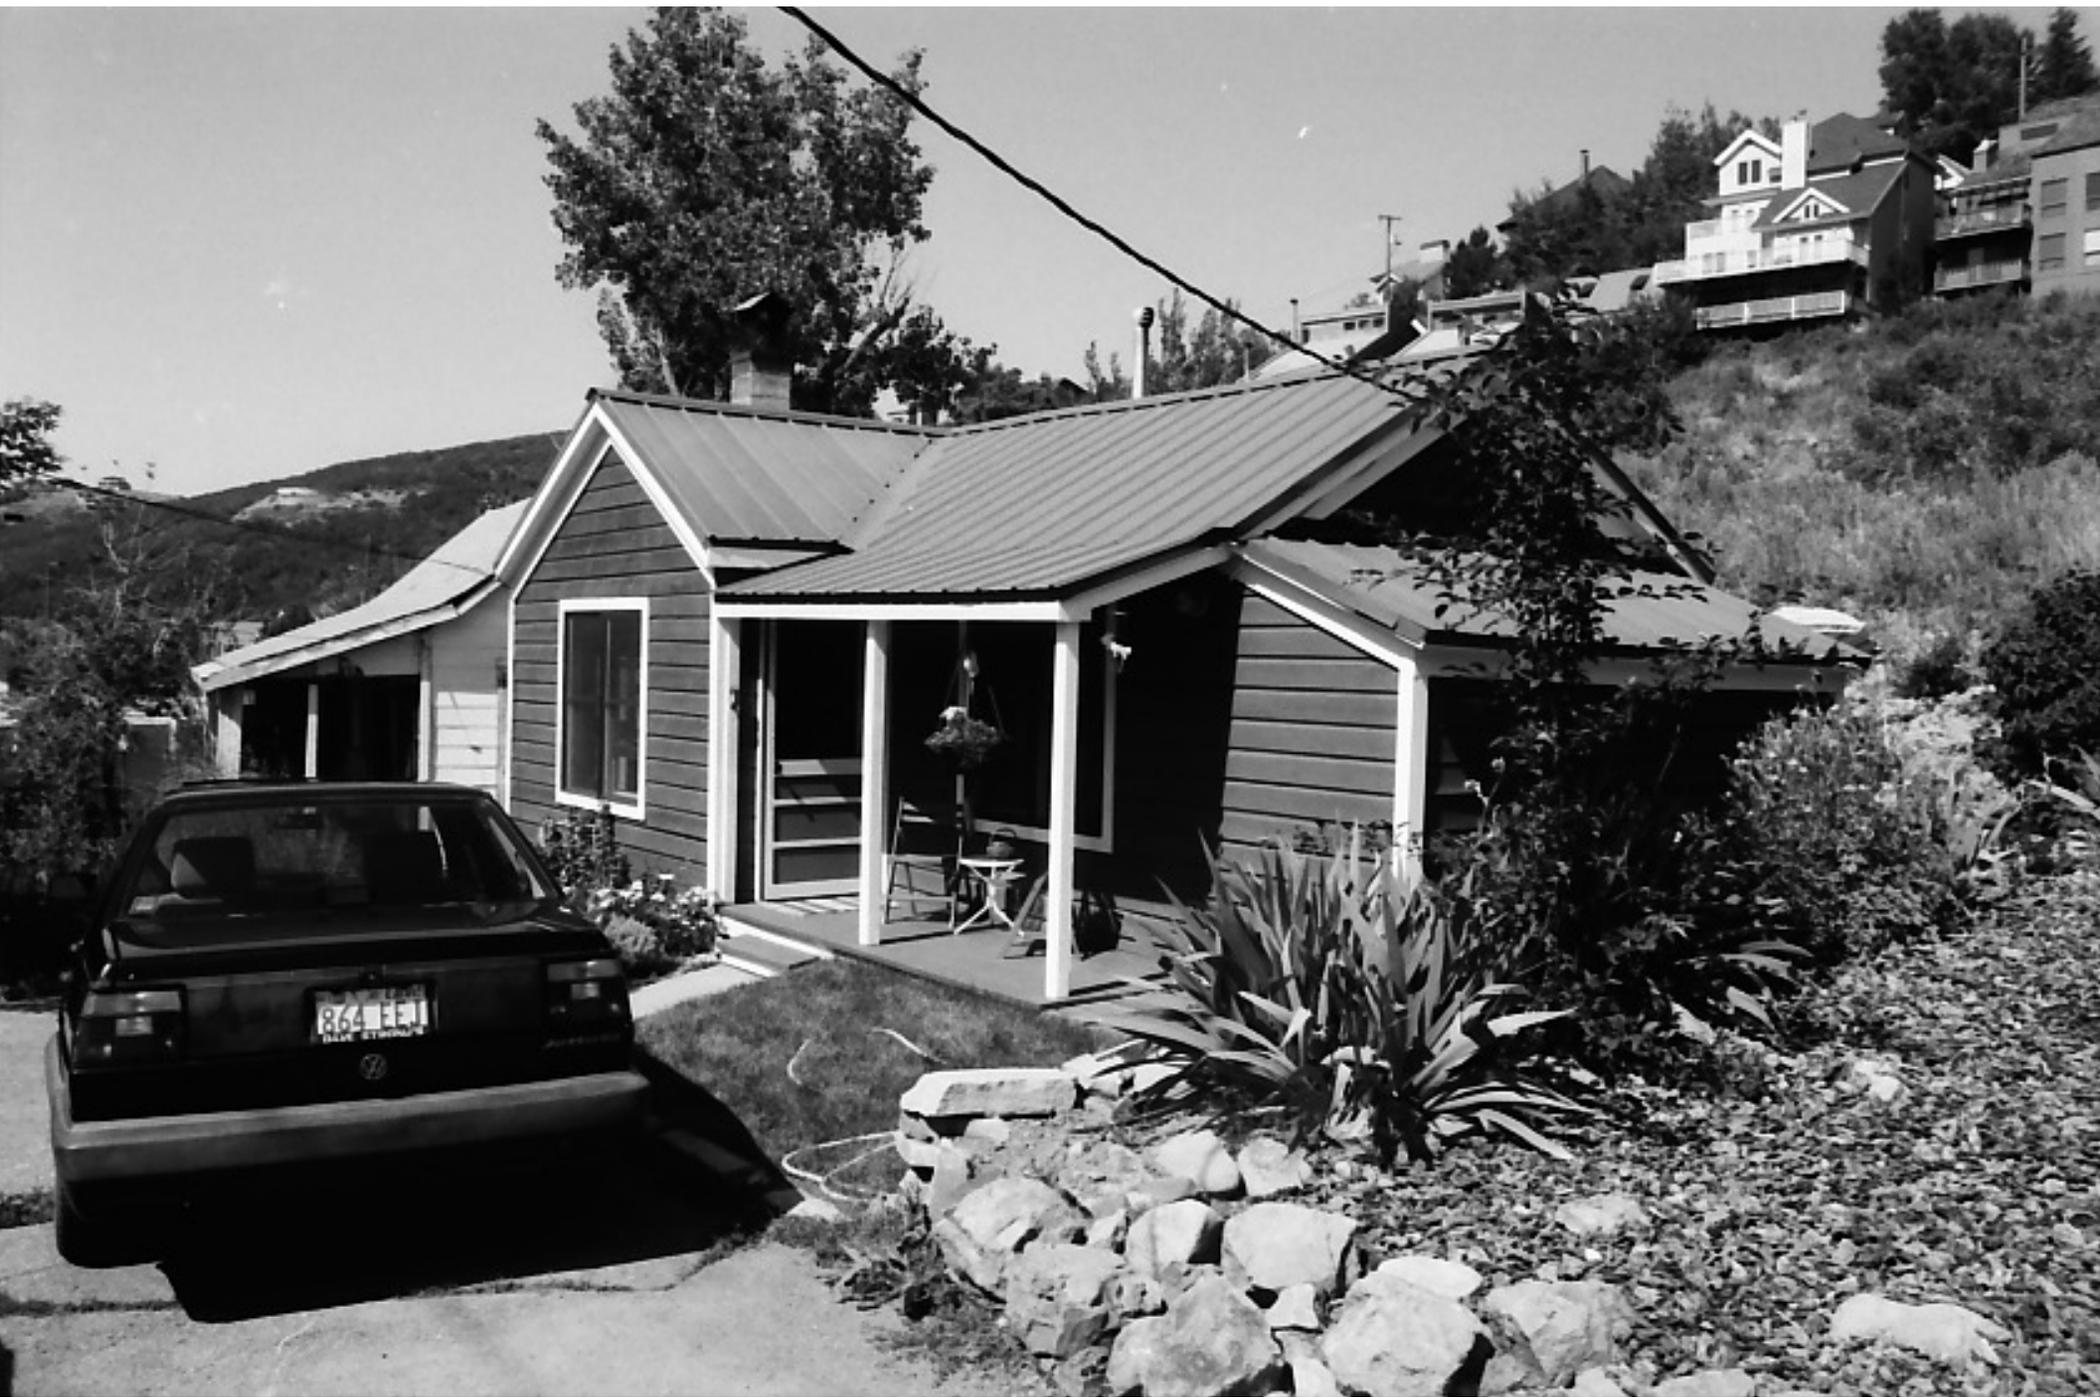
Photo No. 1: Southwest oblique. Camera facing northeast, 2006.

Design (The combination of physical elements that create the form, plan, space, structure, and style. Describe additions and/or alterations from the original design, including dates--known or estimated--when alterations were made): Based on photographic evidence alone, very little has changed in structure or character to this building. Layout appears to match original although material may have been adjusted over time. Porch railings and slight details in original tax photo are the most noticeable change (i.e. 2nd door and six over six pane window in tax photo evolved into a consolidated window opening by 1995 photo.) Also appears that a new foundation was added before 1995. Not verified, but it appears that the siding may have also been replaced at that time. If siding is found to have been replaced with new siding milled to match the old, the Landmark Site status would be lost.

Narrow building lot allows for very tight space of surrounding landscape, significantly decreased by expanded driveway in 2006 photo. Slight hilly incline to property. Neighboring residential structures match in size and scale.
