HISTORIC SITE FORM - HISTORIC SITES INVENTORY

PARK CITY MUNICIPAL CORPORATION (10-08)

Address: 1011 EMPIRE AVE

Building Type and/or Style: Gable front (variant) / vernacular style

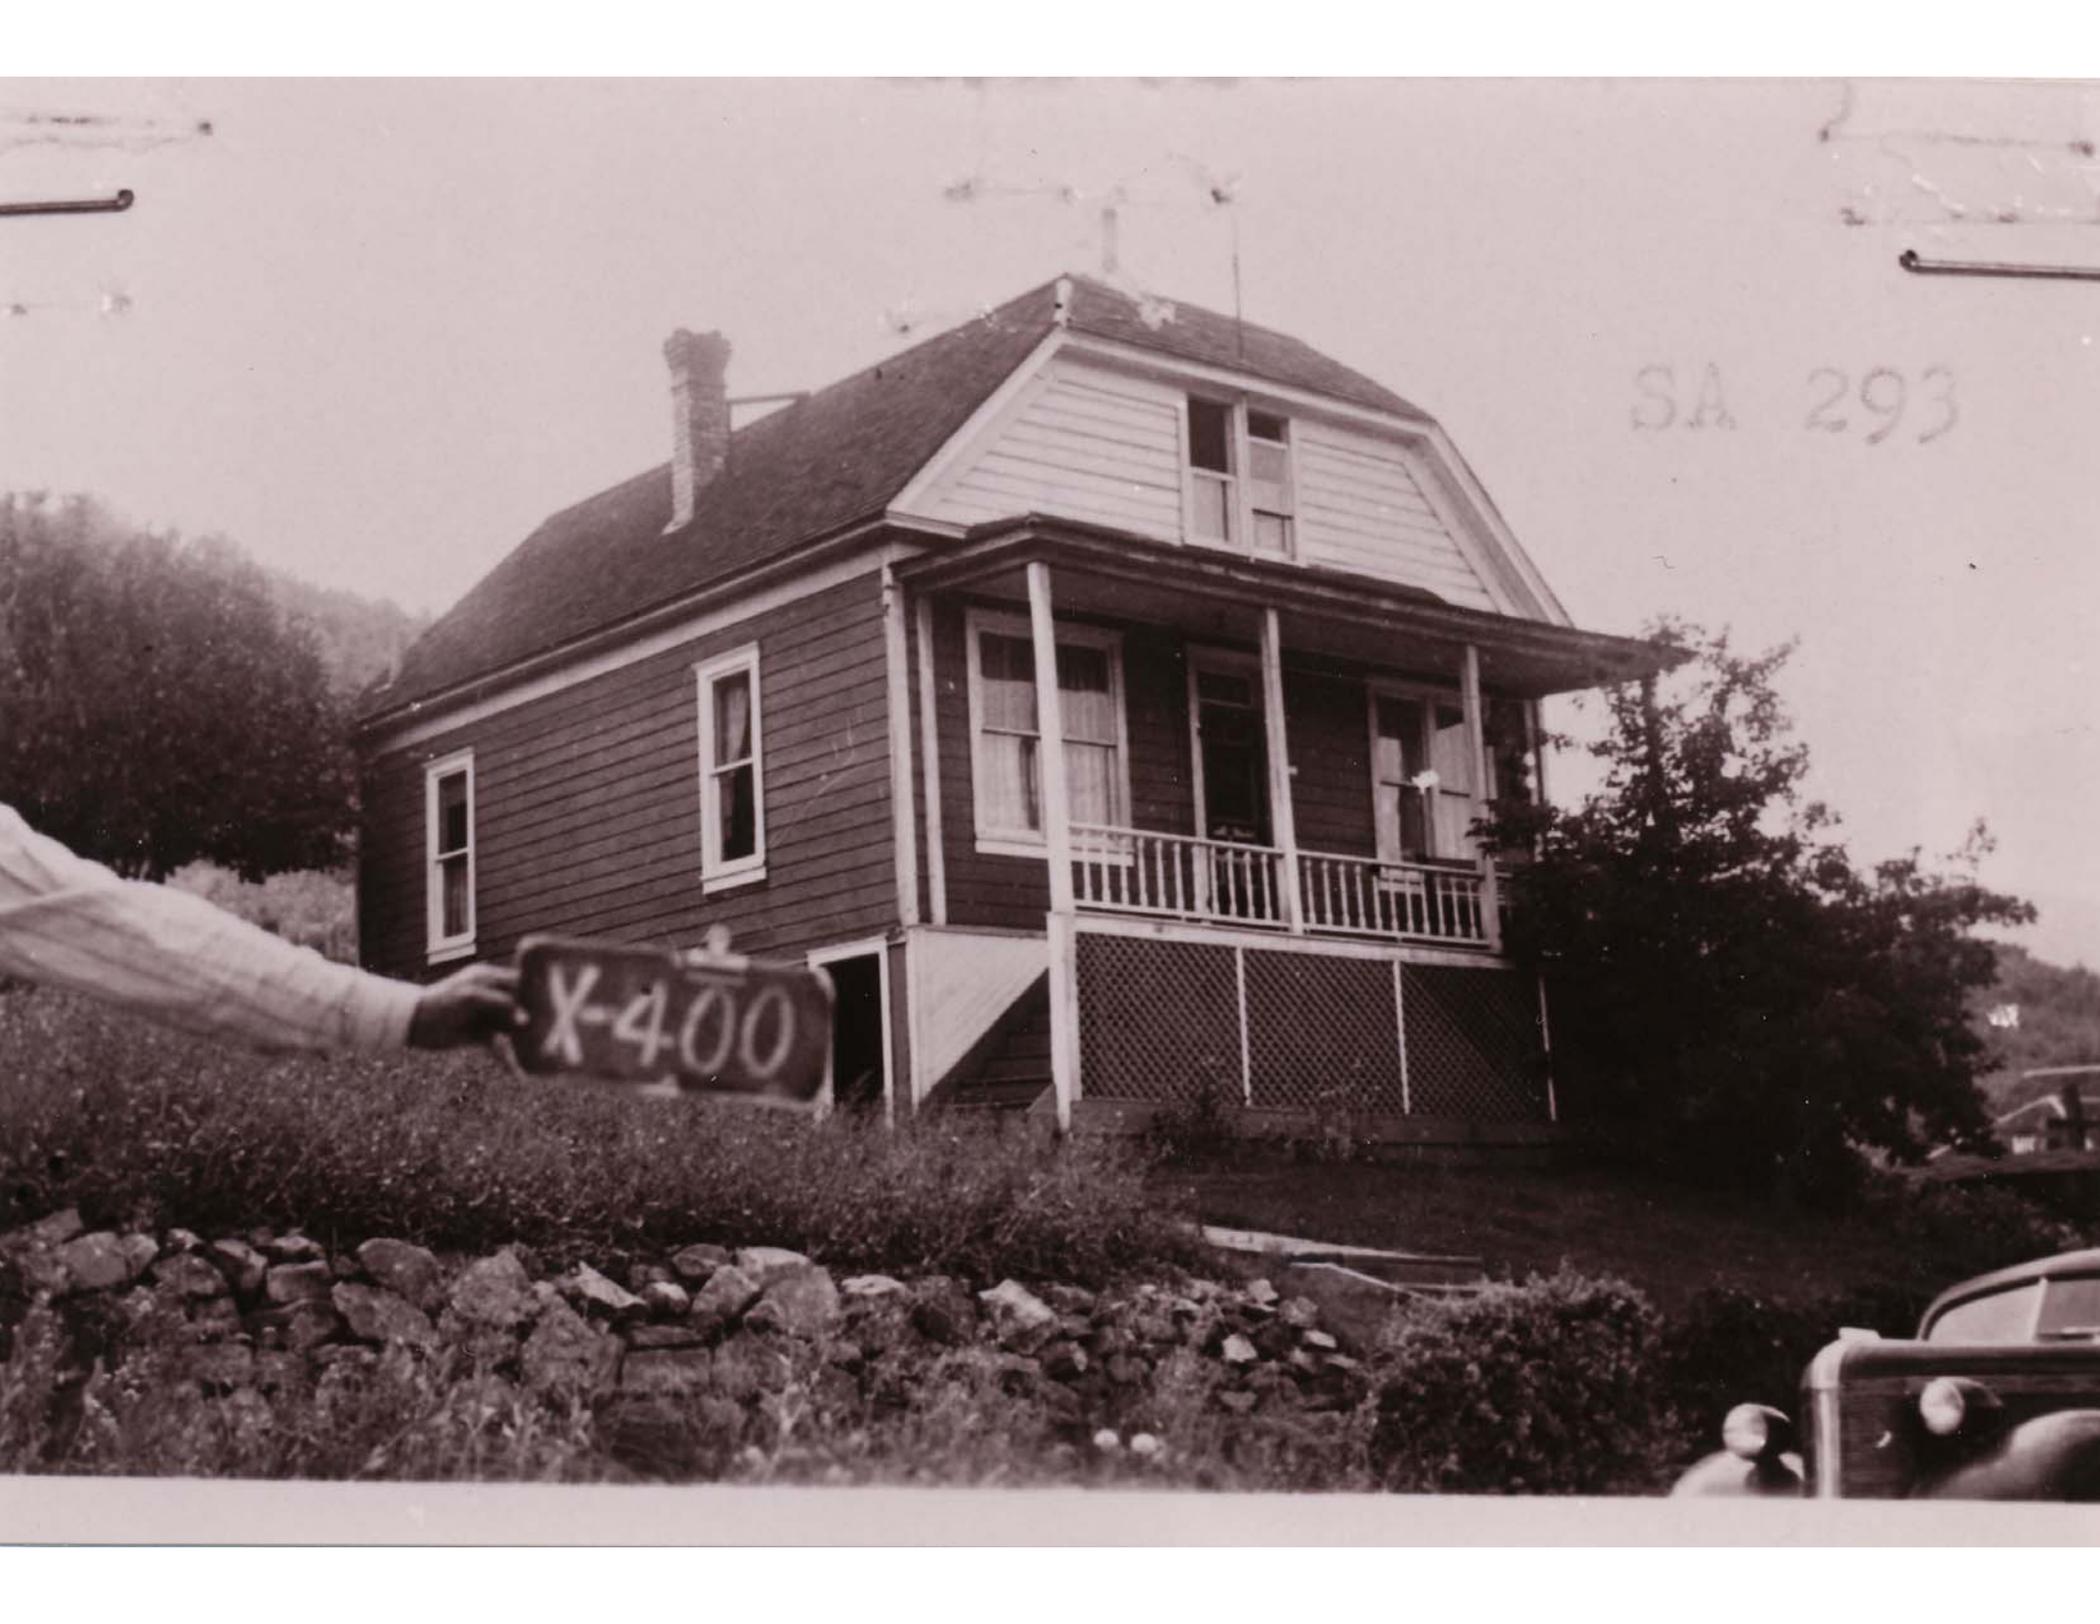
Photo No. 1: East elevation (primary façade). Camera facing west, 2006.

Walls: Possible aluminum siding beneath porch and wooden shingle on upper gable. Unable to determine based on photo alone if siding on original structure is original drop-novelty siding or not.

Roof: Clipped gable form on main house sheathed in metal material. Multiple shed extensions to the south appear to be sheathed in metal material as well.

Windows: Single and paired double-hung units. Basement addition has smaller version of the double-ung units.

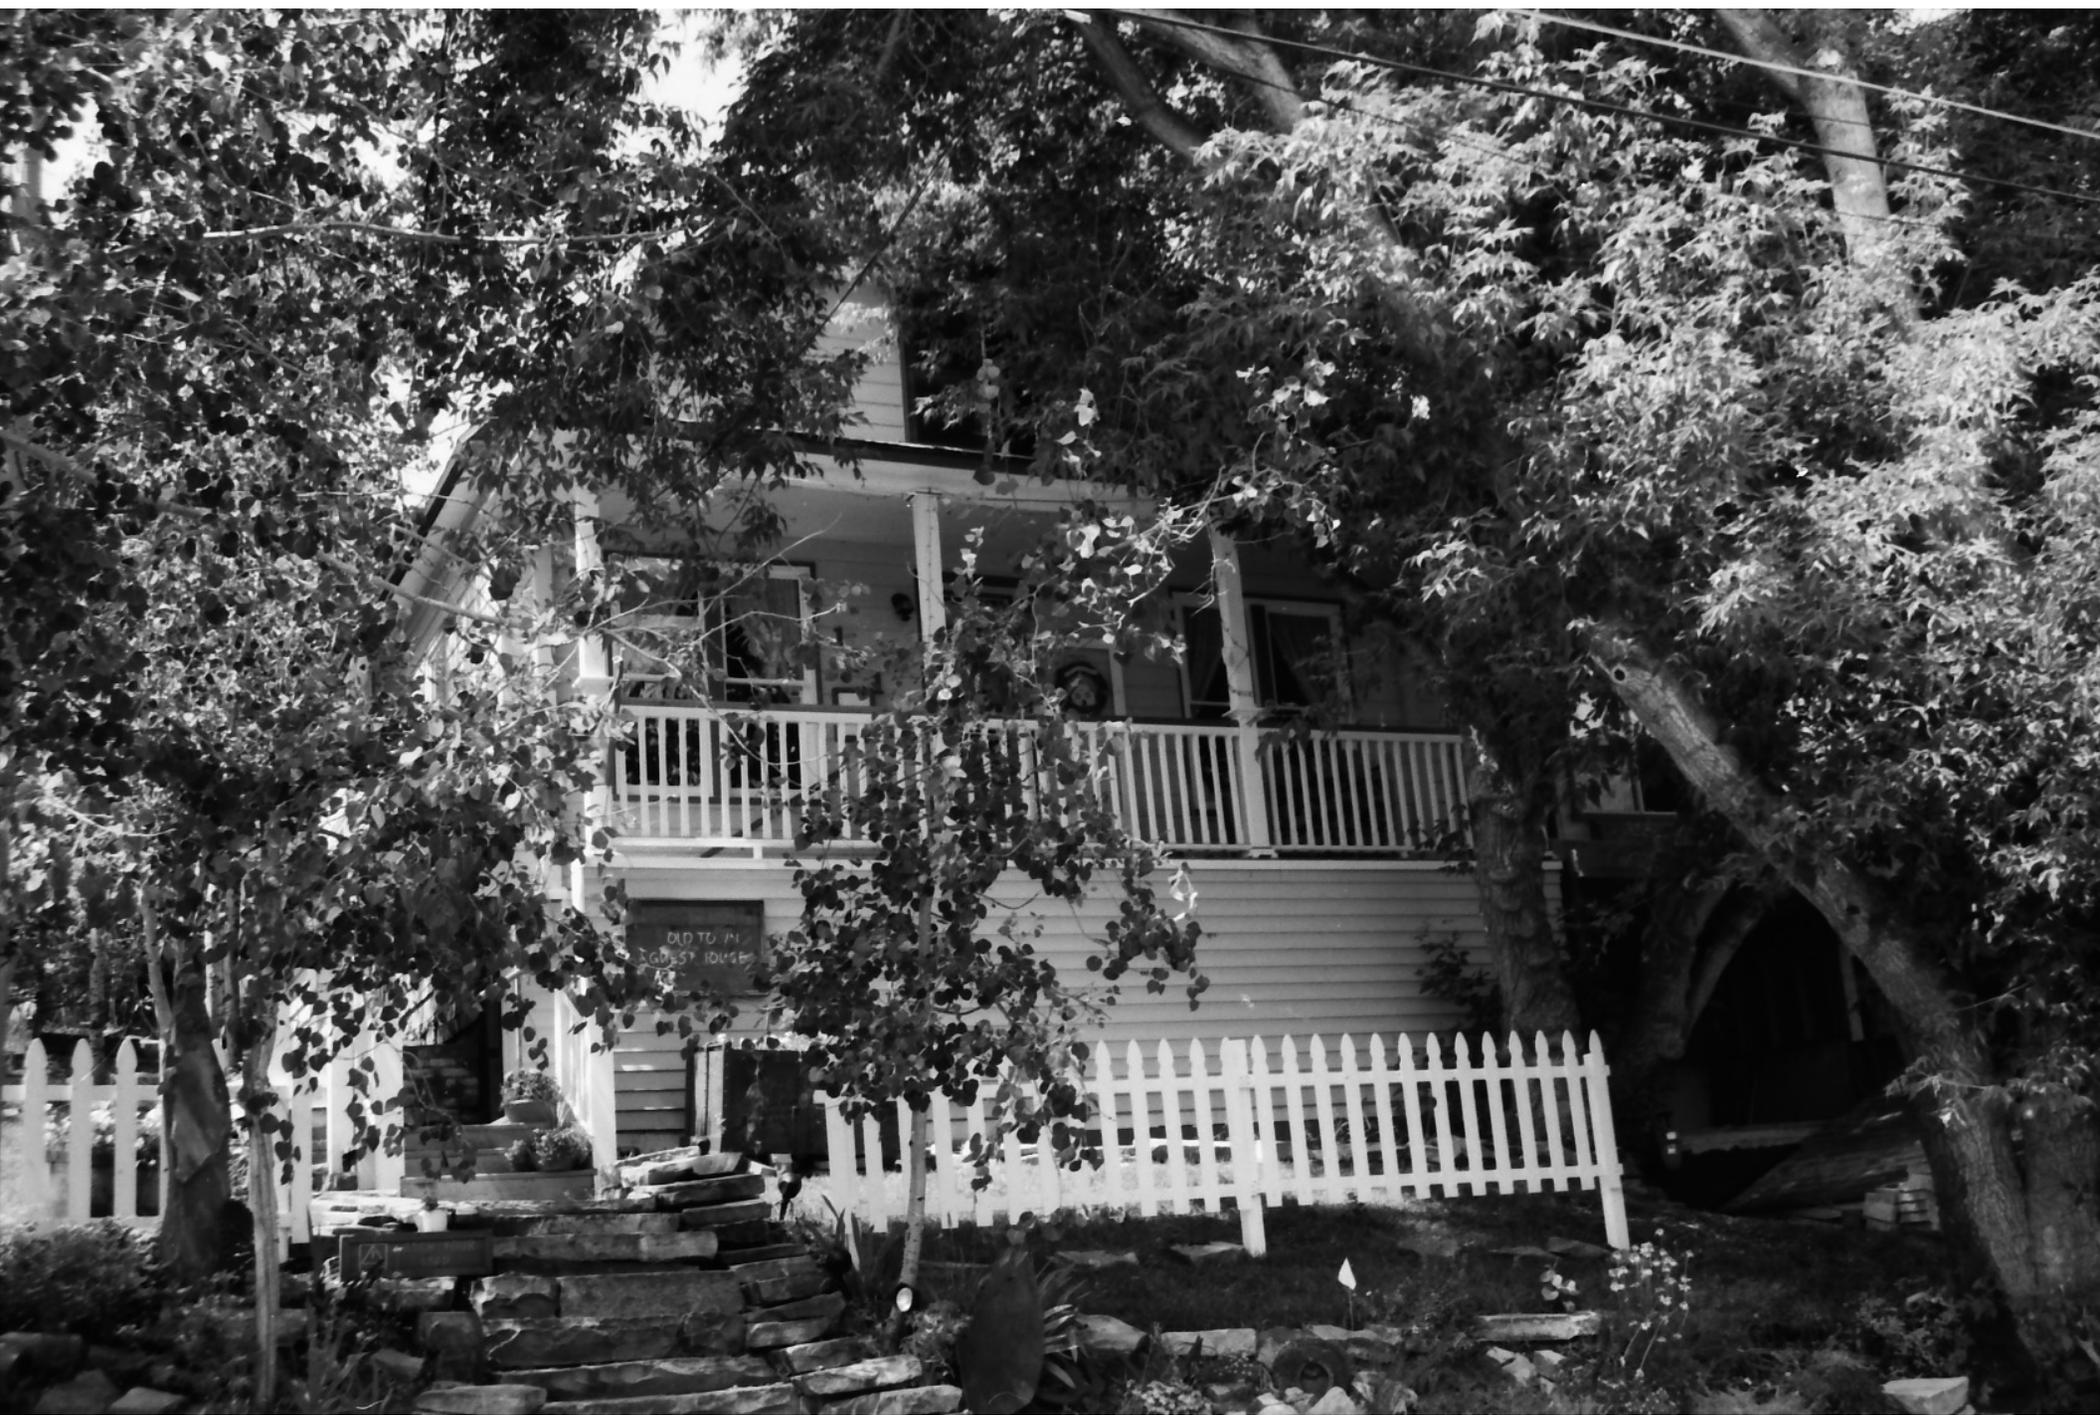
Photo No. 2: Northeast oblique. Camera facing southwest, 2006.

Design (The combination of physical elements that create the form, plan, space, structure, and style. Describe additions and/or alterations from the original design, including dates--known or estimated--when alterations were made): Original structure is not much altered from early tax photo, except that gable material has switched from siding to shingle, porch balustrade style has been simplified, roofing material has been switched from shingle to metal roofing, and living space has been added beneath the porch. Significant additions made to side wing of structure, although a separating distinction from original to addition is evident. Two-car garage also a significant addition, but separate from house structure.
