HISTORIC SITE FORM - HISTORIC SITES INVENTORY

Name of Property: Evans L. Smith House

Address: 64 Chambers Avenue

City, County: Park City, Summit County, Utah

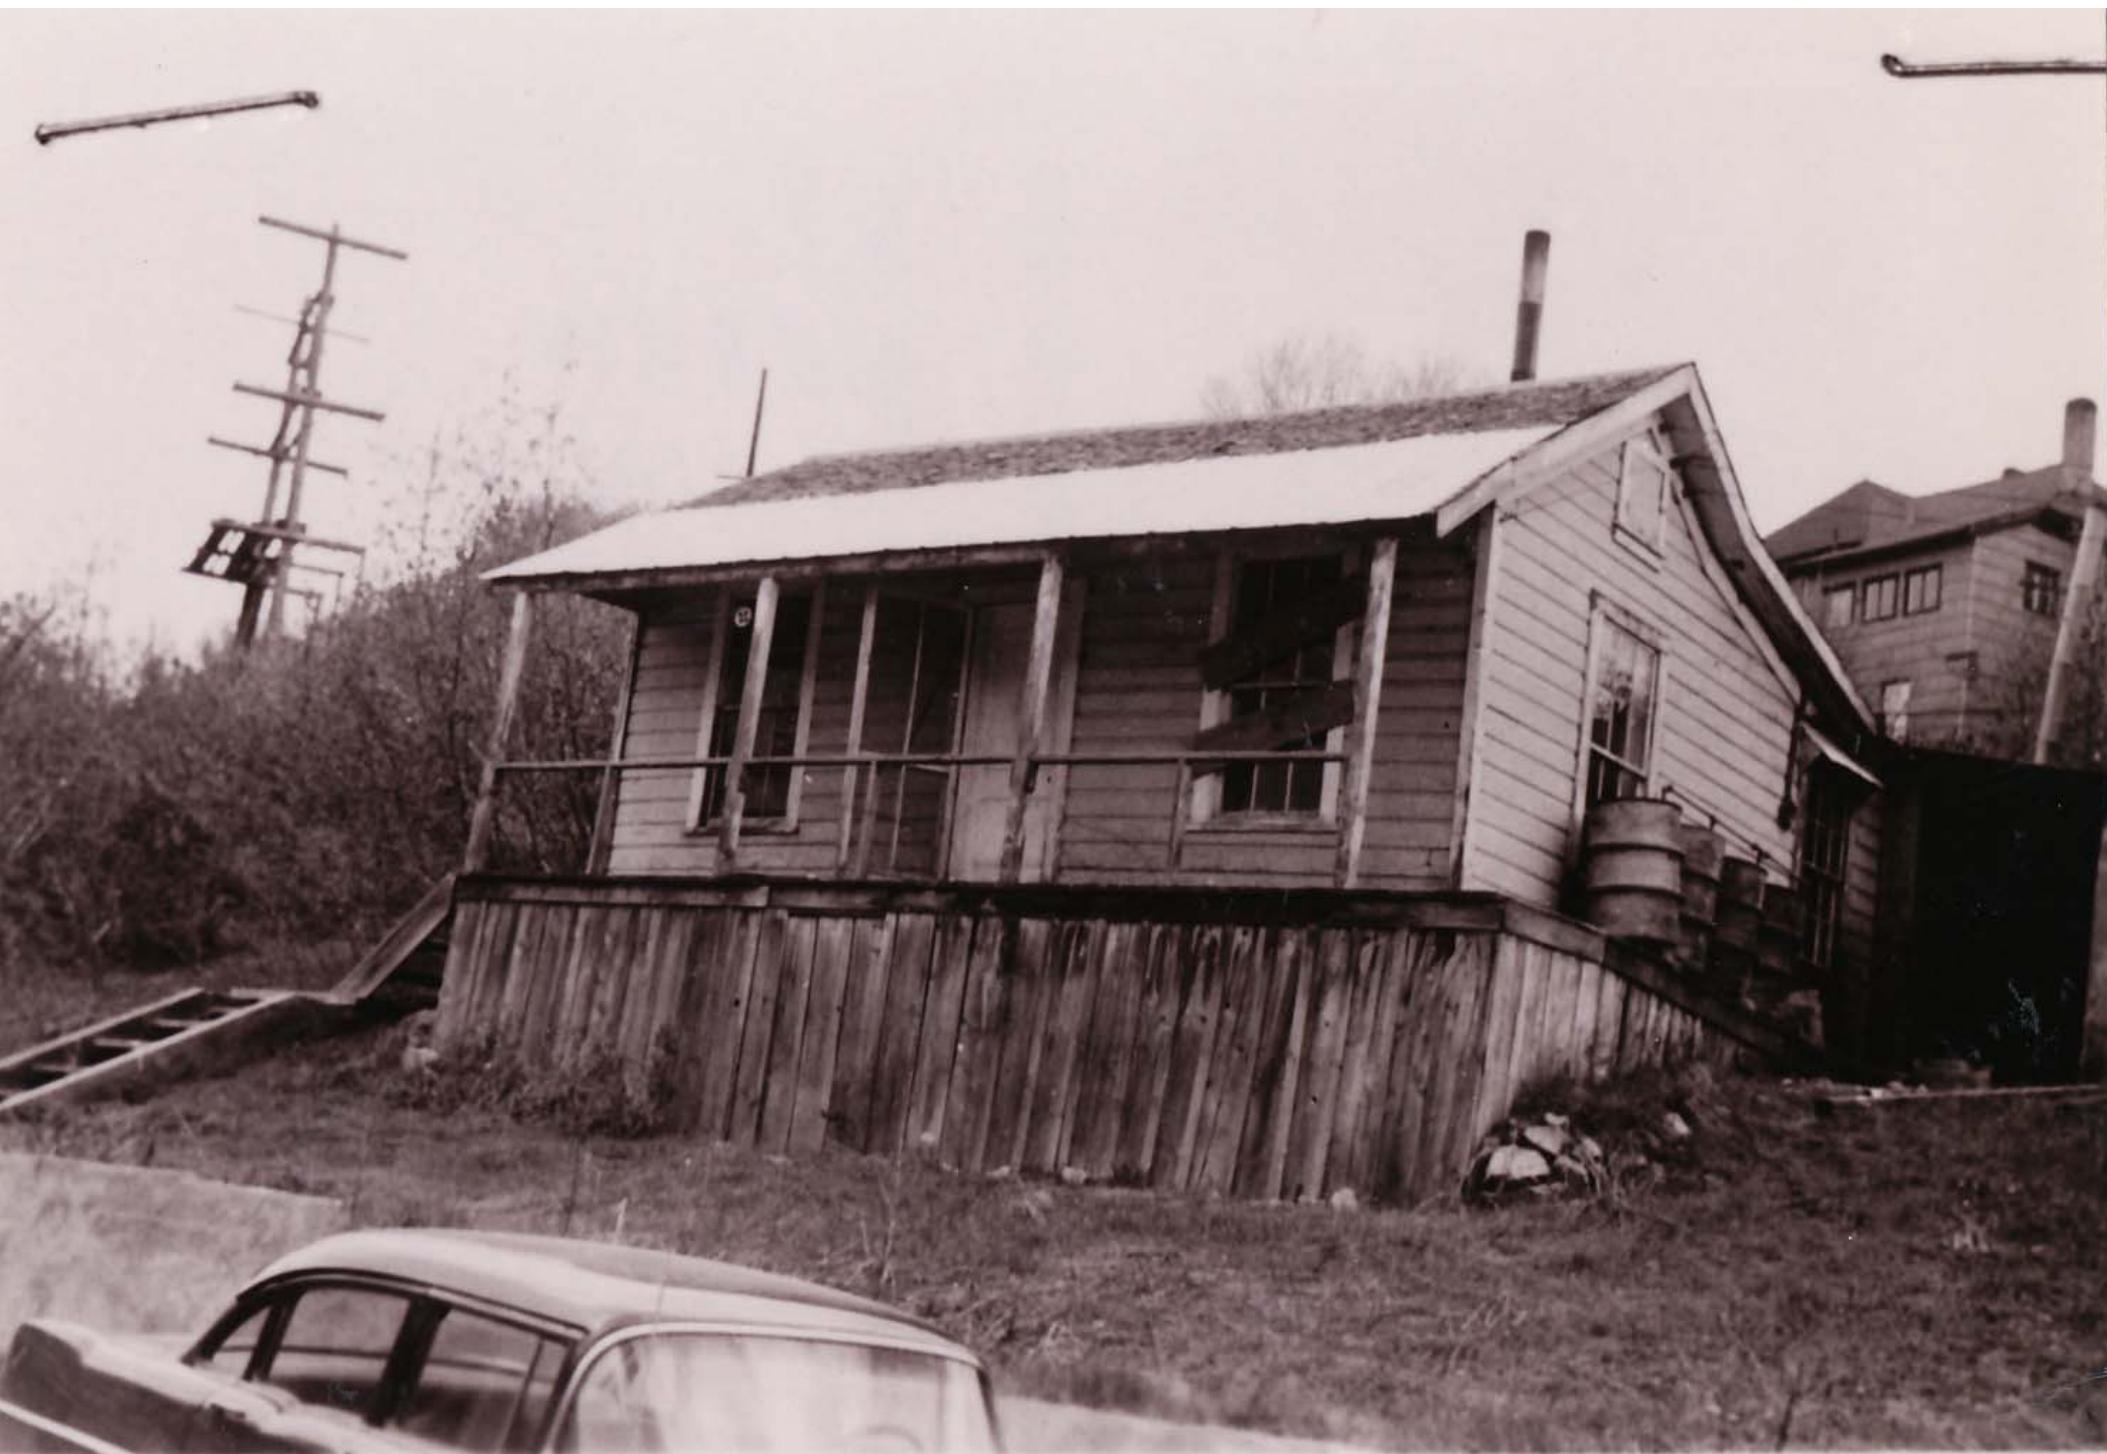
Photo No. 1: East elevation (primary façade). Camera facing west, 2006.

Photo No. 2: East elevation (primary façade). Camera facing west, 1995.

Photo No. 3: East elevation (primary façade). Camera facing west, 1983.

Photo No. 4: Northeast oblique. Camera facing southwest, 1983.
