HISTORIC SITE FORM - HISTORIC SITES INVENTORY

PARK CITY MUNICIPAL CORPORATION (10-08)

Address: 528 Park Ave

Utah State Historical Society
Historic Preservation Research Office
Structure/Site Information Form

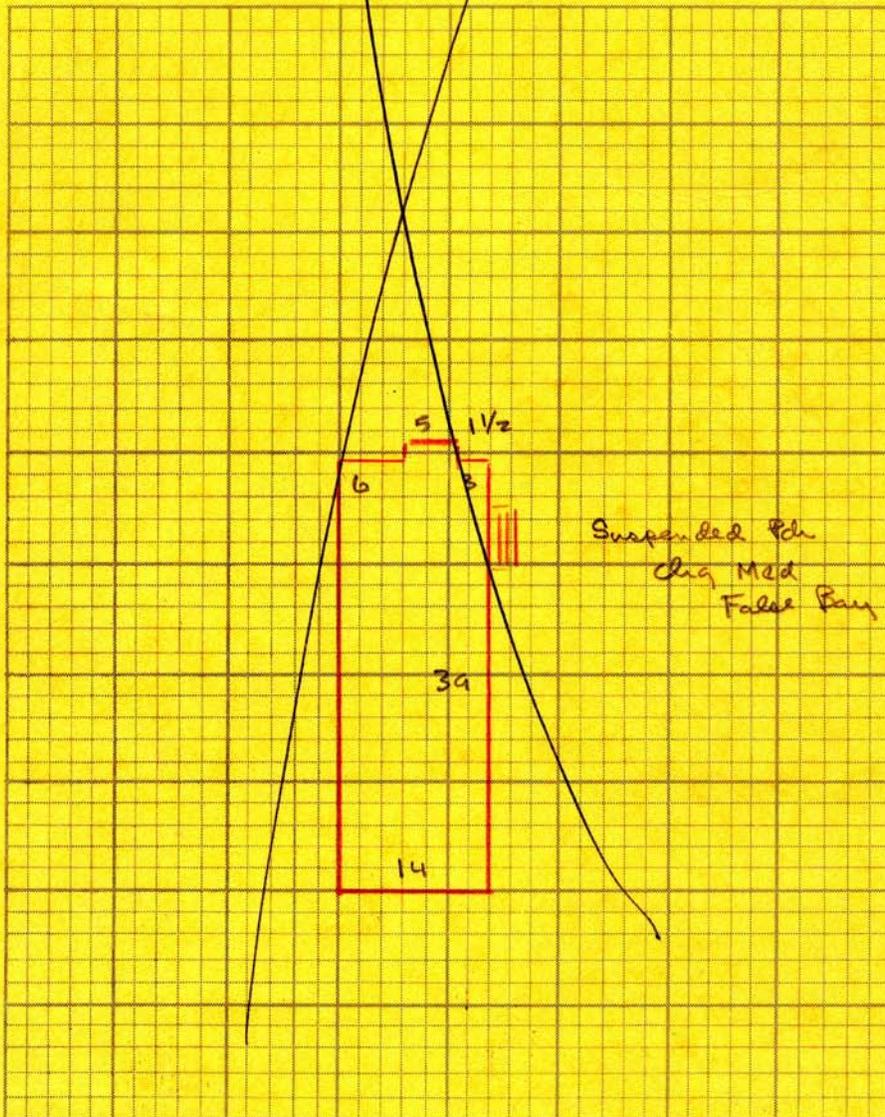
Description of Building	Additions
Foundation— Stone <input checked="" type="checkbox"/> Conc. <input type="checkbox"/> None <input type="checkbox"/>	
Ext. Walls COMMON BRICK	
Insulation— Floors _____ Walls _____ Clgs. _____	
Roof Type flat Mtl. BU	
Dormers— Small _____ Med. _____ Large _____	
Bays— Small _____ Med. 1 Large _____	35
Porches — Front _____ @ _____	
Rear _____ @ _____	
Basement Entr. _____ @ _____	
Planters _____ @ _____	
Cellar Bsmt. — 1/4 1/3 1/2 3/4 Full _____ Floor Conc	70
Bsmt. Apt. _____ Rooms Fin. _____ Unfin. _____	
Attic Rooms Fin. _____ Unfin. _____	
Plumbing { Class <input checked="" type="checkbox"/> Tub <input checked="" type="checkbox"/> Trays _____ Basin _____ Sink 2 Toilet 2 Urns _____ Frns. _____ Shr. _____ Dishwasher _____ Garbage Disp. _____	530
Heat— Stove <input checked="" type="checkbox"/> H.A. _____ Steam <input checked="" type="checkbox"/> Sskr. _____ Blr. <input checked="" type="checkbox"/> Oil _____ Gas <input checked="" type="checkbox"/> Coal _____ Pipeless _____ Radiant _____

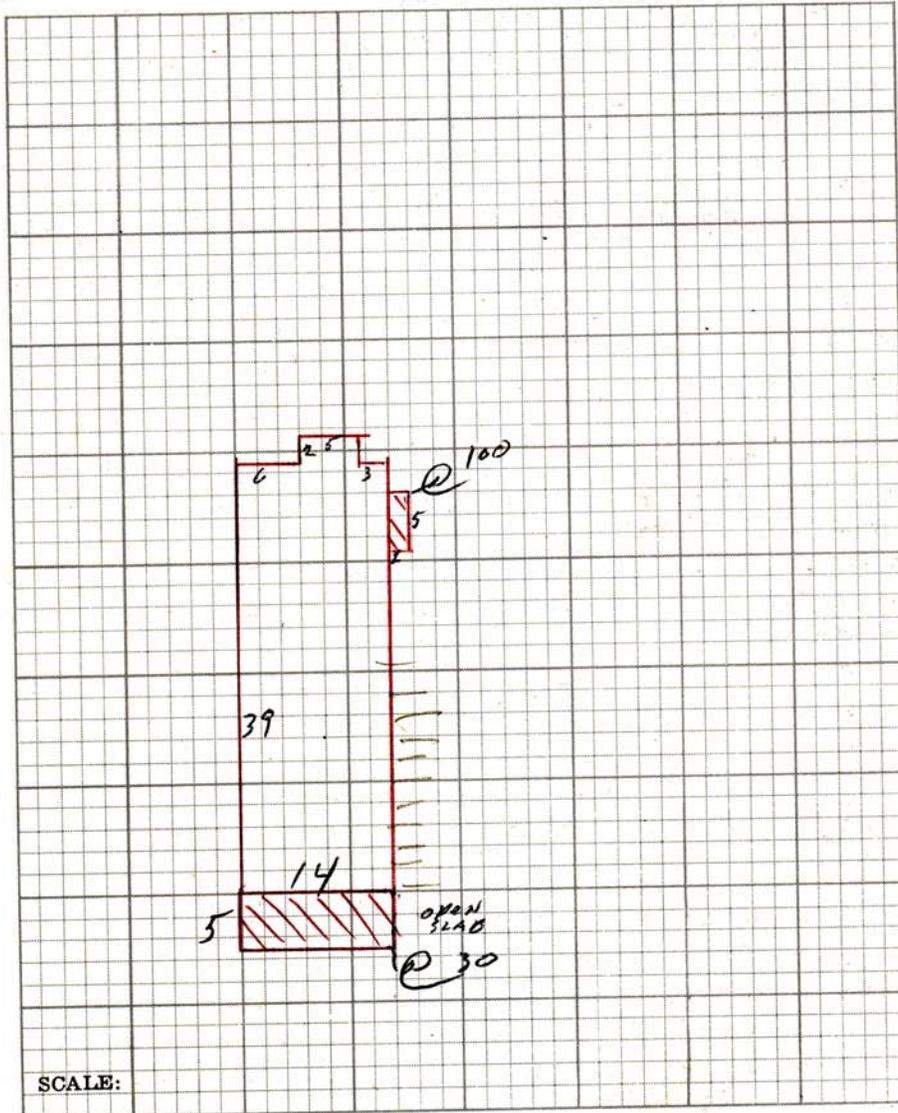
Foundation—Stone Conc. _____ Sills _____

Ext. Walls Com Brk (B)

Roof Type Flat Mtl. RK

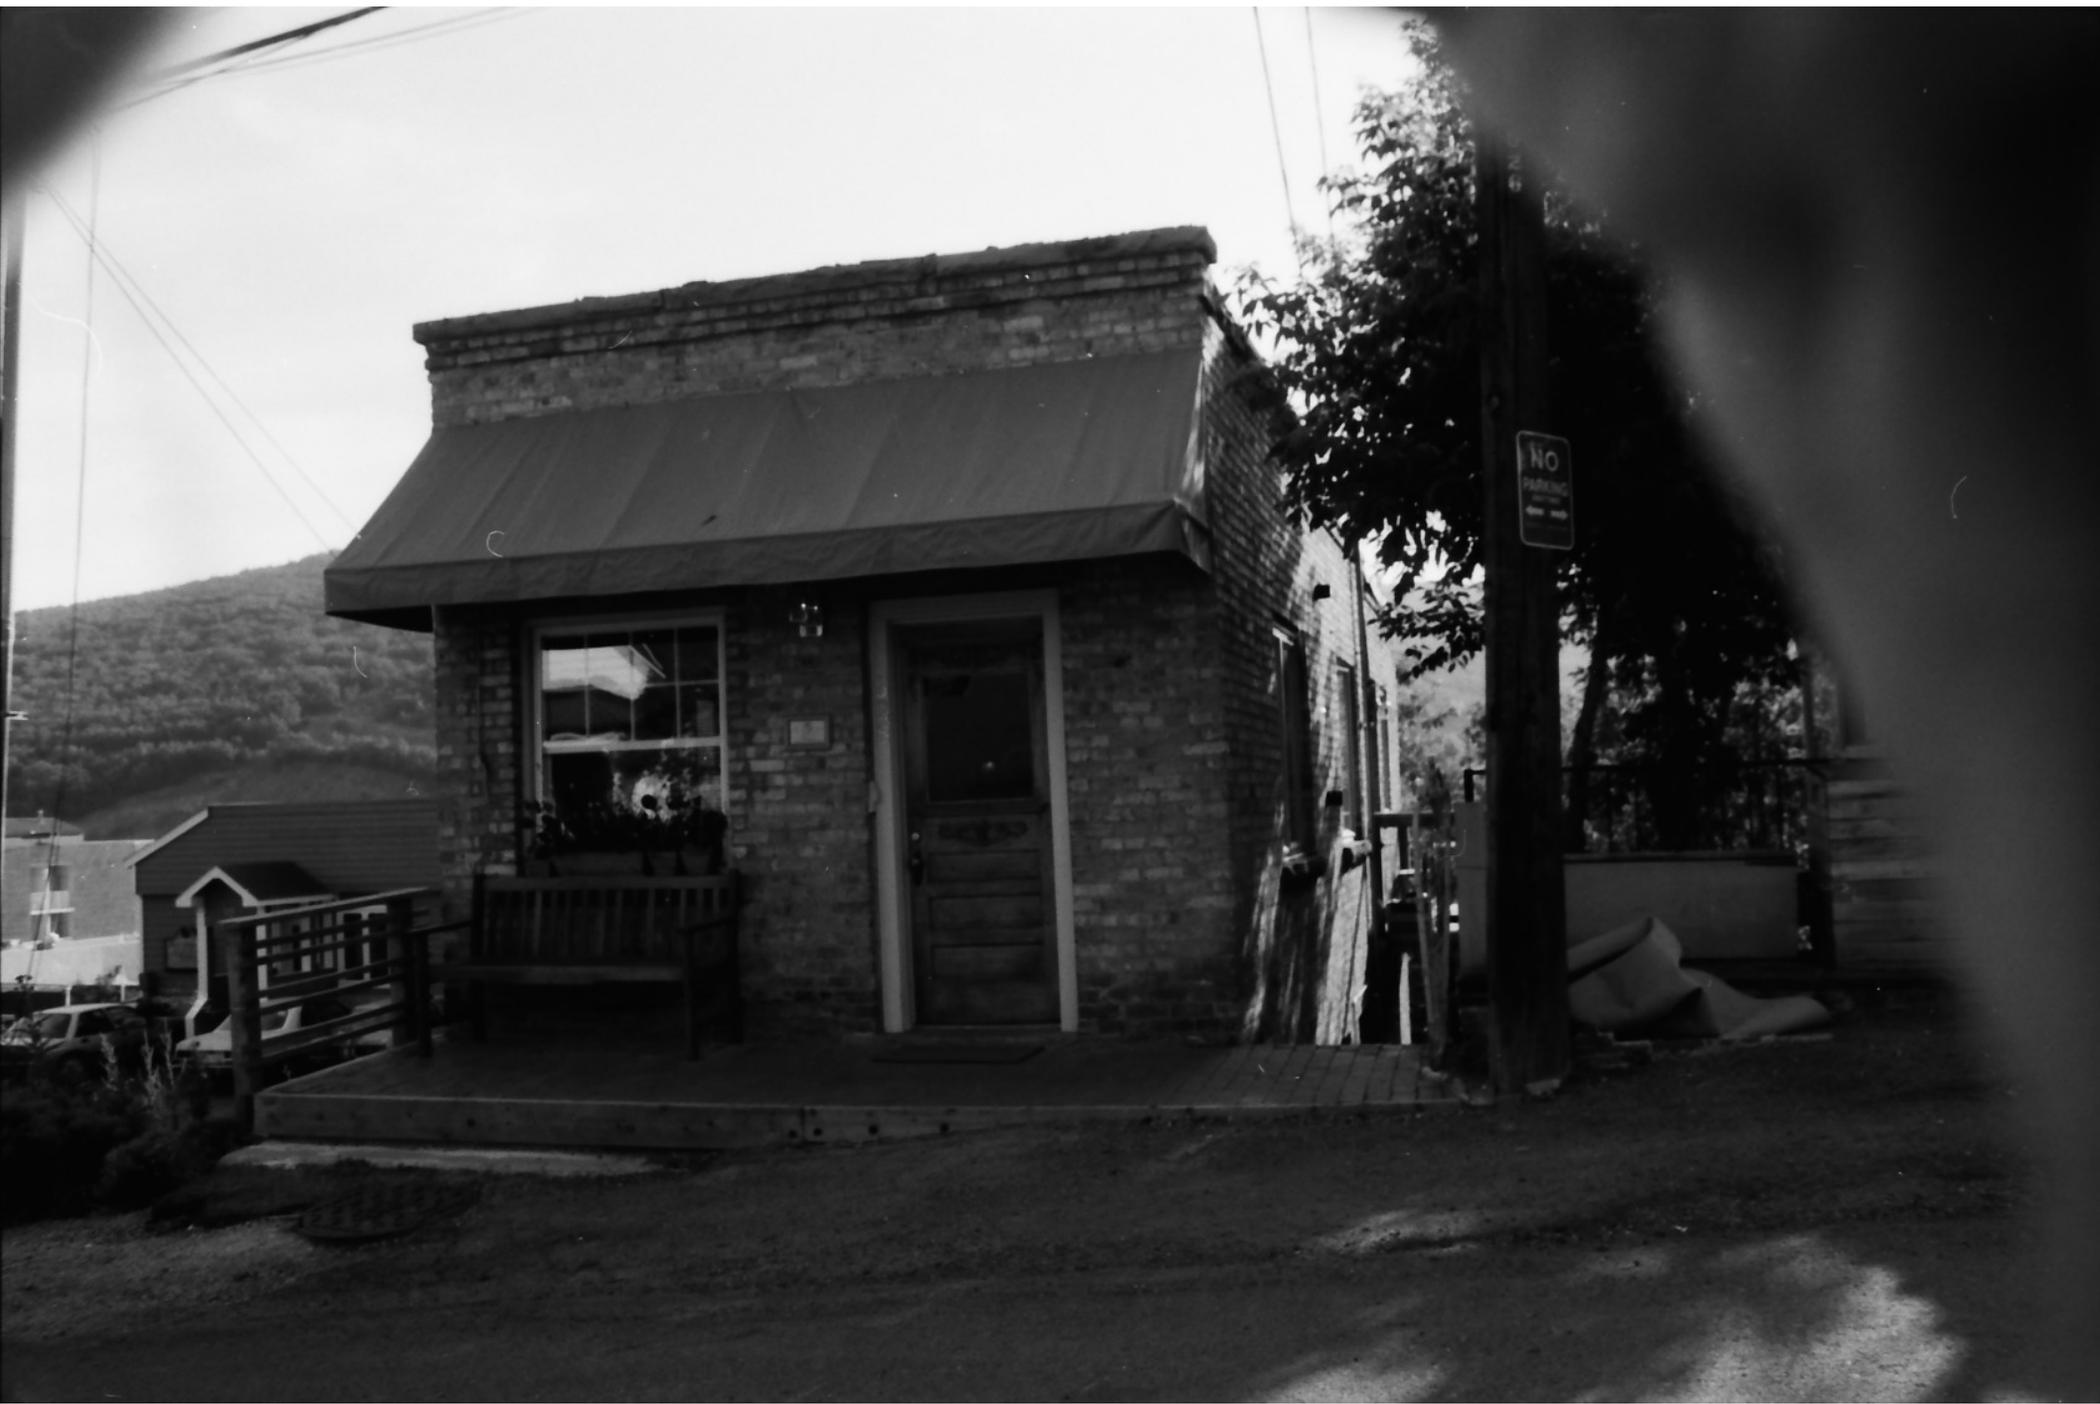
One-story rectangular structure constructed of common brick with a flat roof, the foundation is stone. The facade now has only an entry with a stone lintel; however, a 1940 tax photo shows the existence at that time of six-over-six double hung frame window, with stone lintel, just north of the entry. The opening has since been filled-in.
