HISTORIC SITE FORM - HISTORIC SITES INVENTORY

PARK CITY MUNICIPAL CORPORATION (10-08)

Address: 929 PARK AVE

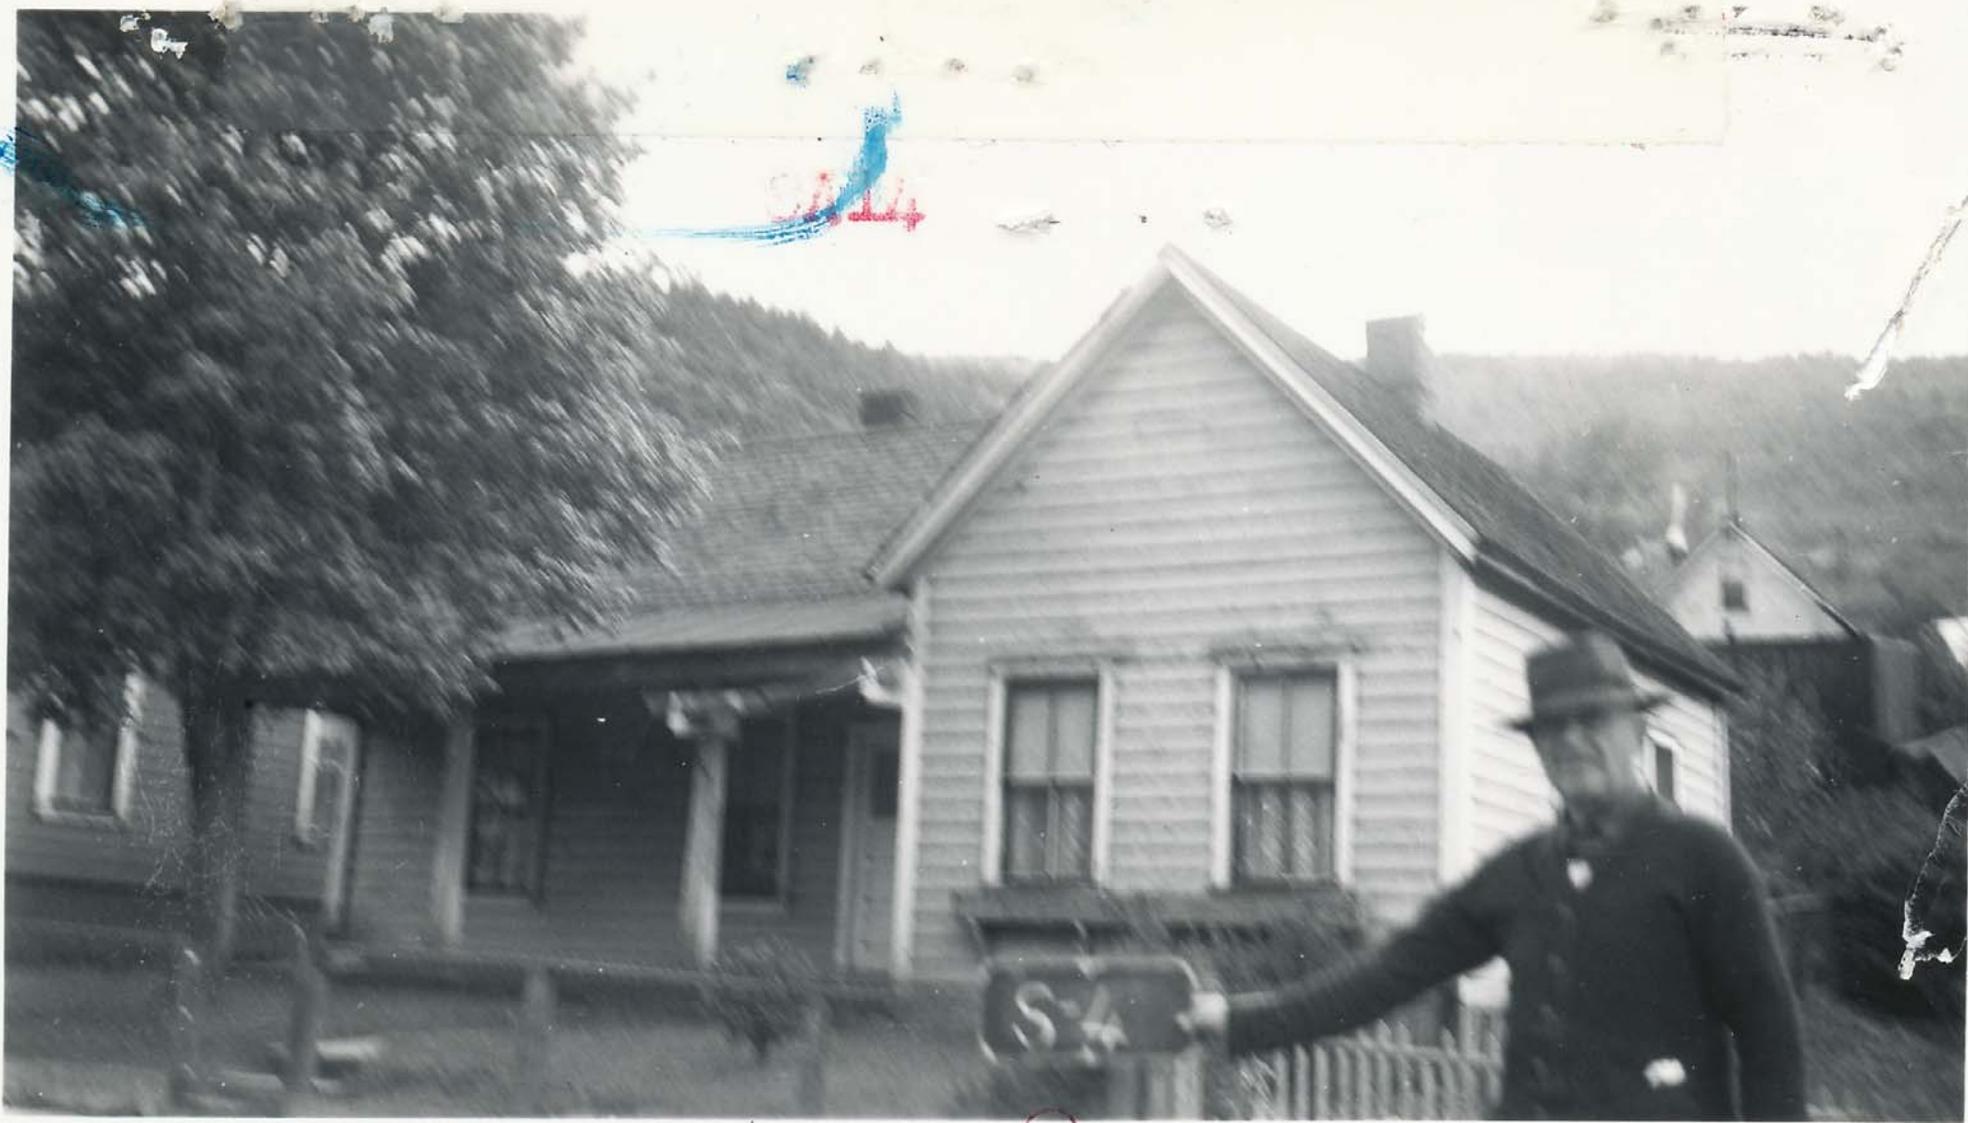
One-story frame residence, cross gable construction. The gable end, to the north-east, forms the front facade, with a porch to the south. Siding has been added with window openings and porch supports having been altered. On gable end, were two two-over-two double-hung windows.

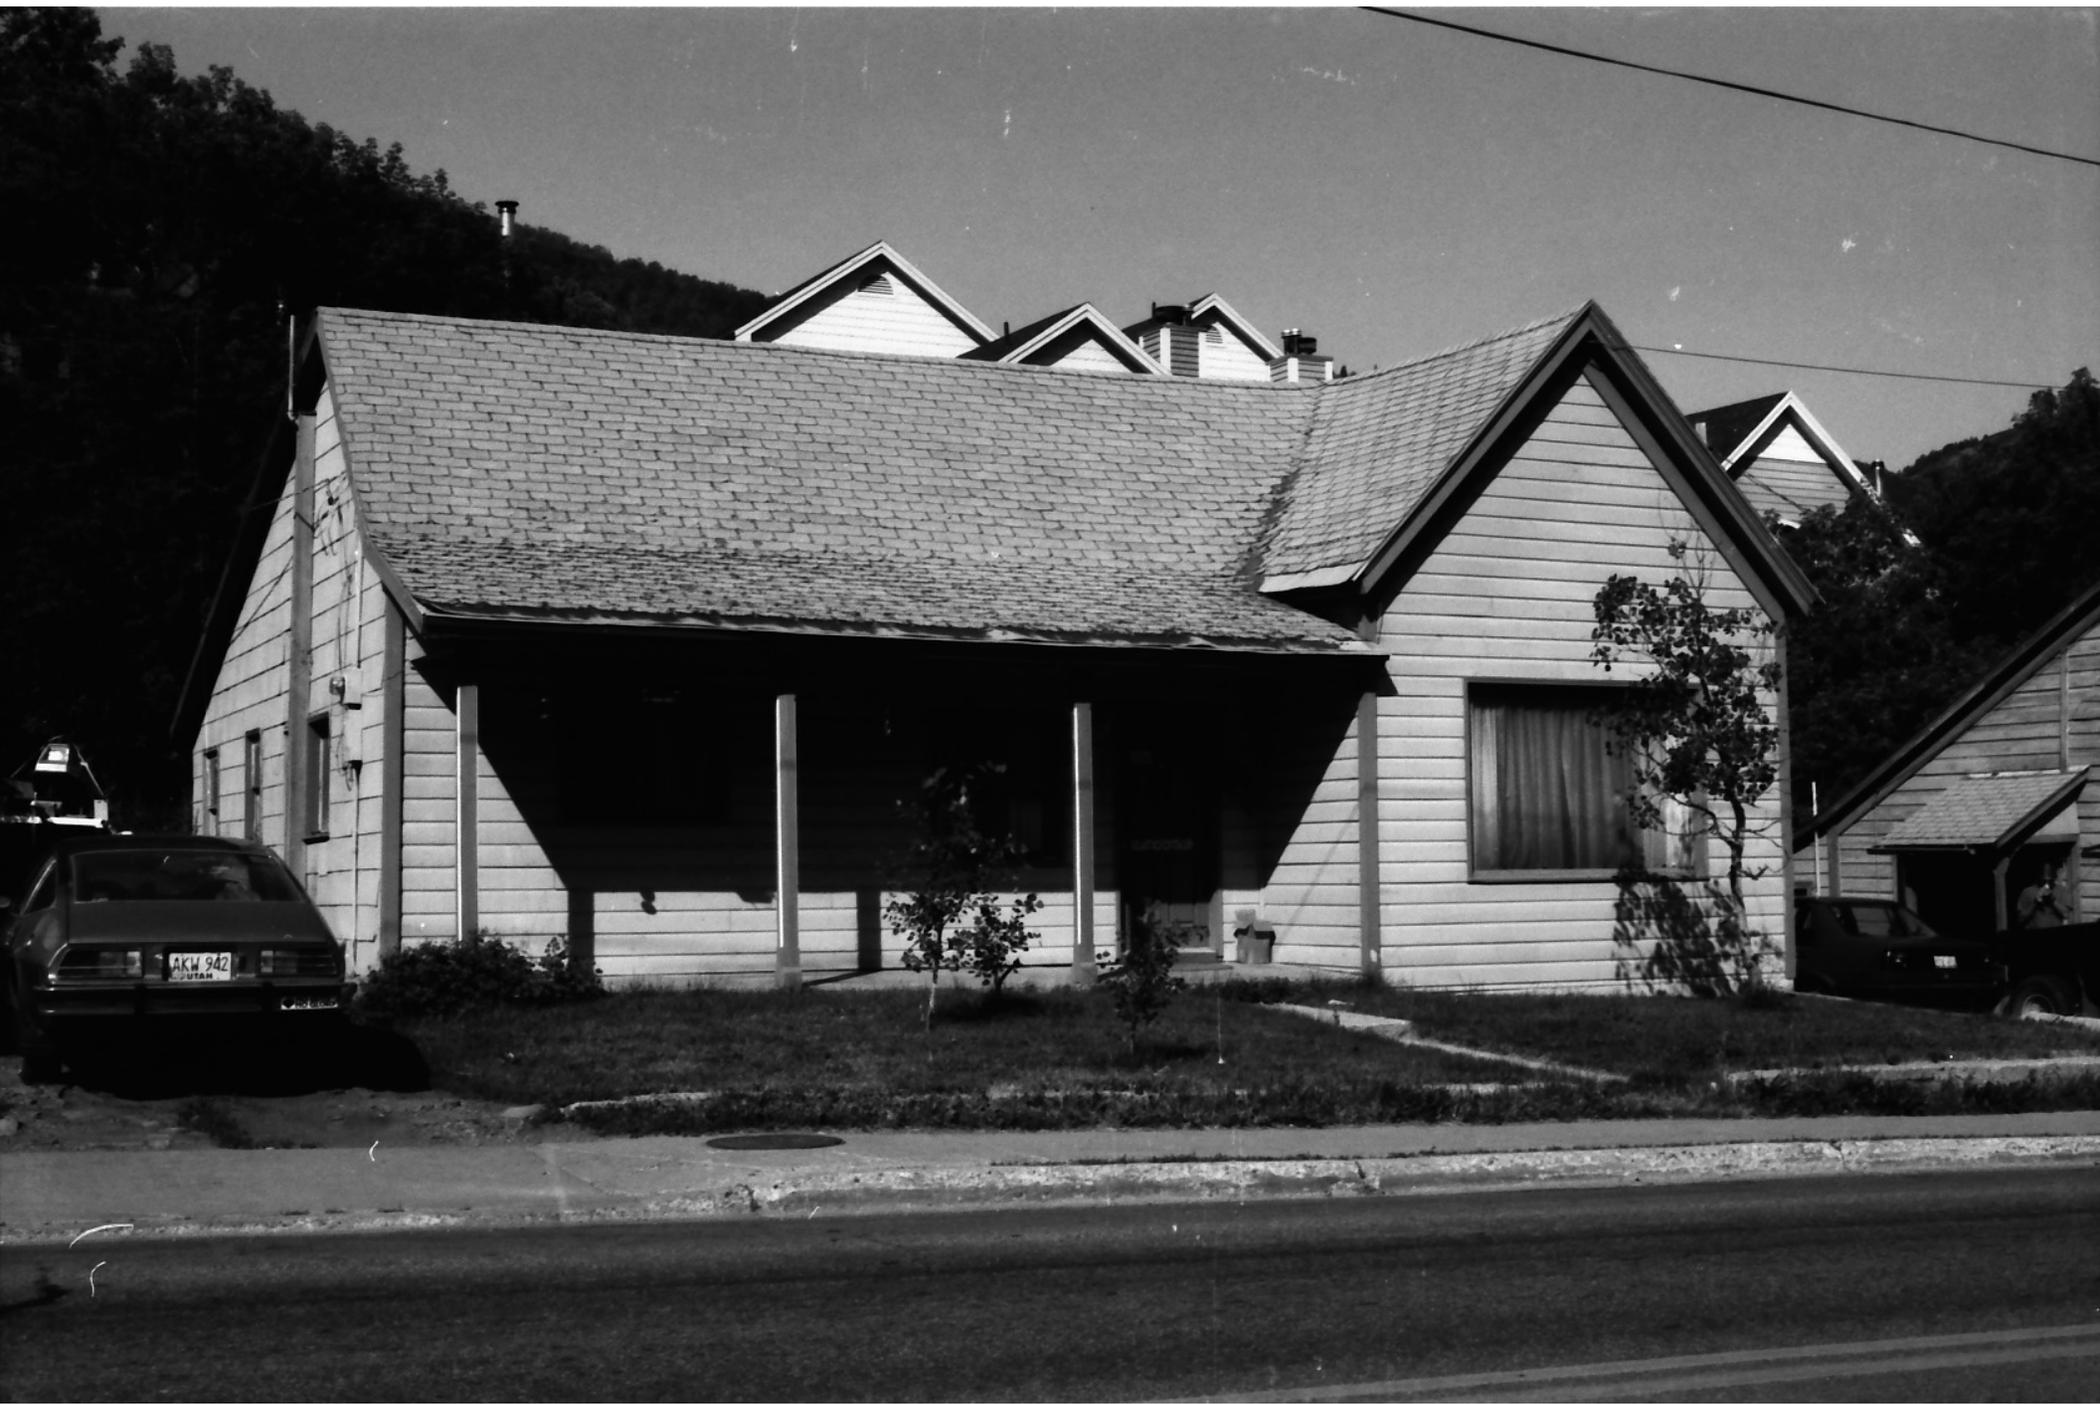
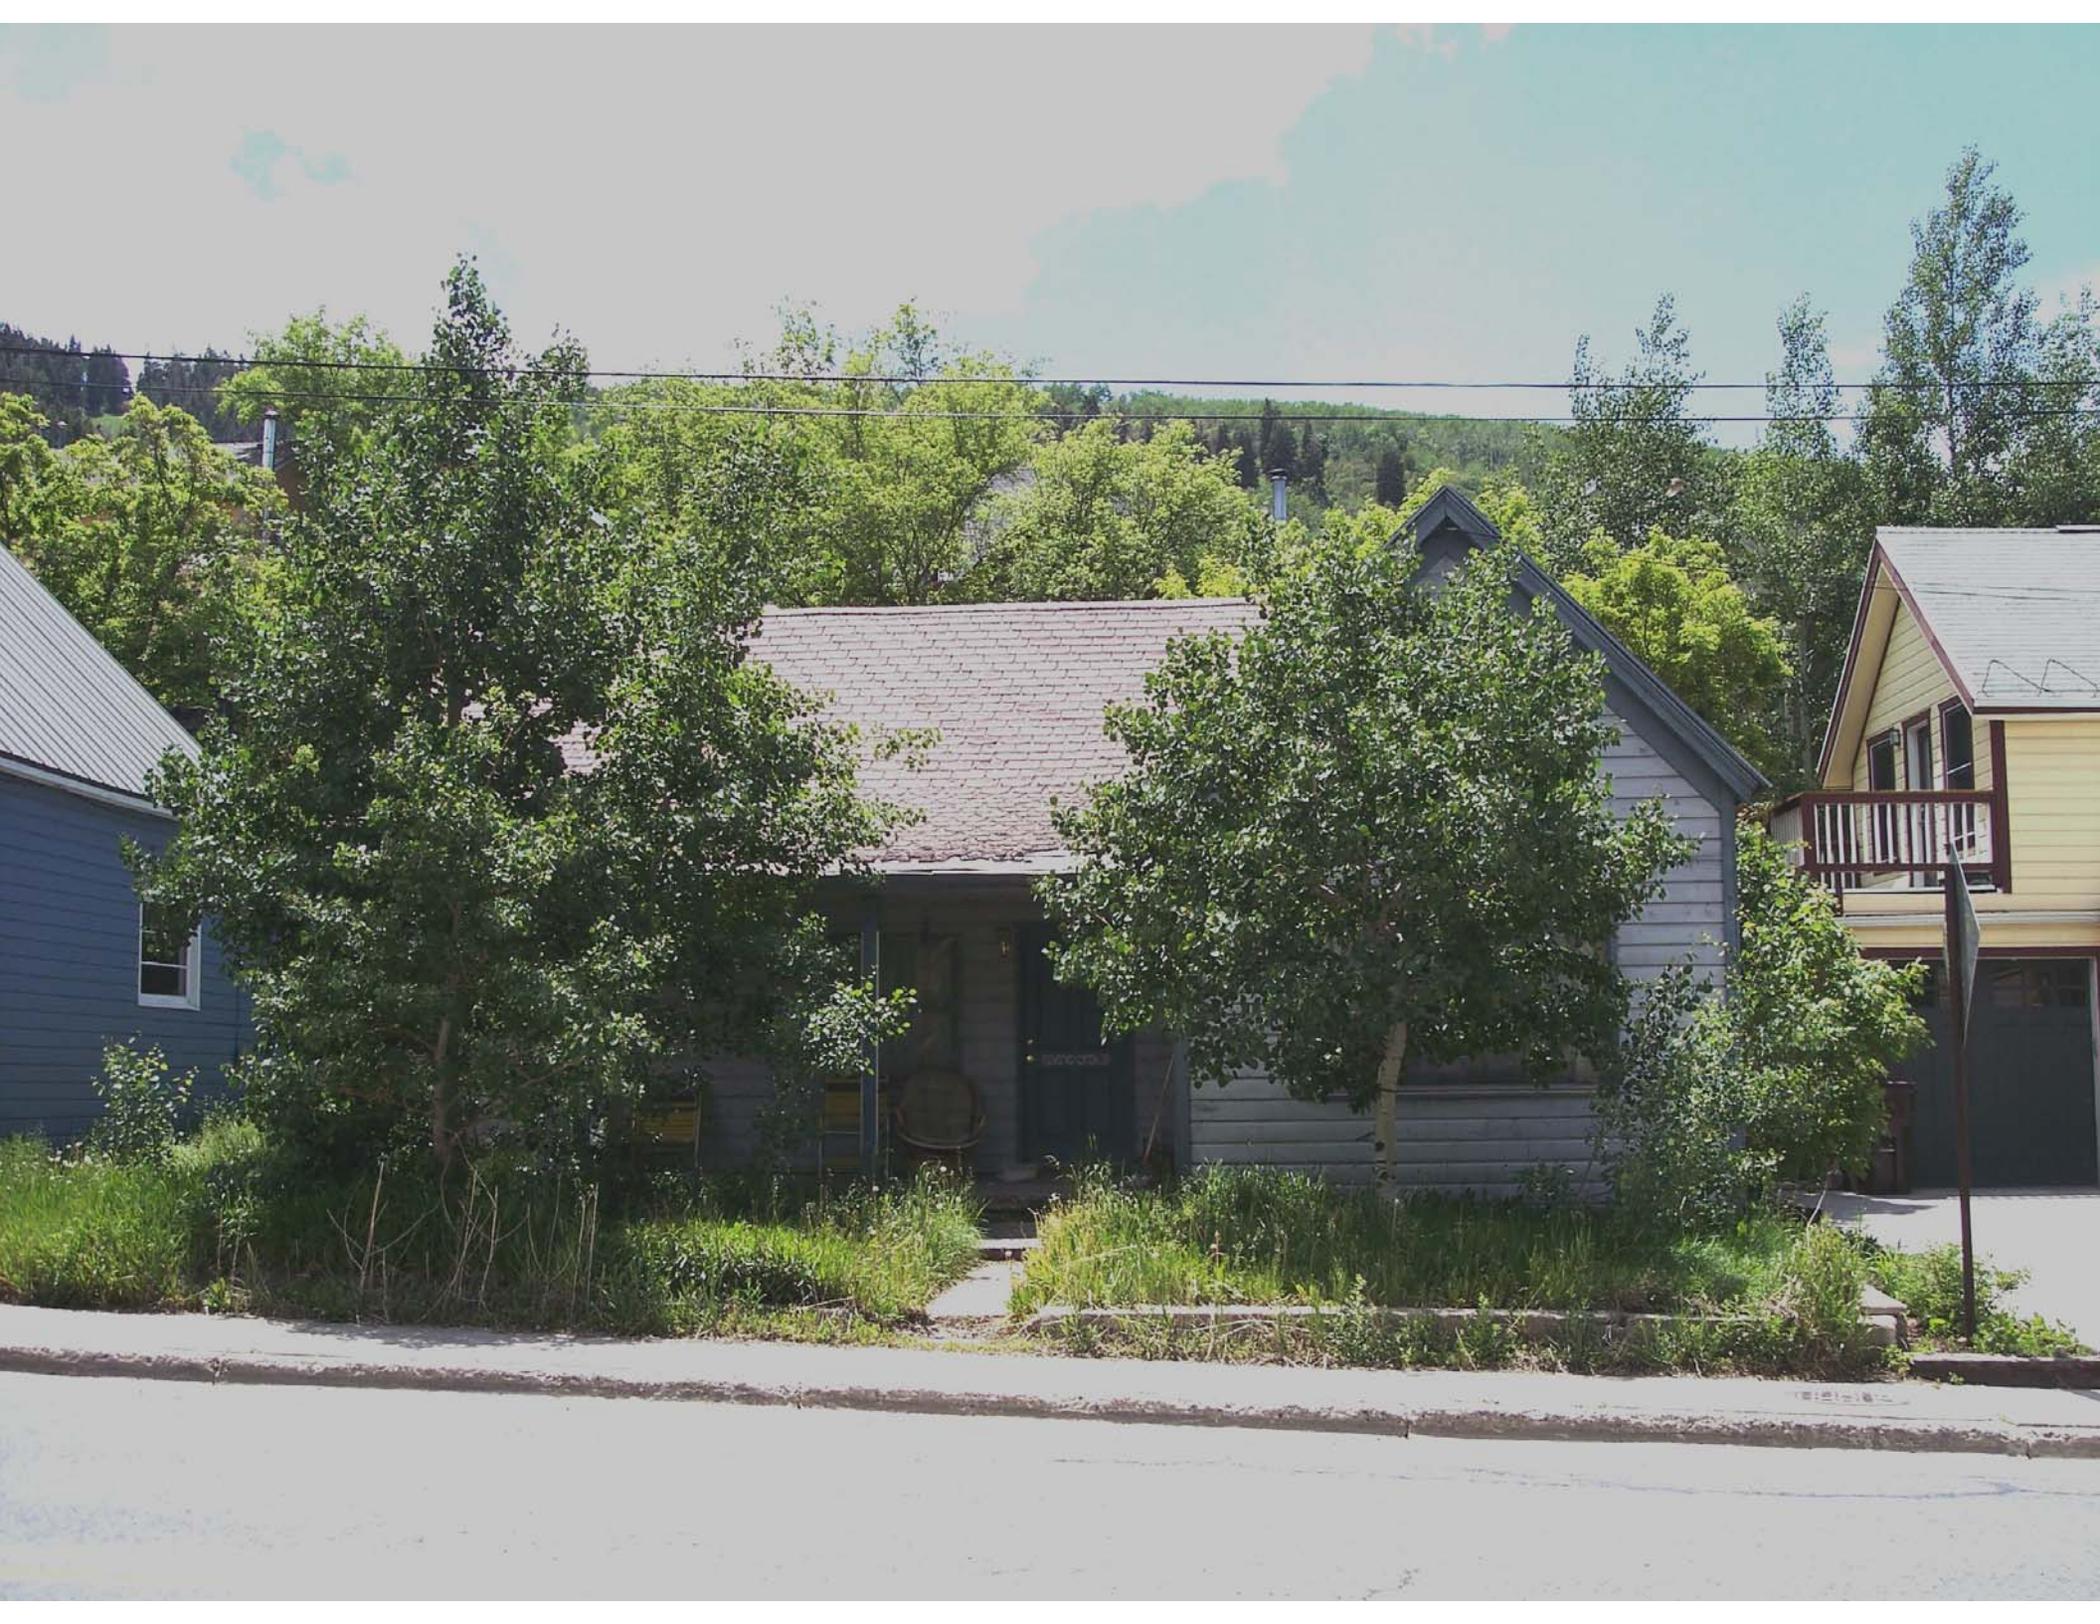
- Photo No. 1:** East elevation (primary façade). Camera facing west, 2006.
Photo No. 2: East elevation (primary façade). Camera facing west, 1995.
Photo No. 3: East elevation (primary façade). Camera facing west, tax photo.
