HISTORIC SITE FORM - HISTORIC SITES INVENTORY

PARK CITY MUNICIPAL CORPORATION (10-08)

Address: 943 PARK AVE

Building Type and/or Style: "L" cottage or "T" cottage

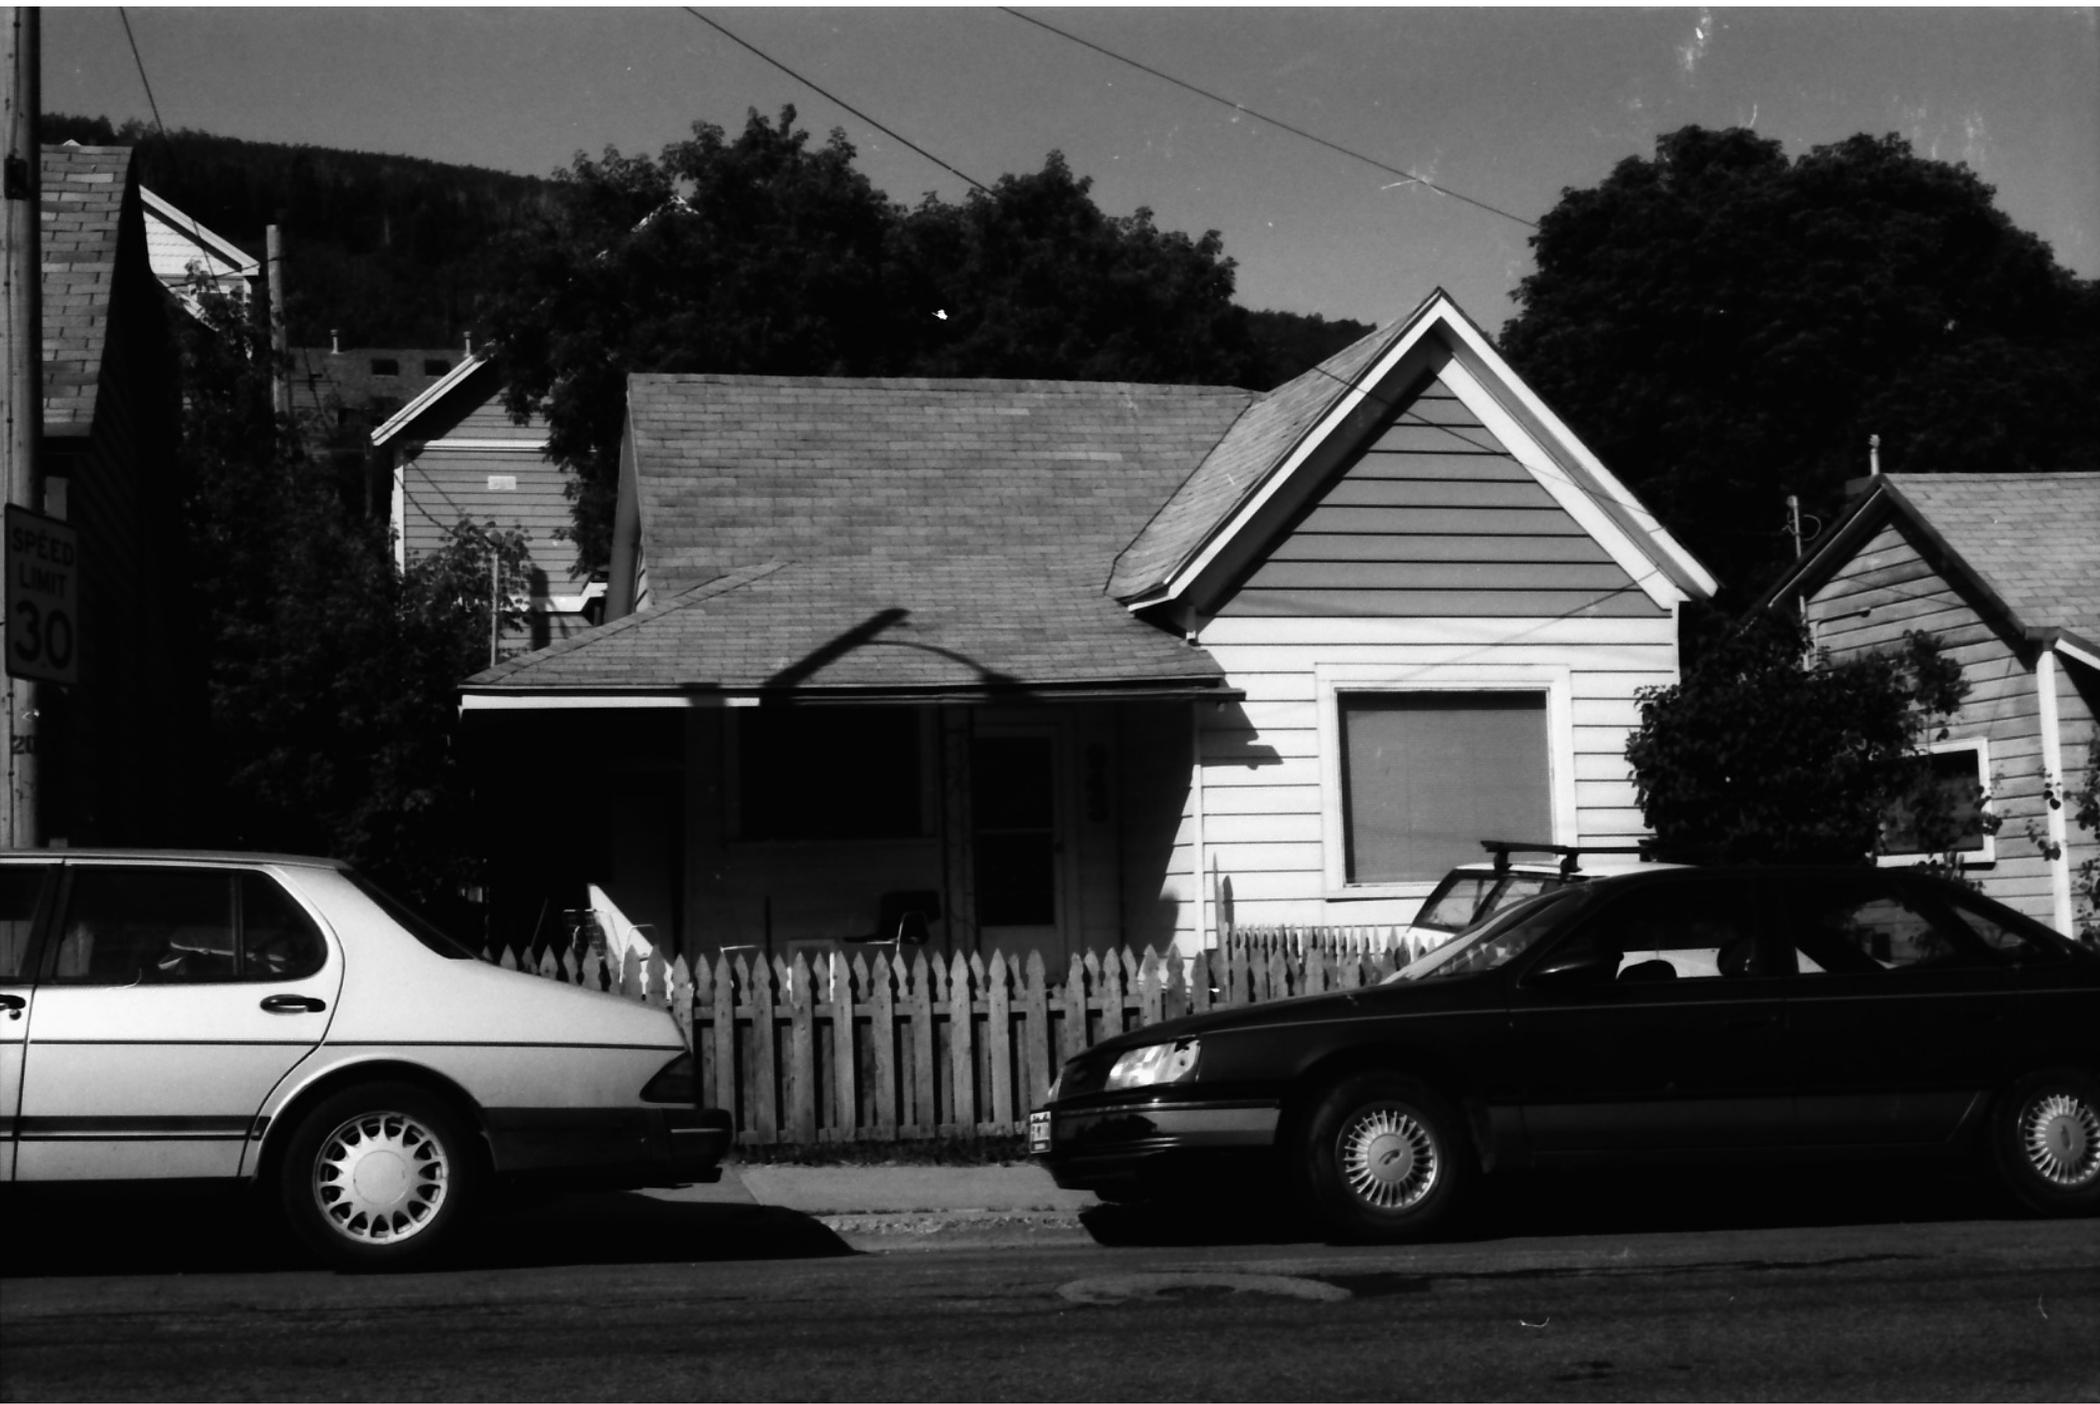
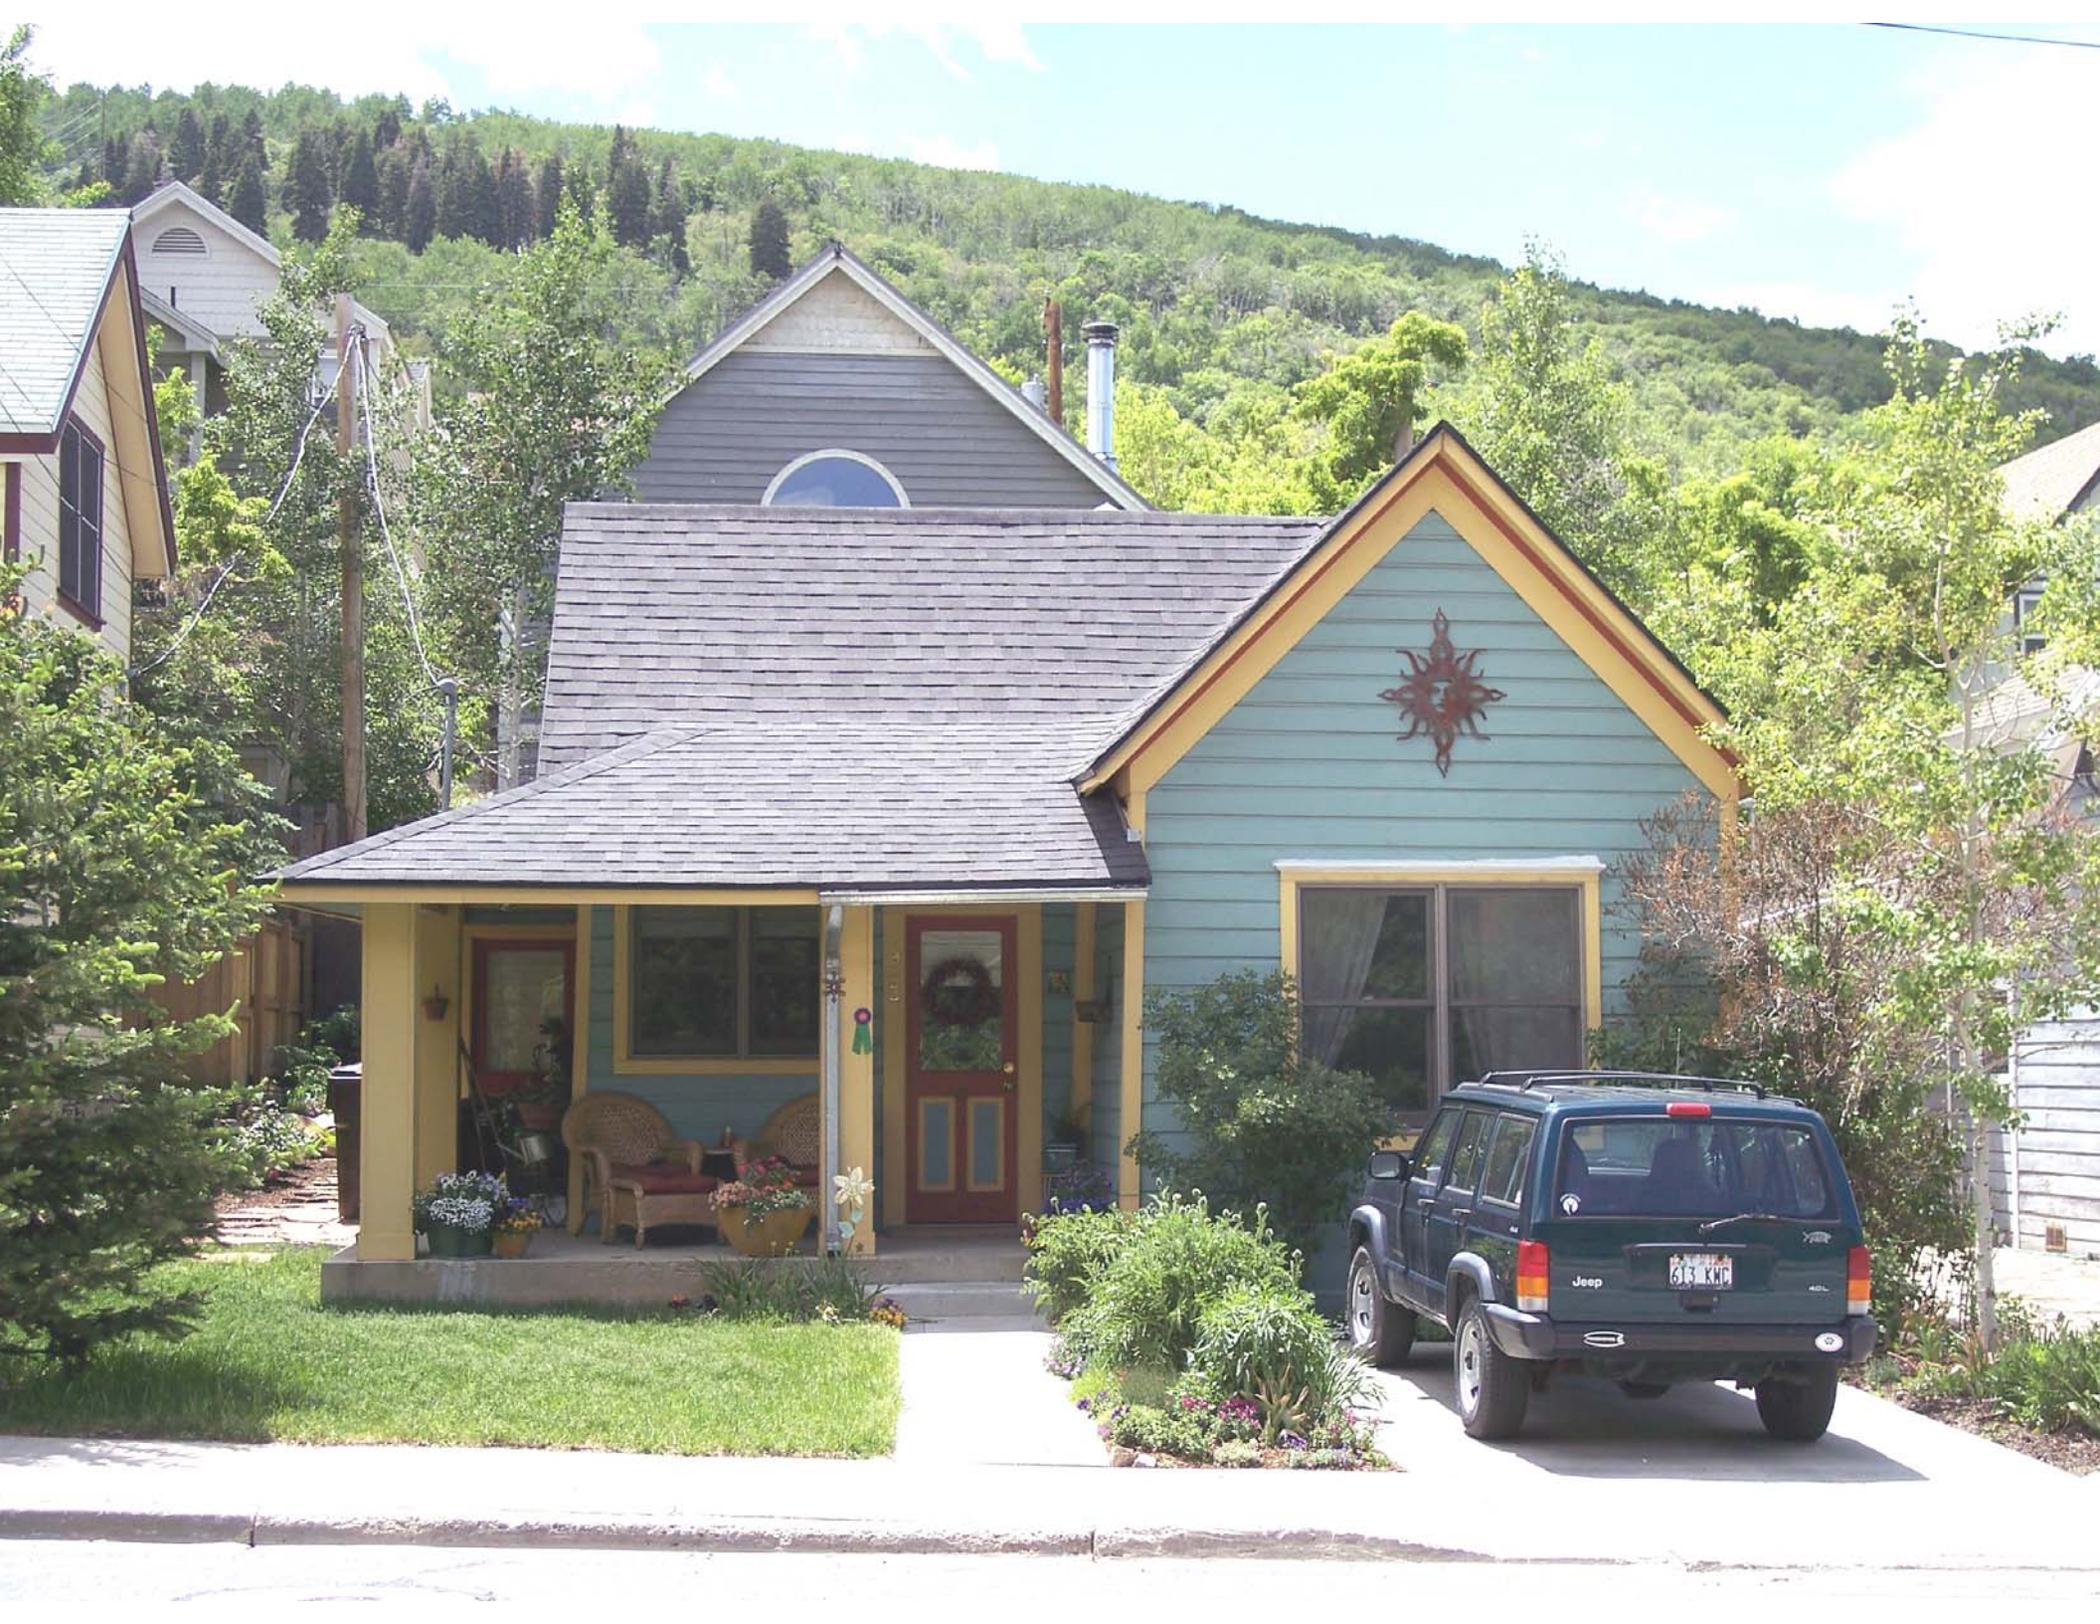
- Photo No. 1:** East elevation (primary façade). Camera facing west, 2006.
Photo No. 2: East elevation (primary façade). Camera facing west, 1995.
Photo No. 3: East elevation (primary façade). Camera facing west, tax photo.
