PARK CITY MUNICIPAL CORPORATION
HISTORIC PRESERVATION BOARD
445 MARSAC AVENUE
CITY HALL, COUNCIL CHAMBERS
June 5, 2019

| 1060 Park Avenue – Application to Remove a Significant Site from the Park City Historic Sites Inventory – The applicant has submitted a Determination of Significance requesting to remove the “Significant” single-family dwelling located at 1060 Park Avenue from the Park City Historic Sites Inventory.
| 1057 Woodside Avenue – Historic District Design Review – The applicant is proposing to Reconstruct the “Landmark” single-car garage that collapsed due to snow loads on the roof structure. A Notice and Order has been issued for the “Landmark” single-car garage.

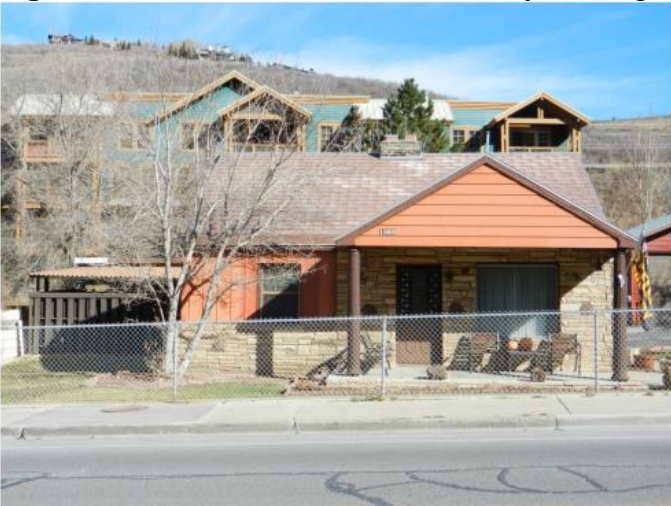
Figure 1: Draft Intensive Level Survey Photographs, 2015 by CRSA Architects

West Elevation.

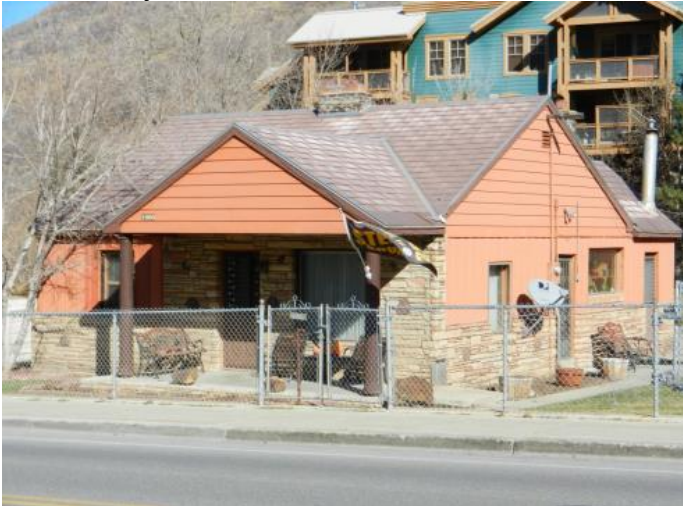
Southwest Oblique.

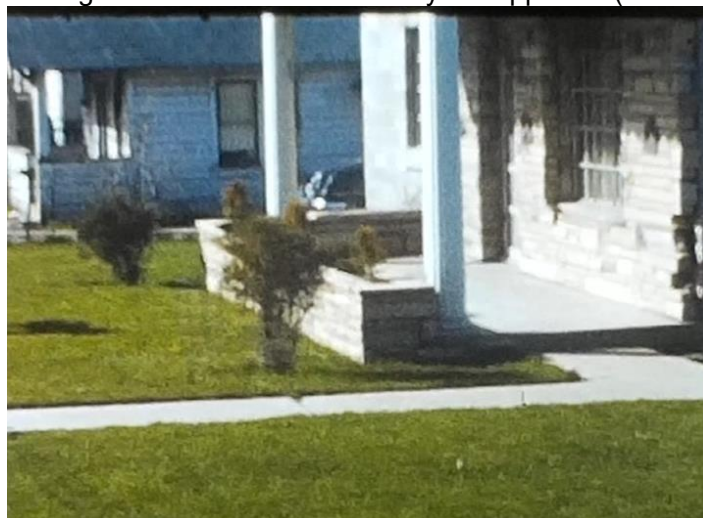
Figure 2: 1950s Film Footage Screenshots submitted by the applicant (see Exhibit B)

Front porch facing north.

Overall, the form of the structure has remained the same. There are no new window or door openings, the porch is in-tact, and the alterations have been cosmetic.

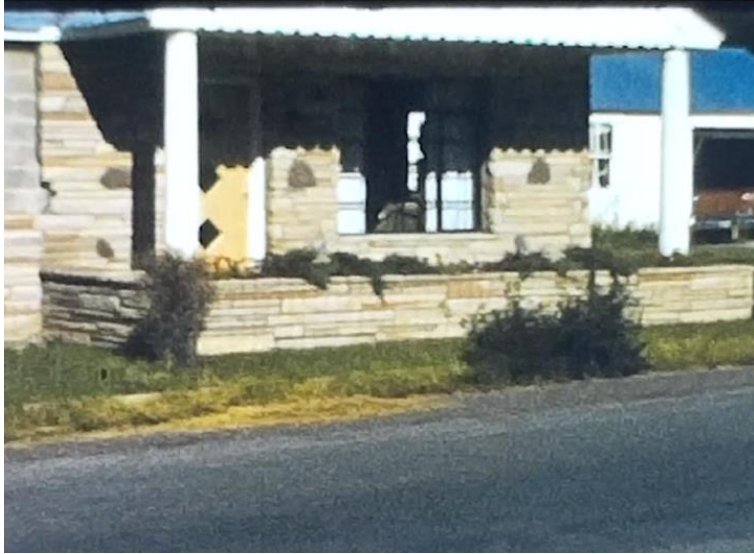
Front porch, facing east.

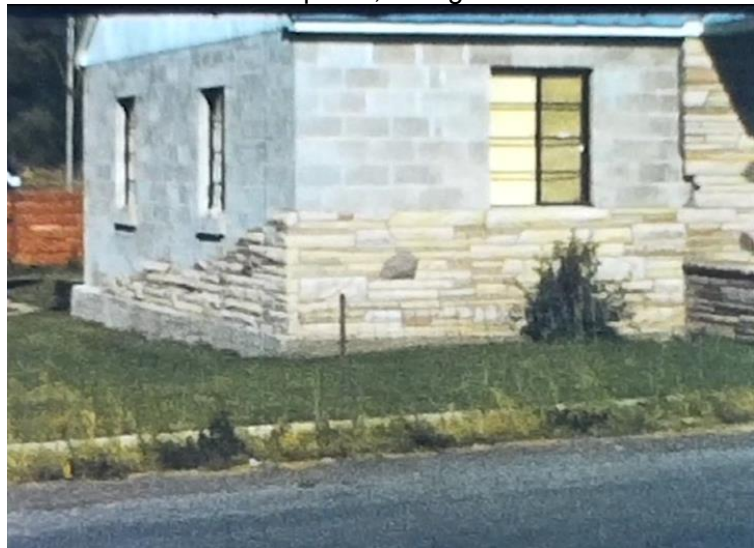
Northwest Oblique (northern half of front [west] façade)

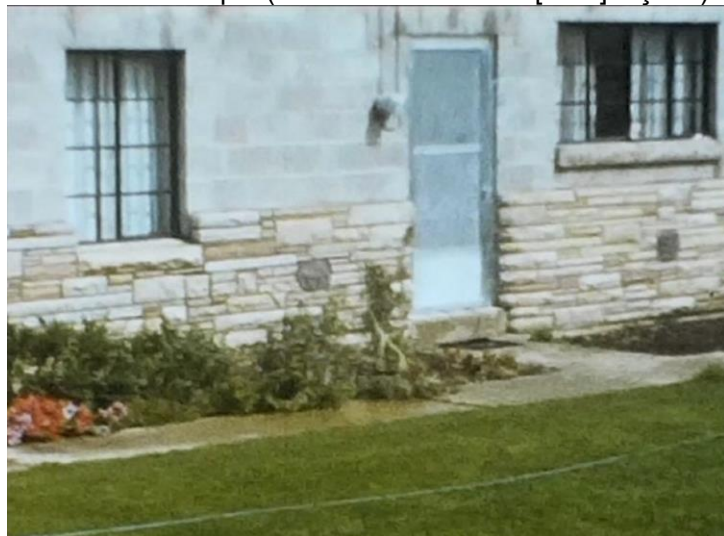
South façade (front half)

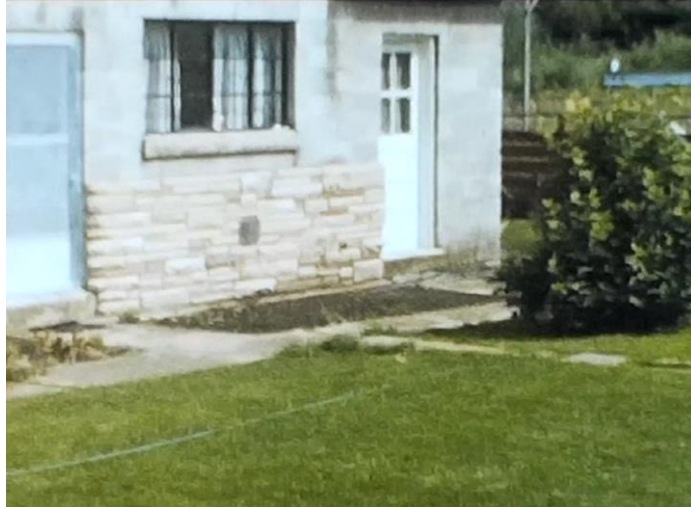
South façade (rear half)

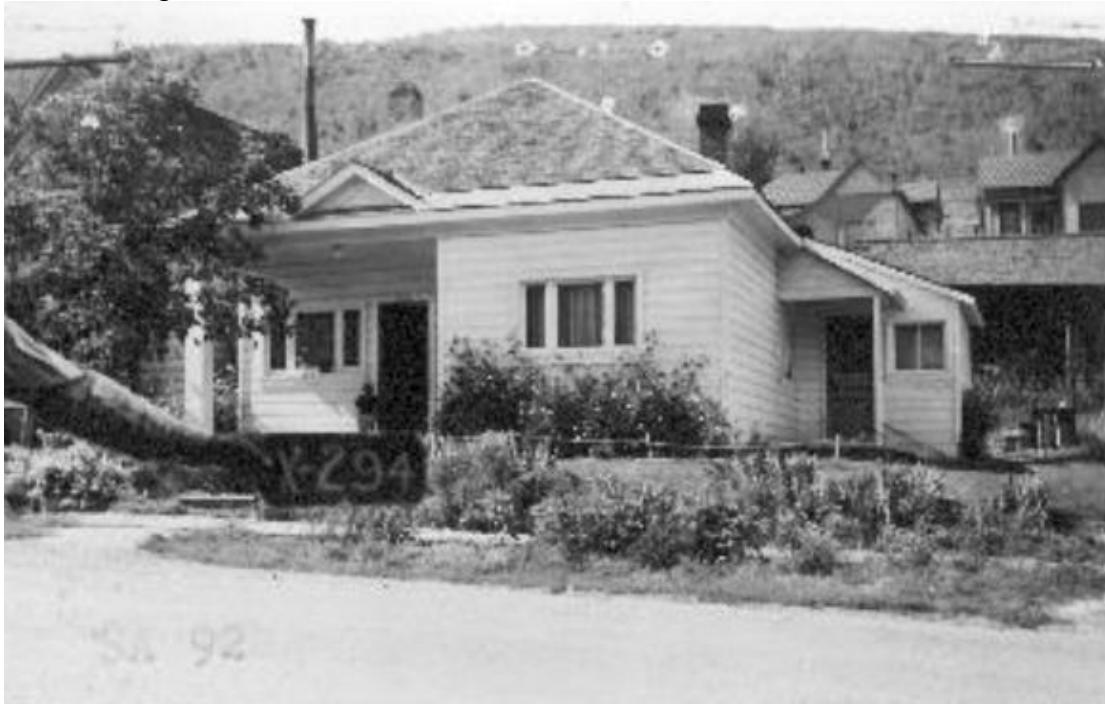
Figure 2: 1057 Woodside Avenue circ. 1940 tax photograph. Visible in this photograph are the circ. 1918 alterations, the circ. 1936 north addition, and the corner of the outbuildings.

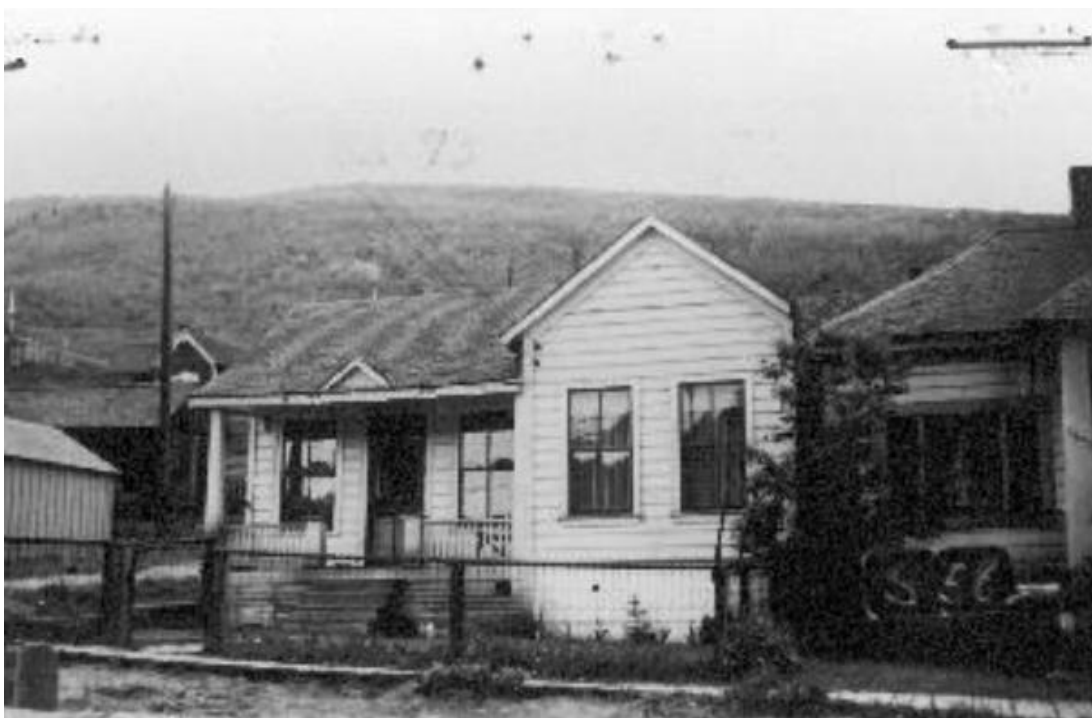
Figure 3: 1103 Woodside Avenue circ. 1940 tax photograph. Visible in this photograph is the single-car garage with its white-painted, board and batten siding and wood-shingled roof.

The circ. 1940 tax photograph of 1103 Woodside Avenue, which is the property on the north side of Crescent Street, provides a better view of the two (2) outbuildings (Figure 3). The white-painted, board and batten building with a wood-shingled roof is clearly the single-car garage in the same location on the property today.

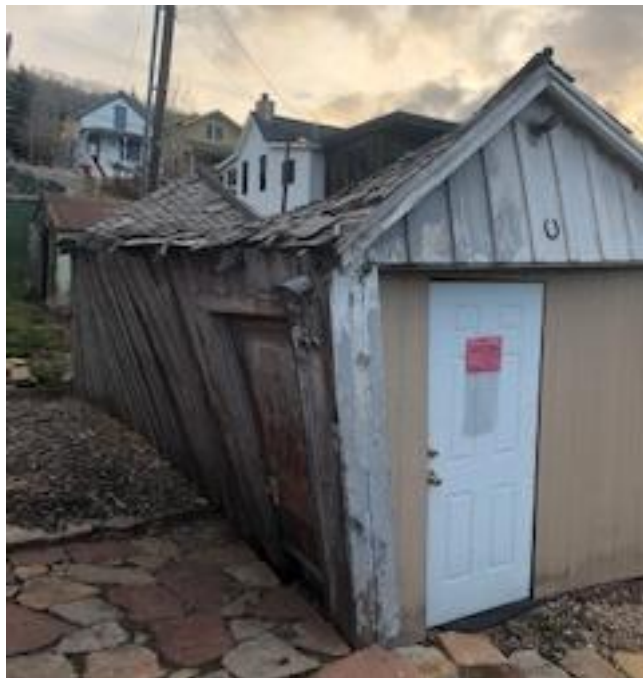
Figure 4: Detailed conditions of the Historic One-Car Garage.

Front Elevation

Due to the instability and collapse of the garage’s roof structure system, the extent of the deterioration of the original materials, as well as the health concerns, the safest approach is to Reconstruct the Historic single-car garage.

9. The applicant is proposing to Reconstruct the Historic Single- Car Garage on the Landmark site at 1057 Woodside Avenue. The existing condition of the single-car garage is poor. The structural members of the single-car garage are compromised, the roof has buckled from the weight of the snow, the exterior siding material is deteriorating, and the building is leaning significantly to the South

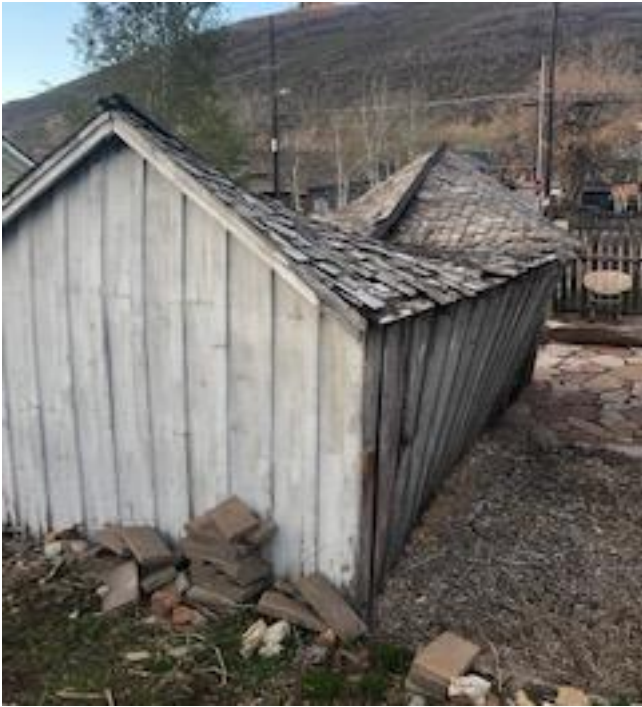
Back Elevation

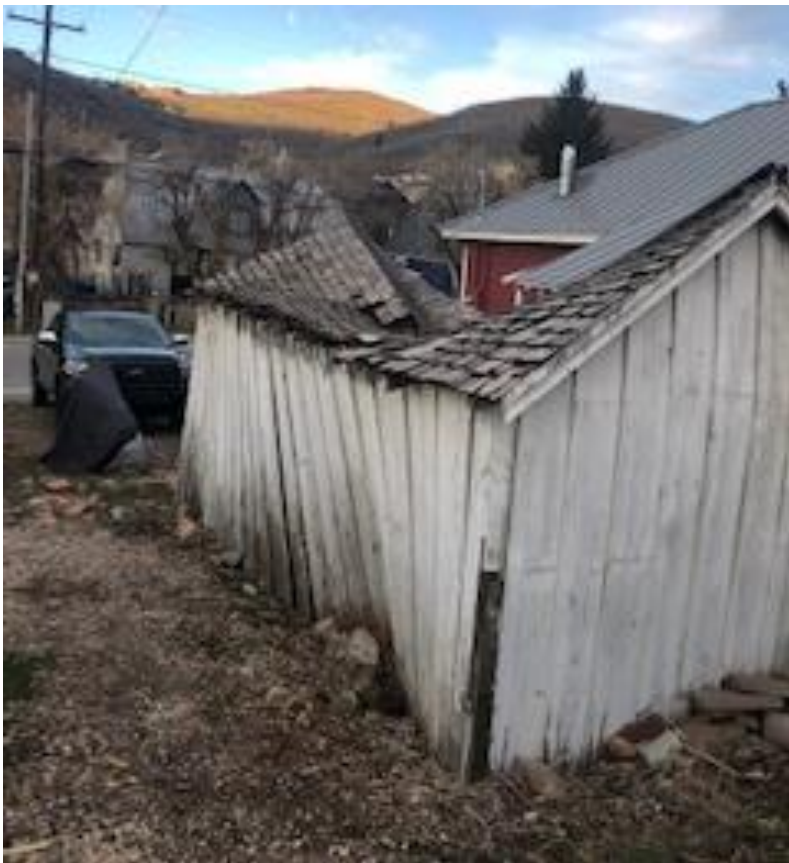
Back Elevation

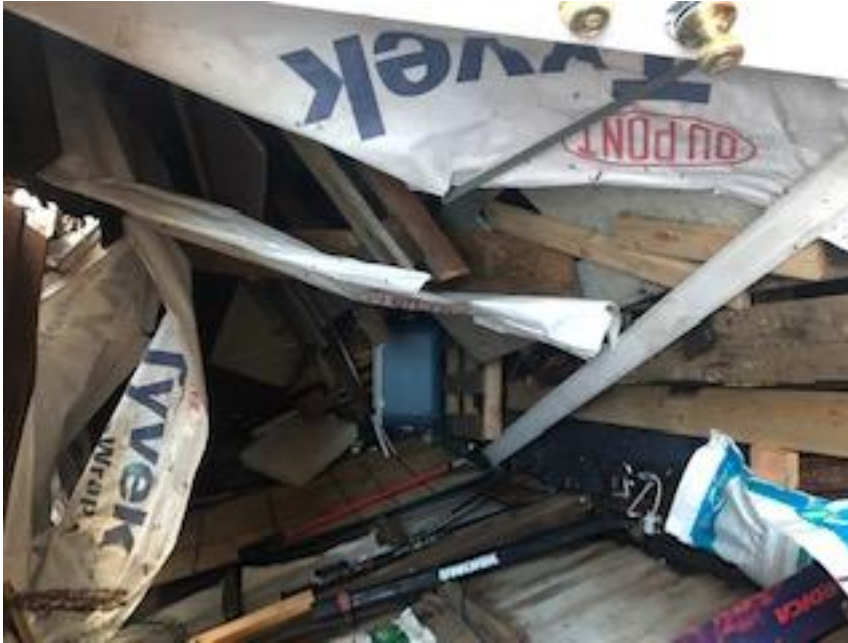
Inside of Garage showing roof collapse
