HISTORIC SITE FORM - HISTORIC SITES INVENTORY

PARK CITY MUNICIPAL CORPORATION (10-08)

Name of Property: **Dr. Harold I. Goodwin House**

Address: 1100 Woodside Avenue

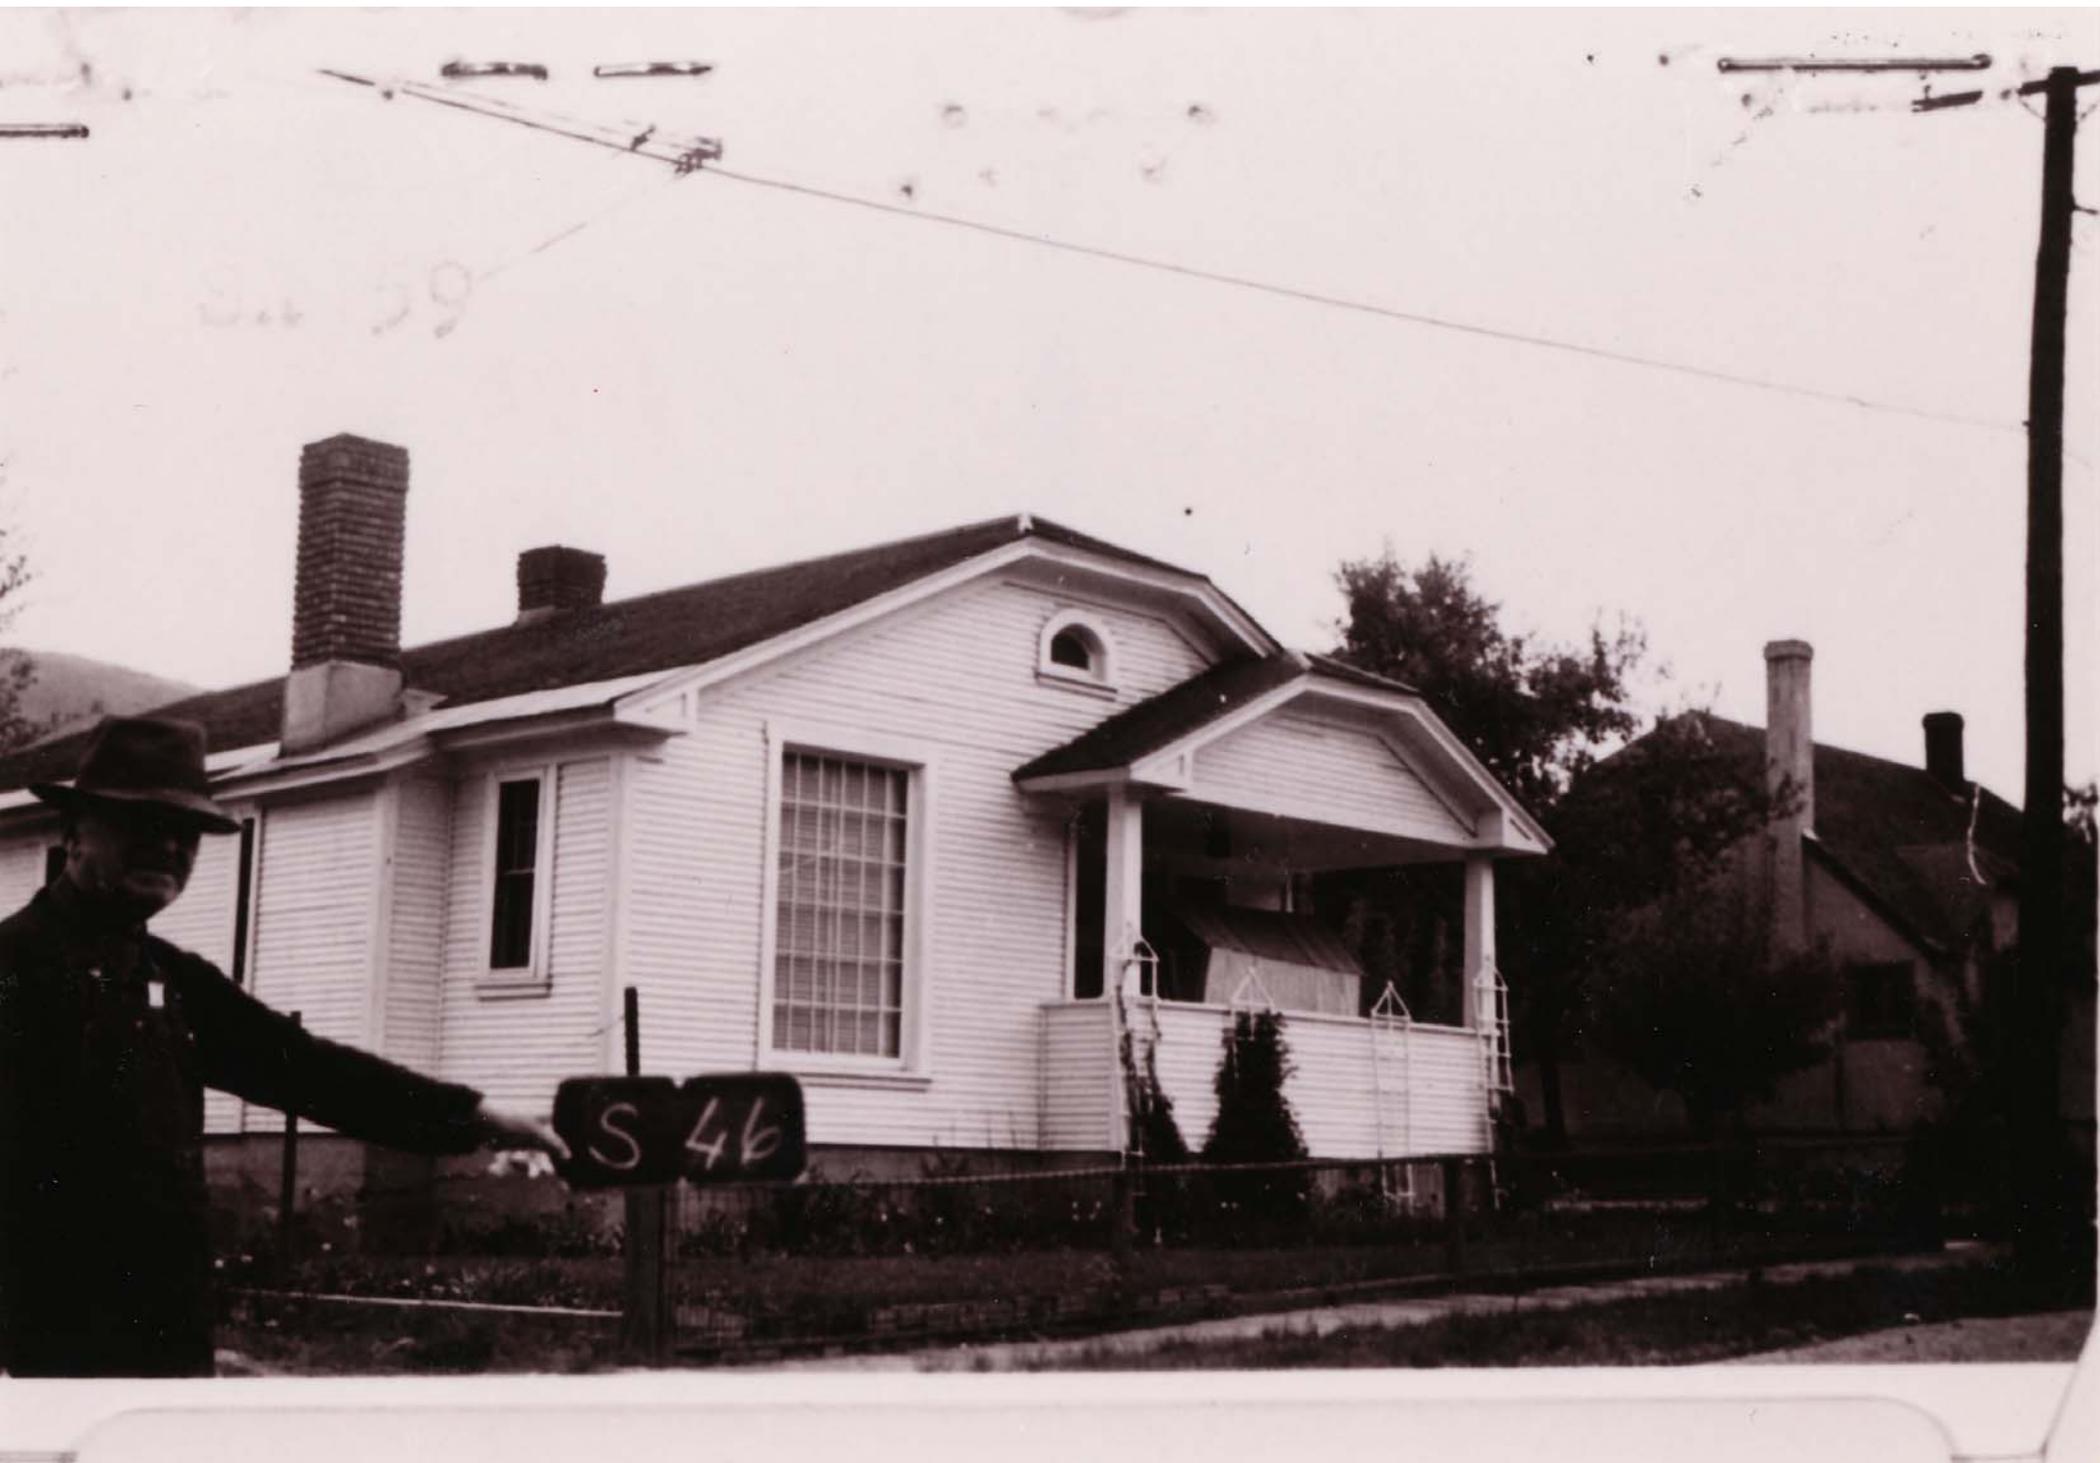
Photo No. 1: West elevation. Camera facing east, 2006.

Design (The combination of physical elements that create the form, plan, space, structure, and style. Describe additions and/or alterations from the original design, including dates--known or estimated--when alterations were made): The one-story frame bungalow has not been altered from the description provided in the 1983 National Register nomination form (see Structure/Site Form, 1983). Alterations include the construction of a small stoop on the rear of the house sometime before 1949. Also, the single broad casement window noted in the nomination has been replaced with a casement window with transom. The changes are minor and do not affect the site's original character.

Setting (The physical environment--natural or manmade--of a historic site. Describe the setting and how it has changed over time.): The setting is largely unchanged from the tax photo with the exception of a row of aspen trees located in the front yard that obstruct the view of the house from the public right-of-way. The tax cards indicate a two-car garage, but its existence is not verified.
