HISTORIC SITE FORM - HISTORIC SITES INVENTORY

PARK CITY MUNICIPAL CORPORATION (10-08)

Address: 114 HILLSIDE AVE AKA: 114 Sandridge Road

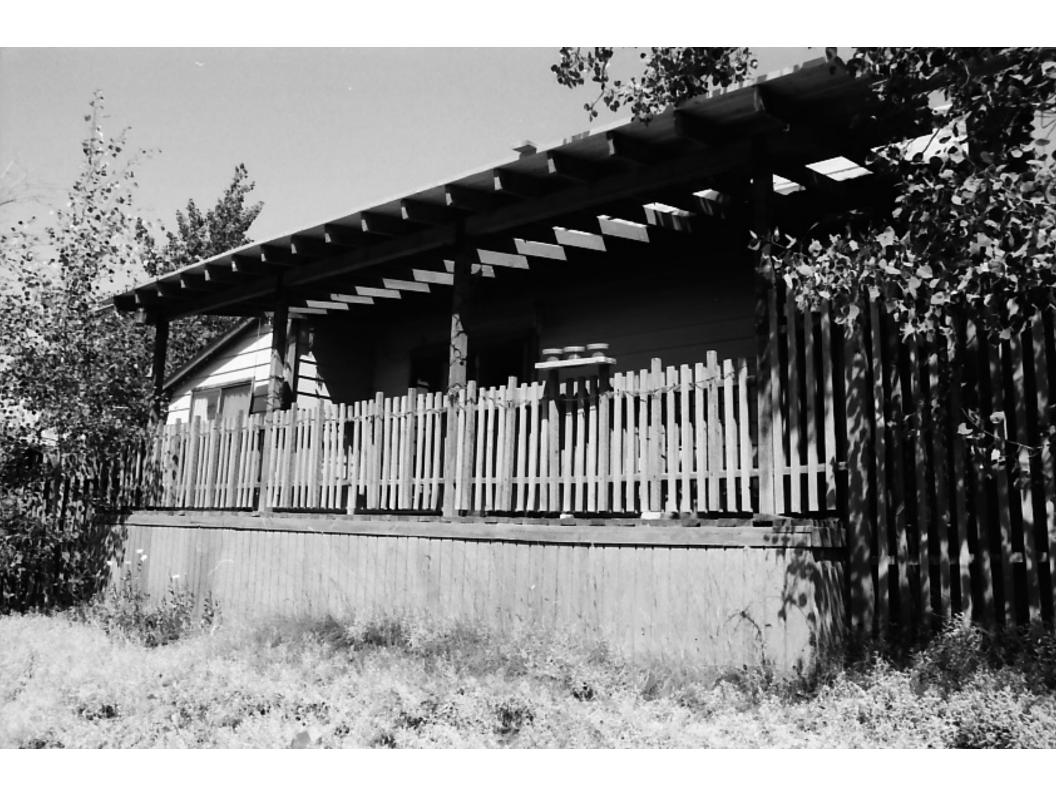
Photo No. 1: elevation. Camera facing .

This house is a single story frame side-gabled hall-parlor house with a crosswing and a rear shed extension with a shed-roofed open front porch. The porch roof has square wooden supports and the porch railing is a picket fence. The porch was most likely added c. 1964.
