HISTORIC SITE FORM - HISTORIC SITES INVENTORY

PARK CITY MUNICIPAL CORPORATION (10-08)

Address: 923 EMPIRE AVE

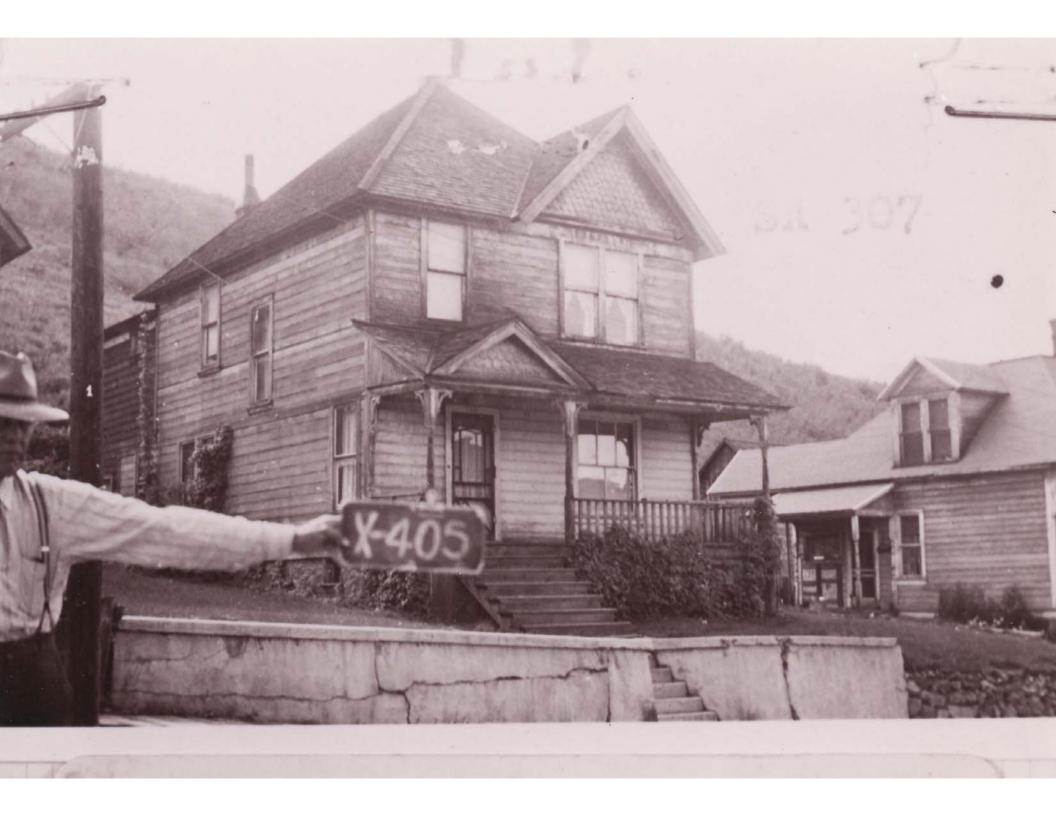
Photo No. 1: East elevation (primary façade). Camera facing west, 2006.
Photo No. 2: Southeast oblique. Camera facing northwest, 1995.
Photo No. 3: Southeast oblique. Camera facing northwest, c. 1940 tax photo.

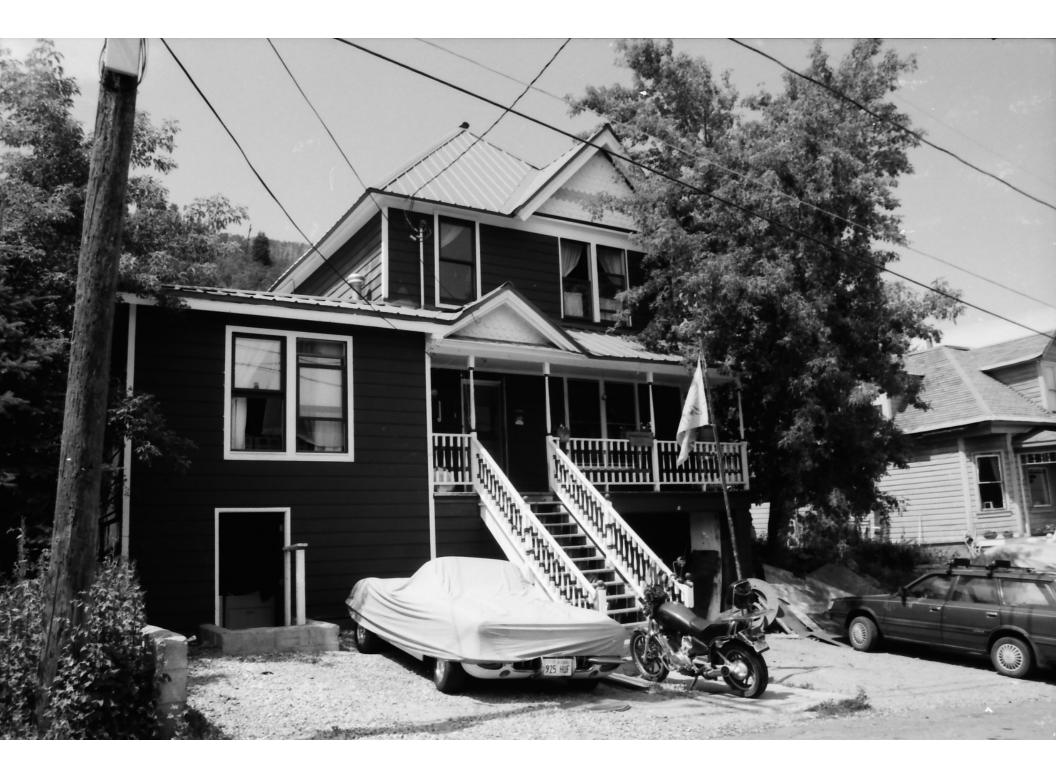
Setting (The physical environment--natural or manmade--of a historic site. Describe the setting and how it has changed over time.): Tax photo indicated a cement and rock retaining wall for minor property slope, which was leveled out for garage space based on 1995 photo. Overgrown tree in 1995 photo appears to have been trimmed back or discarded based on 2006 photo. The narrow building lot, housing style and scale match with surrounding properties.
