HISTORIC SITE FORM - HISTORIC SITES INVENTORY

PARK CITY MUNICIPAL CORPORATION (10-08)

1 IDENTIFICATION				
Name of Property: Harry W. Ha	aumann House			
Address: 939 EMPIRE AVE		AKA:		
City, County: Park City, Summi	t County, Utah	Tax Num	nber: SA-308	
Current Owner Name: TOLY MARY LOU WHEELWRIGHT Parent Parcel(s):			Parcel(s):	
Current Owner Address: PO BO			CK 29 SNYDERS ADDITION TO	
PARK CITY CONT 0.15 AC	ago). 141/2 201 0 a /\cl	12010 0,10 0 11 220	OK 23 OKT DERO ADDITION TO	
2 STATUS/USE				
Property Category ☑ building(s), main ☐ building(s), attached ☐ building(s), detached ☐ building(s), public ☐ building(s), accessory ☑ structure(s), wall	Evaluation* ☑ Landmark Site ☐ Significant Site ☐ Not Historic	Reconstruction Date: Permit #: □ Full □ Partial Historic Places: □ inelig	<u>Use</u> Original Use: Residential Current Use: Residential	
El Structure(s), wan			Residences Thematic District)	
3 DOCUMENTATION				
 ☑ tax photo: c. 1940 ☑ prints: 1983, 1995 & 2006 ☐ tax card ☐ original building sewer permit ☐ Drawings and Plans ☐ Sanborn Maps ☐ with sever permit ☐ Sanborn Maps ☐ obituary index ☐ site sketch map ☐ city directories/ ☐ Historic American Bldg. Survey ☐ original plans

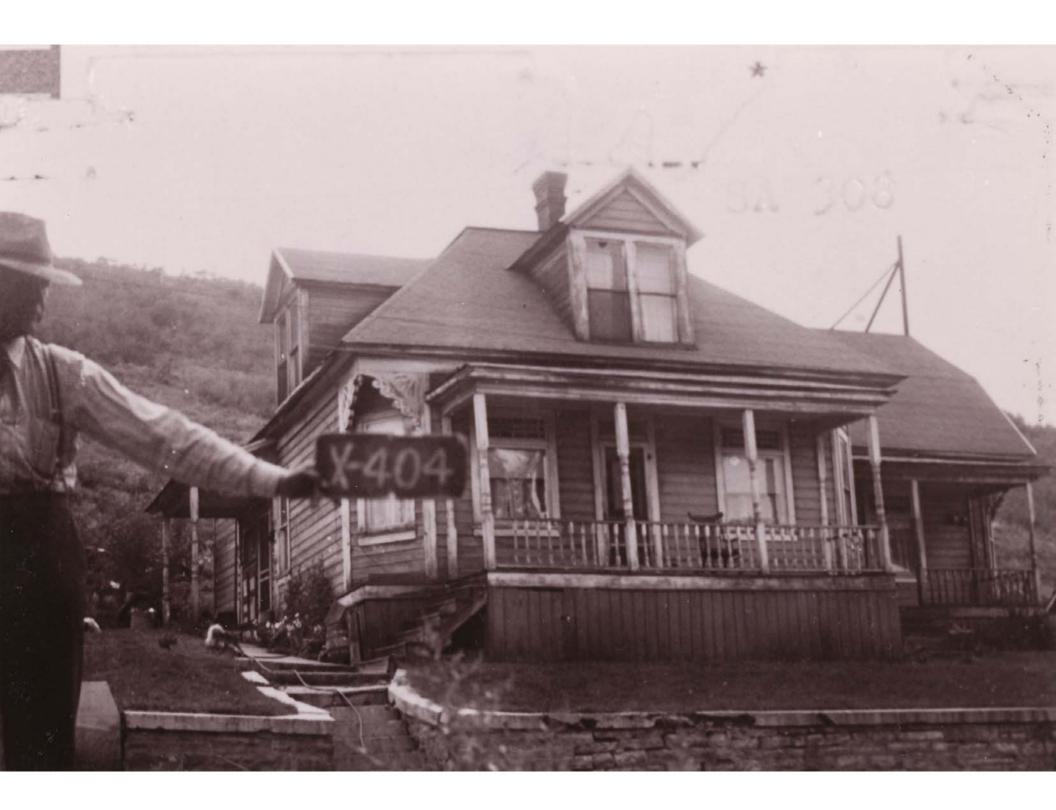
Photo No. 1: East elevation (primary façade). Camera facing west, 2006.

Walls: The exterior walls are clad in wood non-beveled (drop-novelty) siding. The siding is in good condition.				
Roof: The roof is sheathed in asphalt shingles.				
Windows/Doors: Windows on the main façade include large fixed-pane casement windows with multi-pane transom windows and single-pane double-hung sash windows. The main door appears to be original.				
Essential Historical Form: ☑ Retains ☐ Does Not Retain, due to:				
Location: ☑ Original Location ☐ Moved (date) Original Location:				
Design /The combination of physical elements that erects the form plan appear atrusture, and atrus. Describe additions and/or alterations

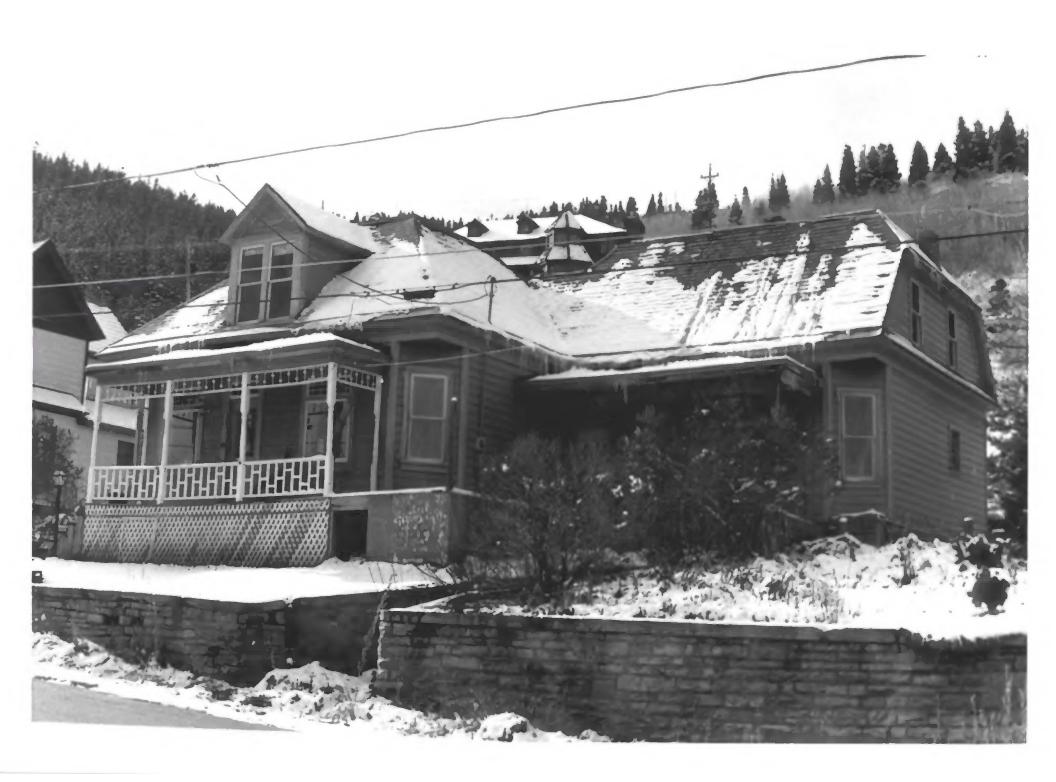
Harry W. Haumann House 939 Empire Park City, Summit County, Utah

Northeast corner
