# HISTORIC SITE FORM - HISTORIC SITES INVENTORY

PARK CITY MUNICIPAL CORPORATION (10-08)

Address: 1063 EMPIRE AVE

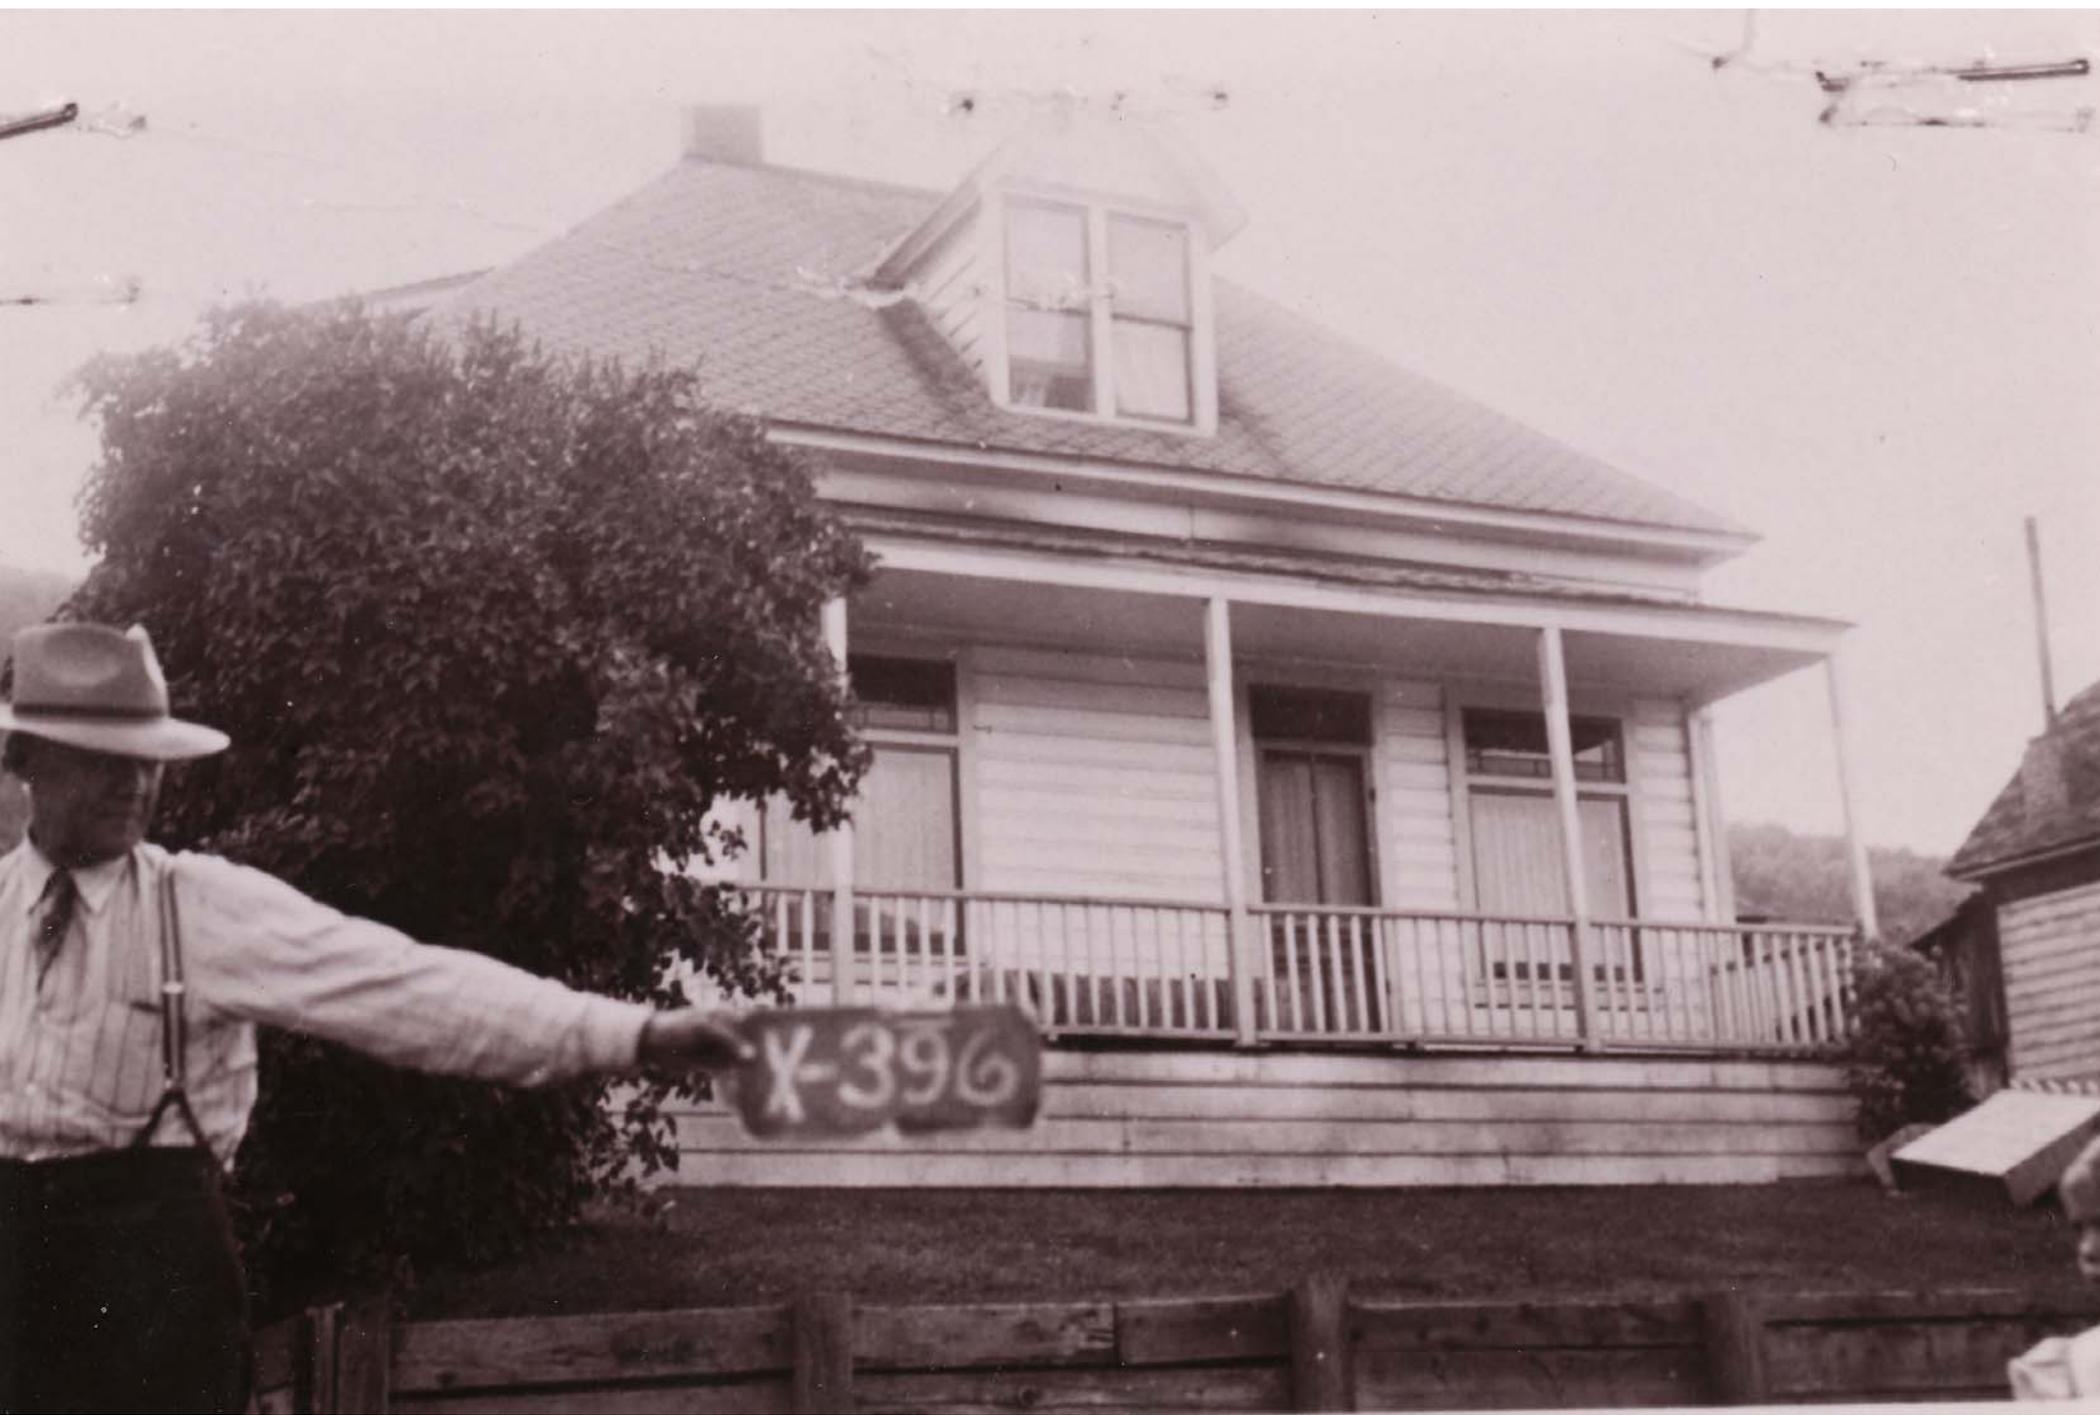
- Photo No. 1:** East elevation (primary façade). Camera facing west, 2006.
- Photo No. 2:** East elevation (primary façade). Camera facing west, 1995.
- Photo No. 3:** East elevation (primary façade). Camera facing west, c. 1940 tax photo.

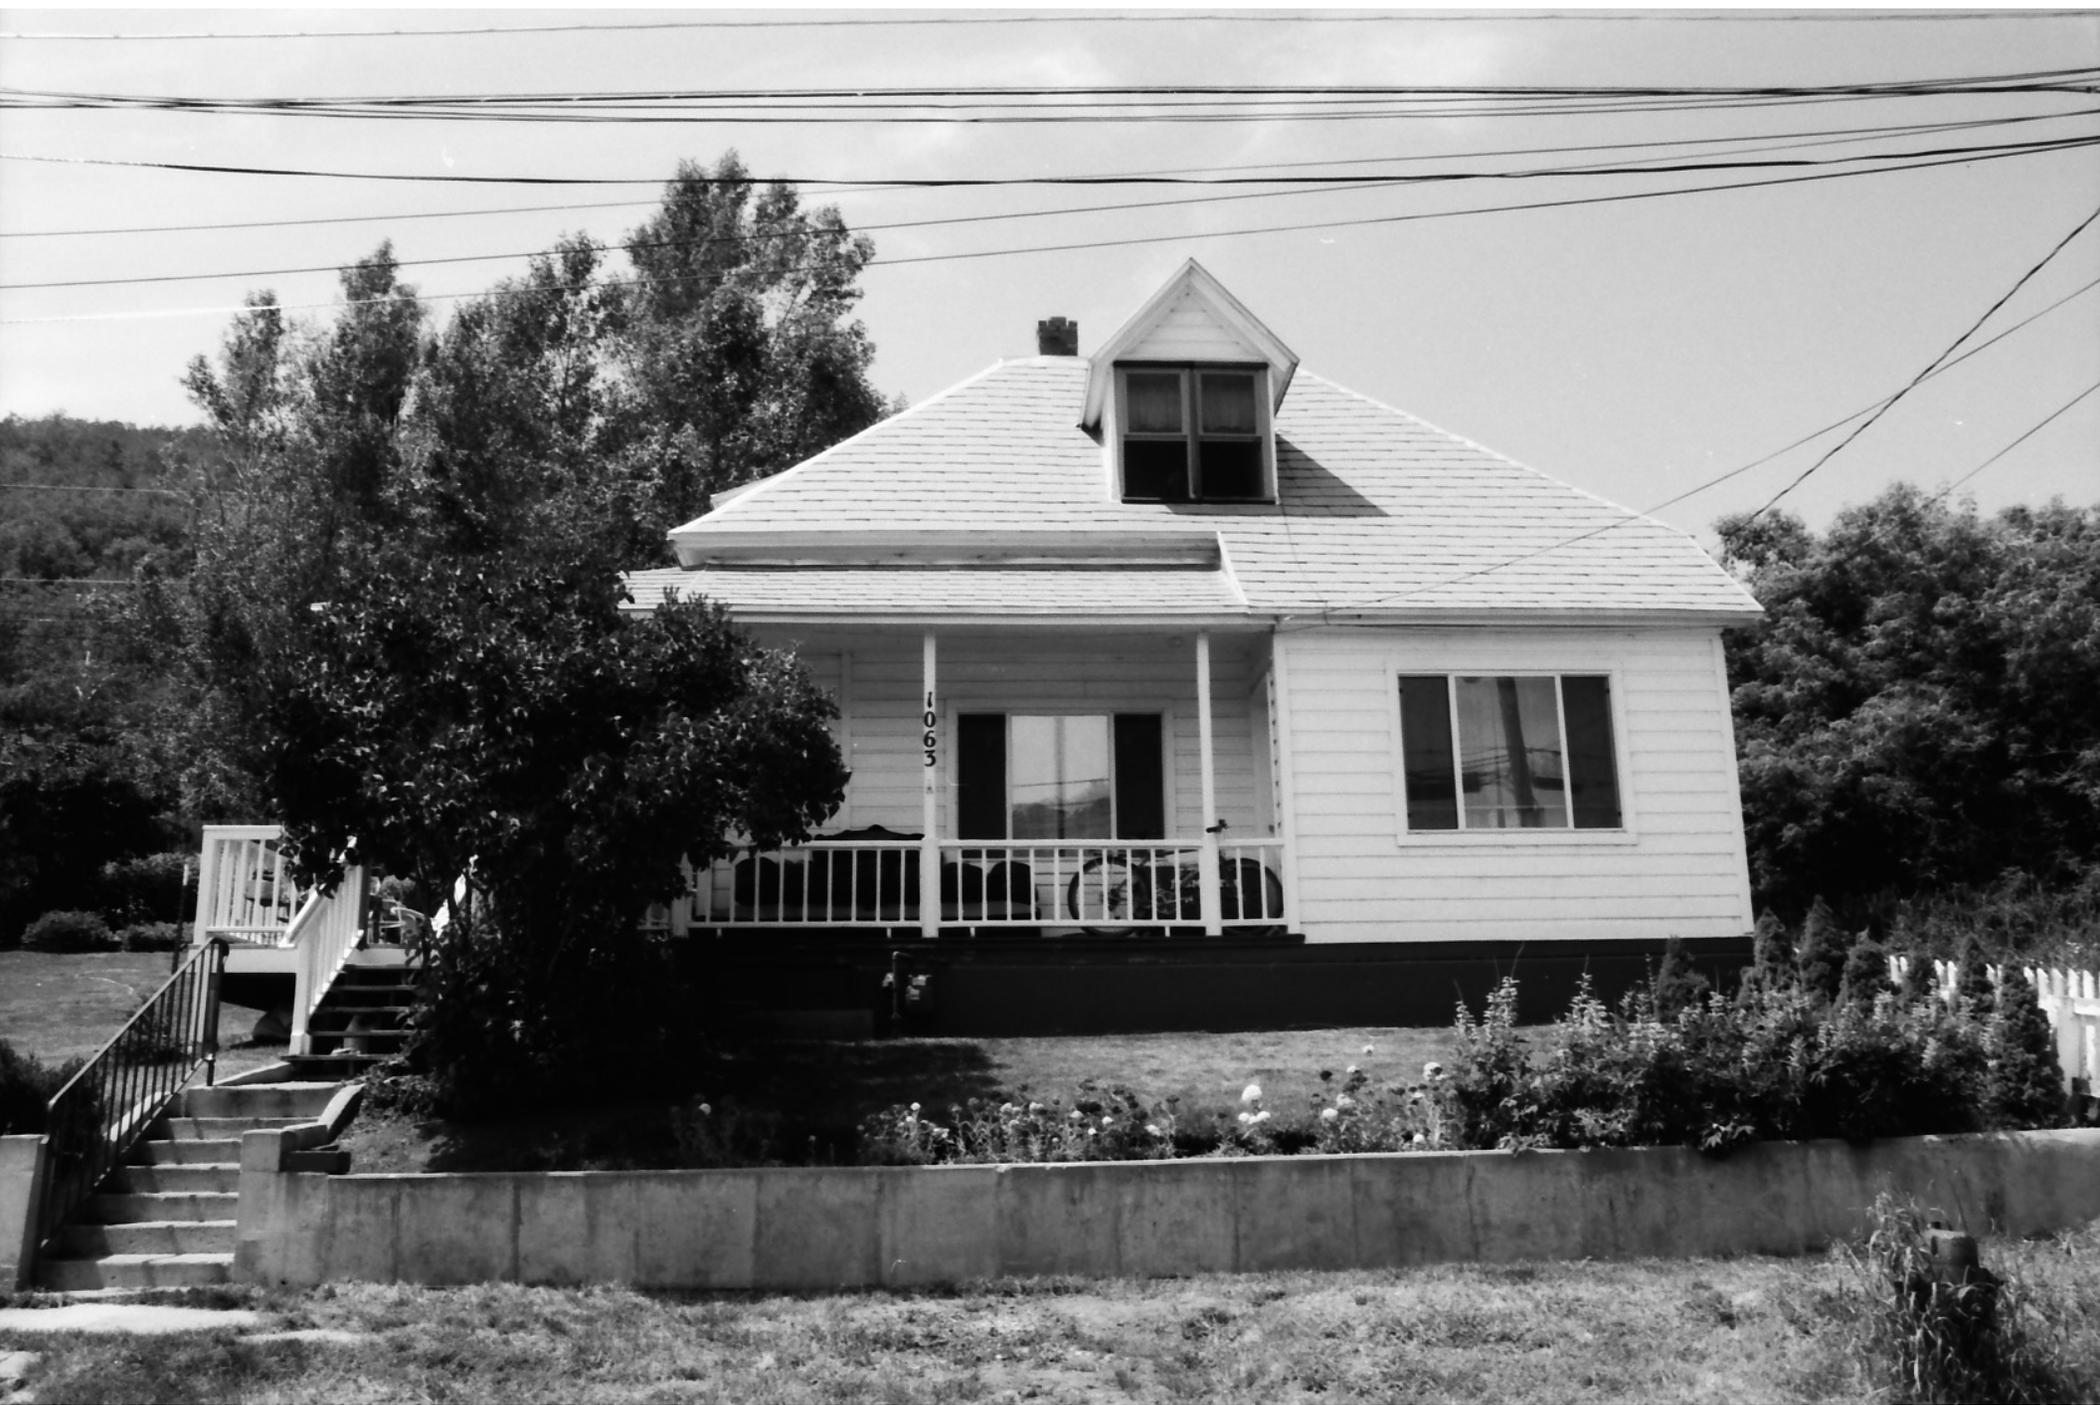
**Design** (The combination of physical elements that create the form, plan, space, structure, and style. Describe additions and/or alterations from the original design, including dates--known or estimated--when alterations were made): Full front porch in tax photo has been altered by 1995 photo as half of porch has been built out onto for interior purposes. This shift has altered the front door entrance from front-facing to side-facing, yet it is still oriented towards porch access. Essence of historical character of form remains, despite significant changes in window shape and style, roofing material, and porch railing detail. Large deck has been constructed to the south of the main building.

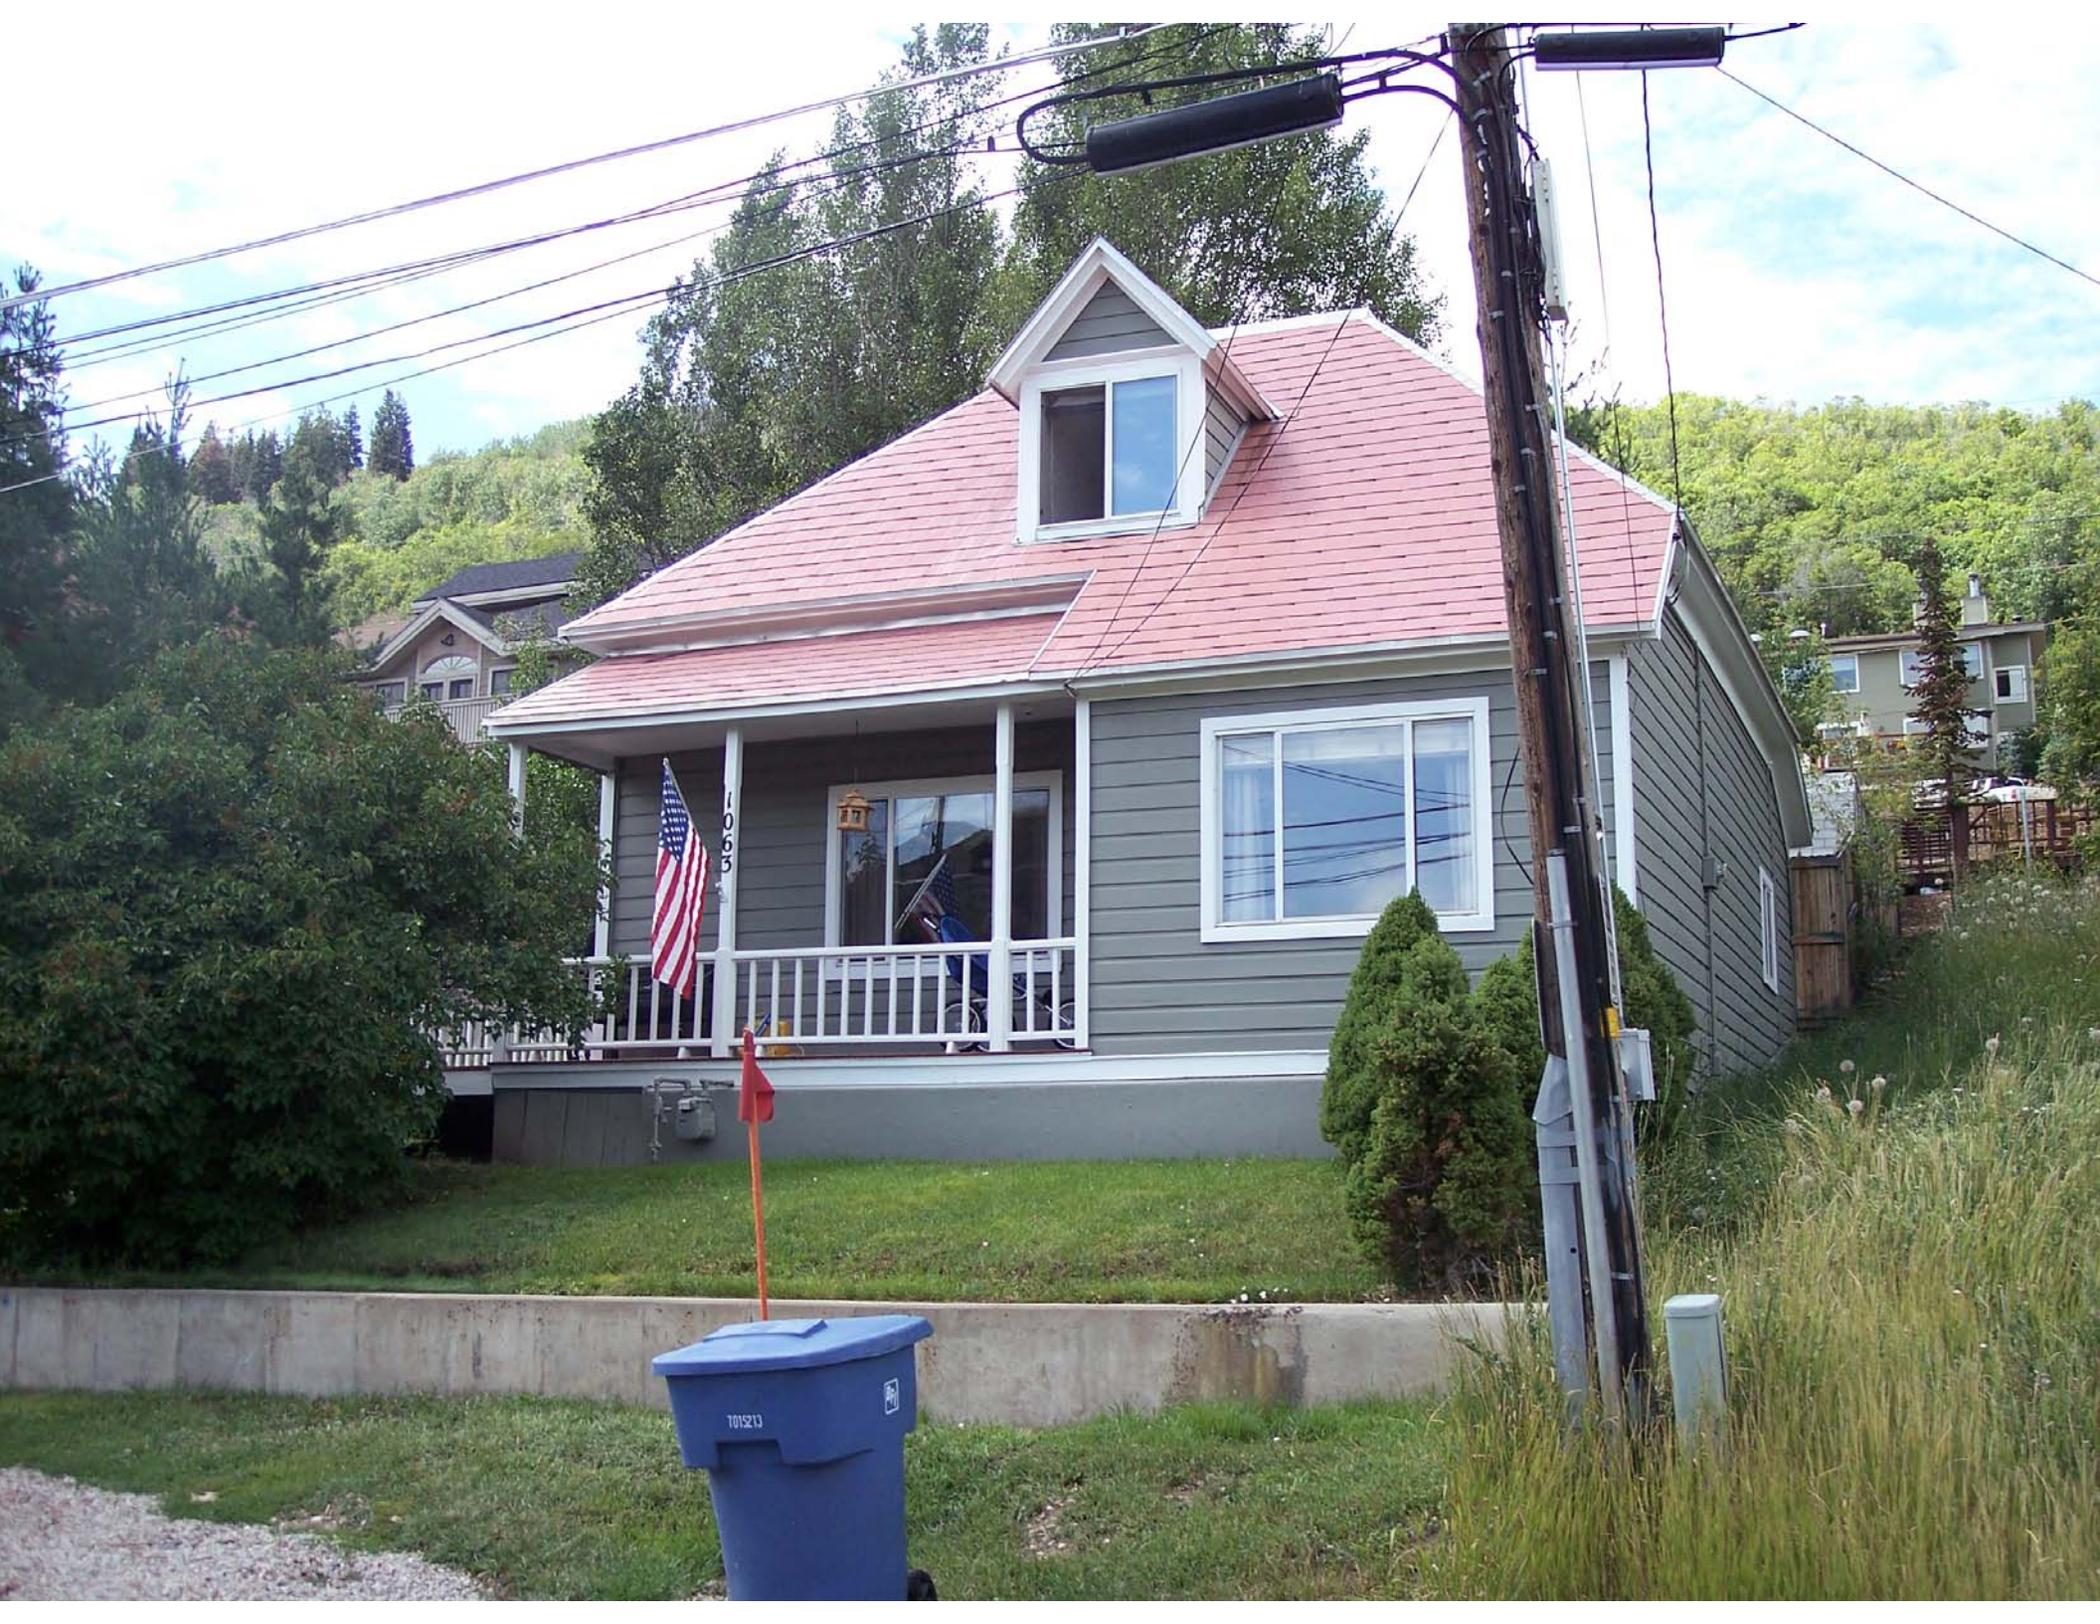
**Setting** (The physical environment--natural or manmade--of a historic site. Describe the setting and how it has changed over time.): Narrow building lot exhibits a slight slope downwards towards the front elevation of property. Wooden beam retaining wall seen in tax photo has been altered to a cement retaining wall by 1995 photo. House is recessed at least 20 feet from street edge of property, with planted natural shrubs and grasses throughout the landscape. The lillac bush on corner of front elevation appears in all photos available. The 1907 Sanborn map indicates a large accessory building to the rear of the house. Its current condition--if extant--was not assessed for the purposes of this site form.
