AGENDA

Historic Preservation Board Staff Report

Subject: 334 Marsac Avenue
John P. Nimmo House
Author: Francisco Astorga, Planner
Date: July 18, 2012
Type of Item: Historic District Grant Application
Project Number: PL-12-01559

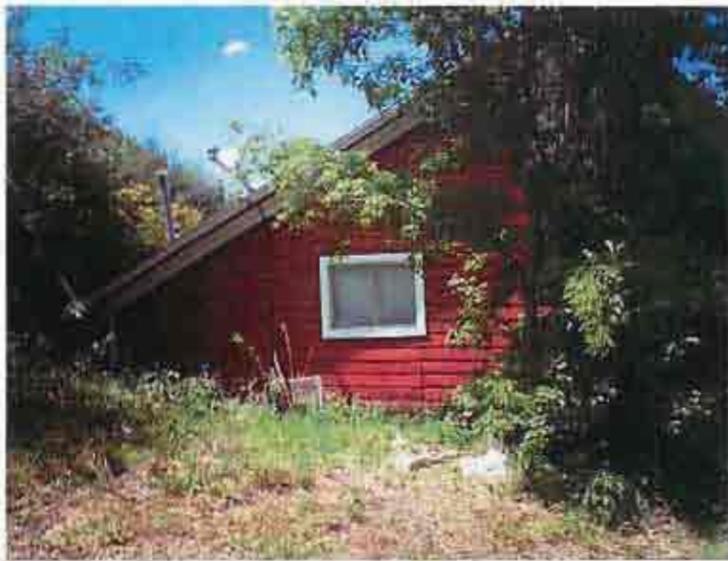
South Side

A. 2 Landscaping

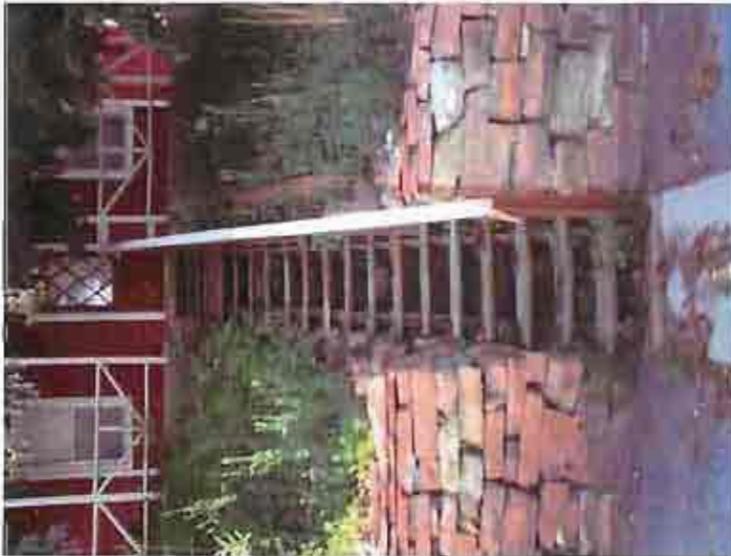
A. 4 Exterior Steps

Steps with Retaining Wall Return

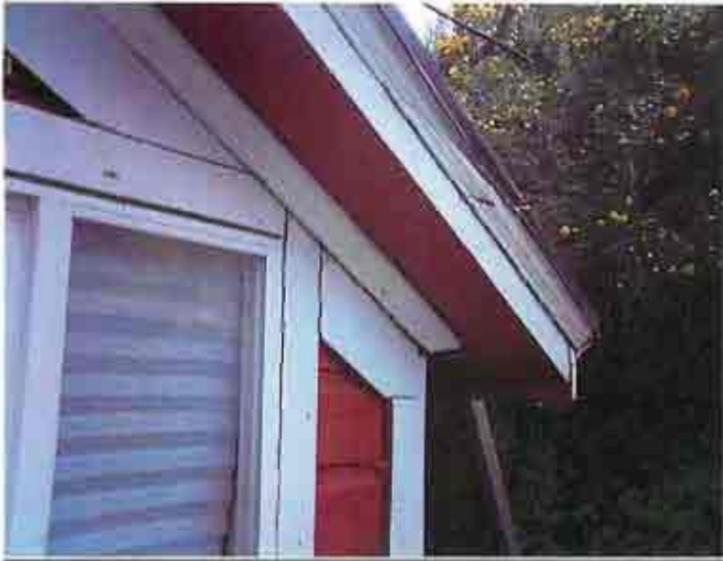
Close Up of Northwest Corner

B. 2 – B.5 Exterior Wall

This façade is the same exterior materials as the other façades. It is in very poor condition because a steep bank of earth comes right down to it. Its proximity to the earth and many winters or deep snow against it has rotted much of the material. This wall is scheduled to be removed because it has been judged to be part of a non-contributory addition.

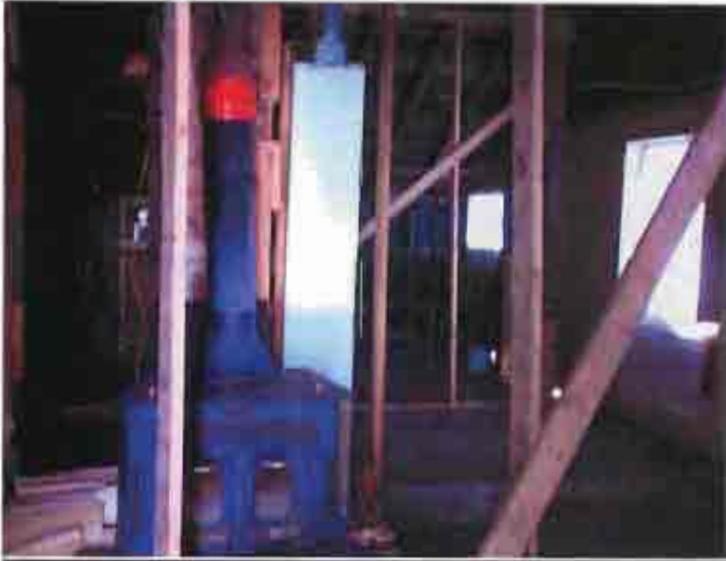
View from Front Door

B.10 – 12 Mechanical System, Electrical System, Structural System

There is no mechanical system. There is an existing brick chimney that starts at the floor and extends up through the roof about 4' west of the main ridge. There is a wood burning stove sitting on the floor that vents into the chimney. The stove is not historic.

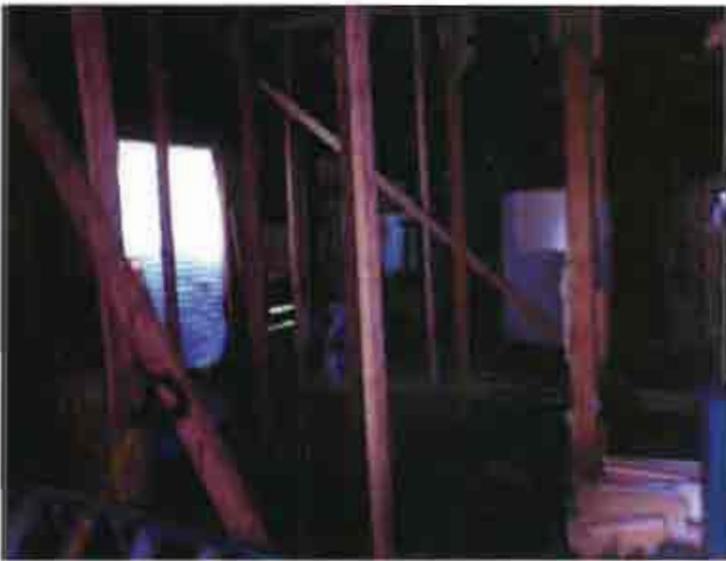
View from Front Door

The existing floor has many layers, and in spots, the original floor is still present. The original is 1"x4" fir. The structure below the floor surface is 2"x4" joists that either sit on dirt or rest slightly above the dirt. Most of the joists are experiencing rot. The floor is very much out of level. There is an 11" drop from the Southwest corner to the Northeast corner.
