Historic Preservation Board Staff Report

Author: Anya Grahn, Historic Preservation Planner
Subject: Material Deconstruction and Reconstruction Review
Address: 803 Norfolk Avenue
Project Number: PL-15-02923
Date: November 11, 2016
Type of Item: Administrative – Material Deconstruction and Reconstruction

Address: 803 Norfolk Avenue
Designation: Significant
Applicant: Jim Hewitson (Architect Jon DeGray)
Proposal:
1. Reconstruction of c.1938 corrugated metal garage along Crescent
2. Material Deconstruction of stacked stone retaining walls, historic roof and dormers, chimney, demolition of historic and non-historic foundation elements, historic and non-historic porch elements on the front and side porches, historic doors, replacement of historic and non-historic windows; removal of portions of historic walls in order to accommodate a new addition on the northwest corner of the historic house.

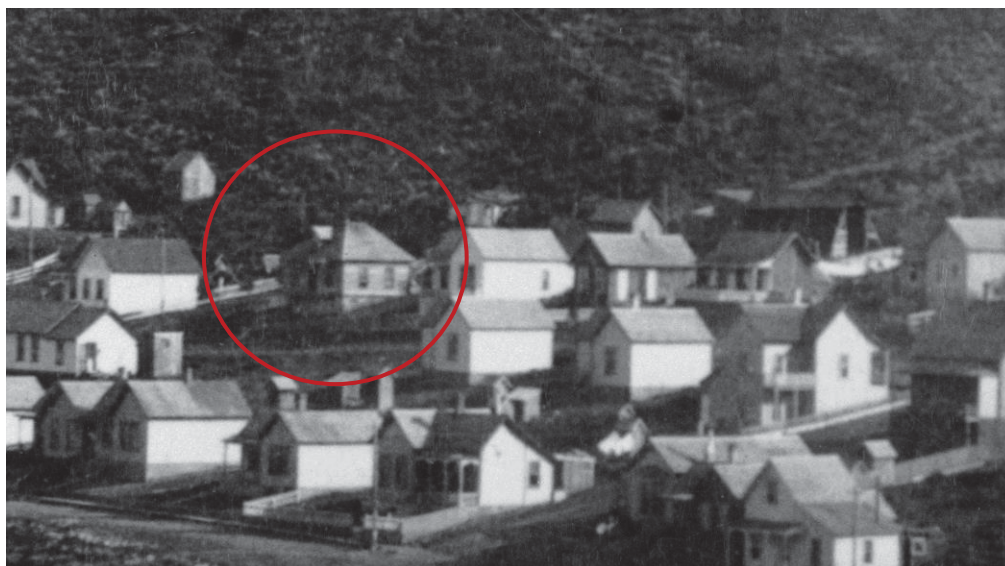
This c. 1900 photograph shows the basement addition, but not the rear addition. Photo courtesy of the Utah State Historical Society.

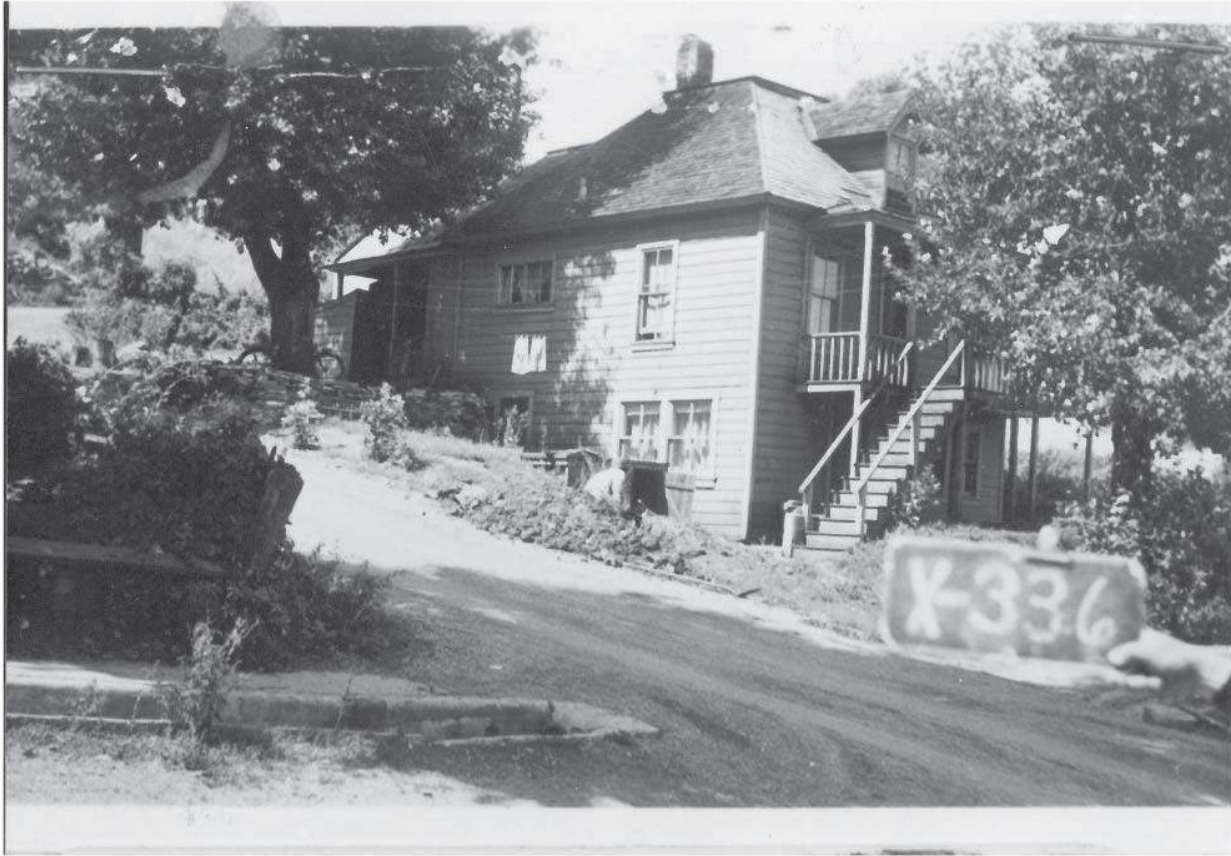
The house largely appeared as it did in the c.1940 historic tax photograph below. As seen in the tax photograph, there was a coal shed to the west of the rear porch on the south elevation. The second bay to the east of the porch had a solid railing and boarded wall adjacent to the house. The west wall of the porch was open to the coal shed.

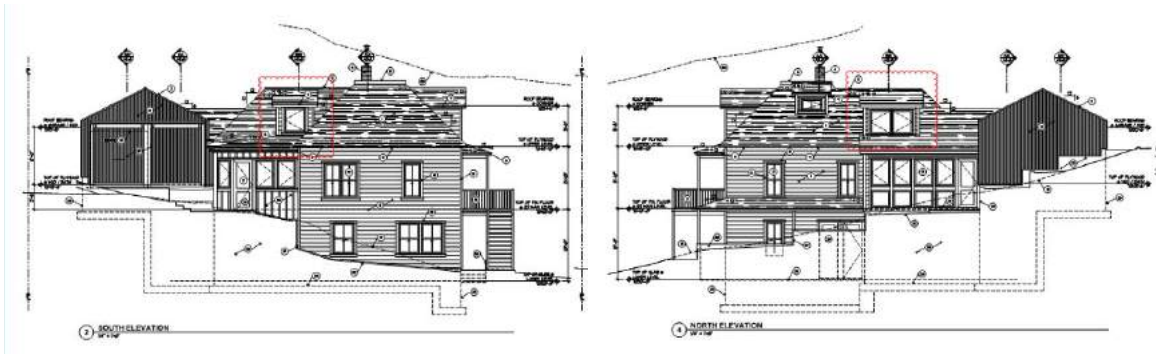
Location of new dormers on the reconstructed roof.

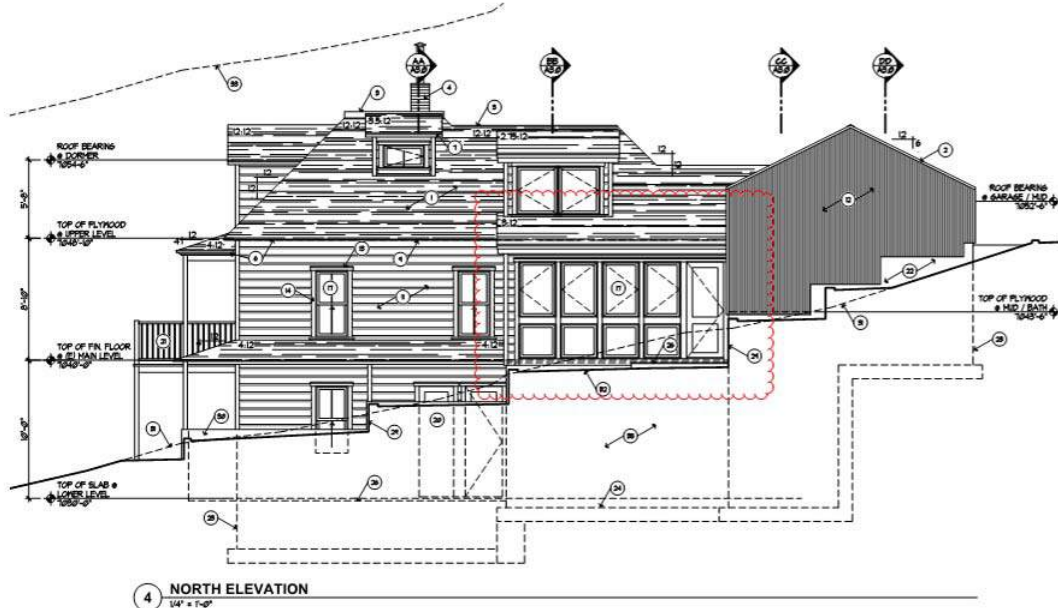
Proposed sunporch addition on the northwest corner of the historic house.

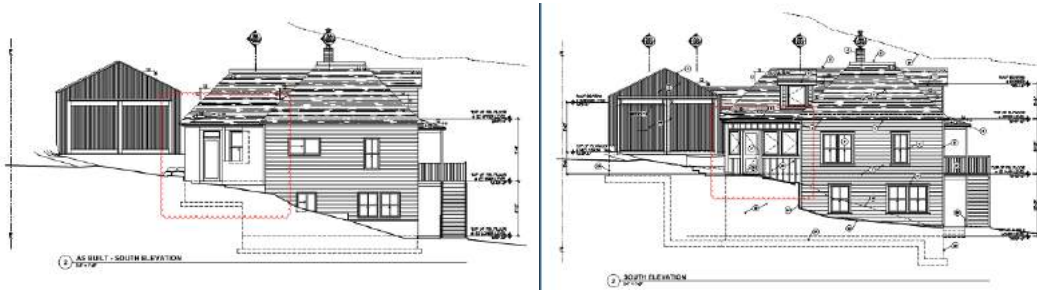
The porch is in poor condition. The wood floor sits directly on the dirt and is largely rotted through. The plywood walls of the porch are not original and the wood shed has been lost. The applicant is proposing to reconstruct this side porch as an

The applicant is proposing to enclose the rear porch.

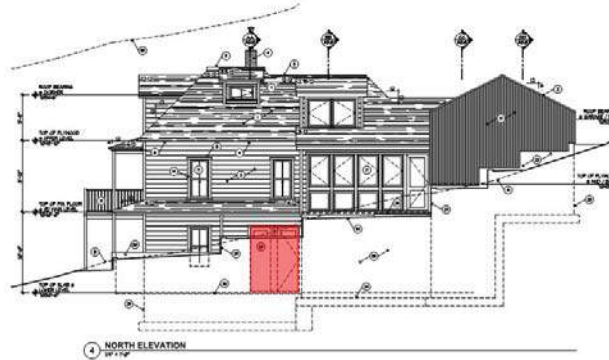
Proposed location of expanded door opening.

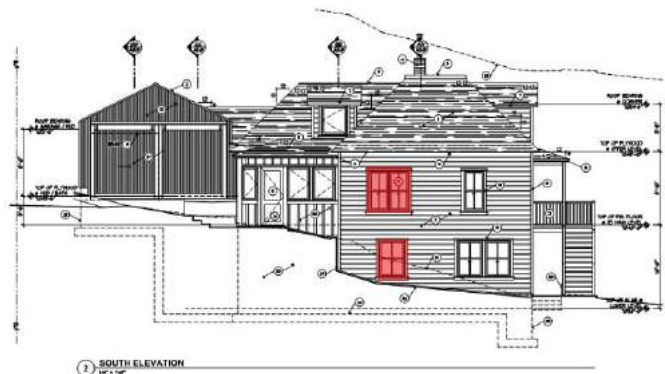
Proposed window alterations.

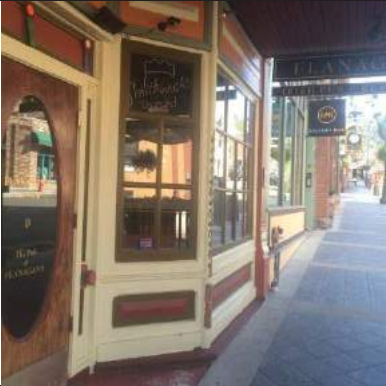
<p>Wood. Wood was utilized extensively for framing, siding, as well as architectural features.</p> <p><i>Wood was used to create architectural interest and ornamentation on Flannigan's façade at 438 Main Street.</i></p>

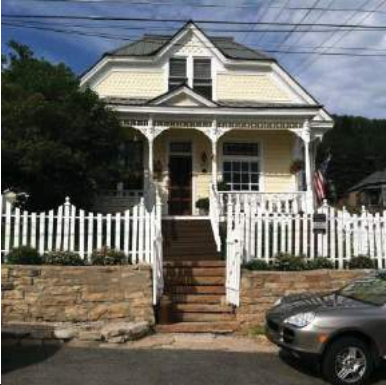
<p><i>Wood was used extensively at this site at 843 Norfolk. The fence, siding materials, architectural ornamentation on the porch, doors, windows, and more consist of wood.</i></p>

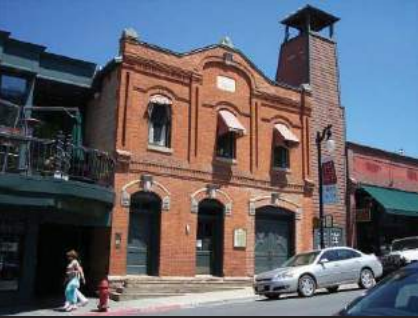
<p>Masonry. Masonry can be in the form of stone, brick, terra cotta, and adobe as well as the mortar that holds these masonry units together.</p> <p><i>The historic Park City City Hall at 528 Main Street consists of brick walls and detailing.</i></p>

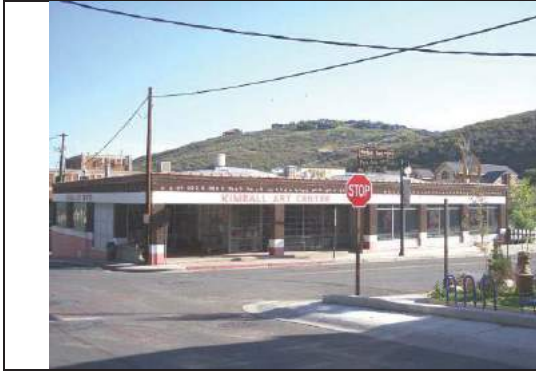
Architectural Metals. Metal was sometimes used as siding or roofing material; however, more commonly, it was used to create cast iron facades, porches, steps, and later siding and windows.

The historic Kimball Garage at 638 Park Avenue historically had steel windows.
