# **MEMORANDUM**

**SUBJECT:** Woodruff Drawing Analysis

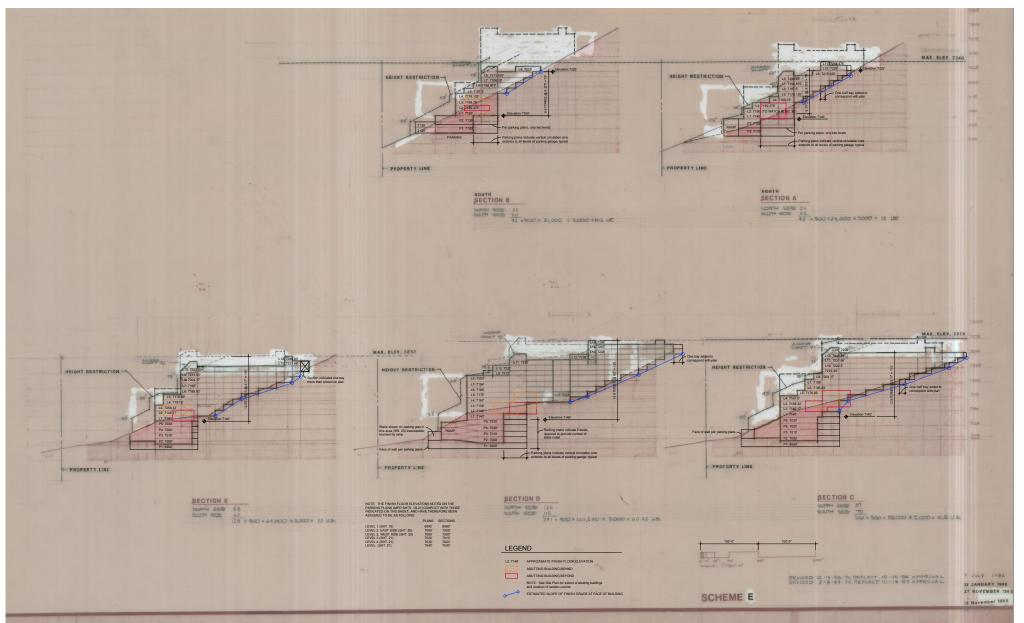
Woodruff Sheet 18 – Floor-to-Floor Height Calculations

On the site plan many of the low-rise buildings have floor/roof elevations noted, all of which indicate 10' floor-to-floor. However, on the sections, when the floor-to-floor heights are calculated by dividing the overall height by the number of stories, the floor-to-floor heights for the five main buildings vary between 9' to 9½'± (see attached Woodruff Sht. 18: Floor-to-Floor Height Calculation). As the main buildings on each site are interconnected, the floor-to-floor heights would have to be consistent. Furthermore, as 10' floor-to-floor would be absolutely the minimum necessary to provide adequate ceiling height, and would be less than optimal for upscale units, the overall height of the buildings would necessarily have to increase. Furthermore, if the roof elevations indicated on the sections are at the maximum allowable further excavation would be required.
