# HISTORIC SITE FORM - HISTORIC SITES INVENTORY

1 IDENTIFICATION									
Name of Property: Ernest Lyni	n Kimball House								
Address: 911 EMPIRE		AKA:							
City, County: Park City, Summi	t County, Utah	Tax Number: EMPIRE-1 (?)							
Current Owner Name: Mary Lo	u Toly, TRUSTEE	Parent Parcel(s): SA-	• • • • • • • • • • • • • • • • • • • •						
Current Owner Address: PO BO	•	• , ,							
			COR LOT 5 BLK 29 SNYDERS						
ADDITION TO PARK CITY; TH S 35*59" E 71.9 FT; N 78*28' W60.3 FT; N 66*06' W 33 FT; N 54*01' E 60 FT TO BEG(LESS PORTION IN LOTS 3 & 4 1720-1086 SA-302-A); 0.10 AC Some question about the above and									
following legal descriptions LOT 1 Empire Subdivision, Cont 2996.7 sq ft or 0.07 AC (Old Town Lands, LLC)									
2 STATUS/USE									
December October	F -1 - ('+	Danas and a stiera	H						
<u>Property Category</u> ☑ building(s), main	<u>Evaluation*</u> ☑ Landmark Site	<u>Reconstruction</u> Date:	<u>Use</u> Original Use: Residential

Park City, Summit County, Utah Ernest Lynn Kimball House

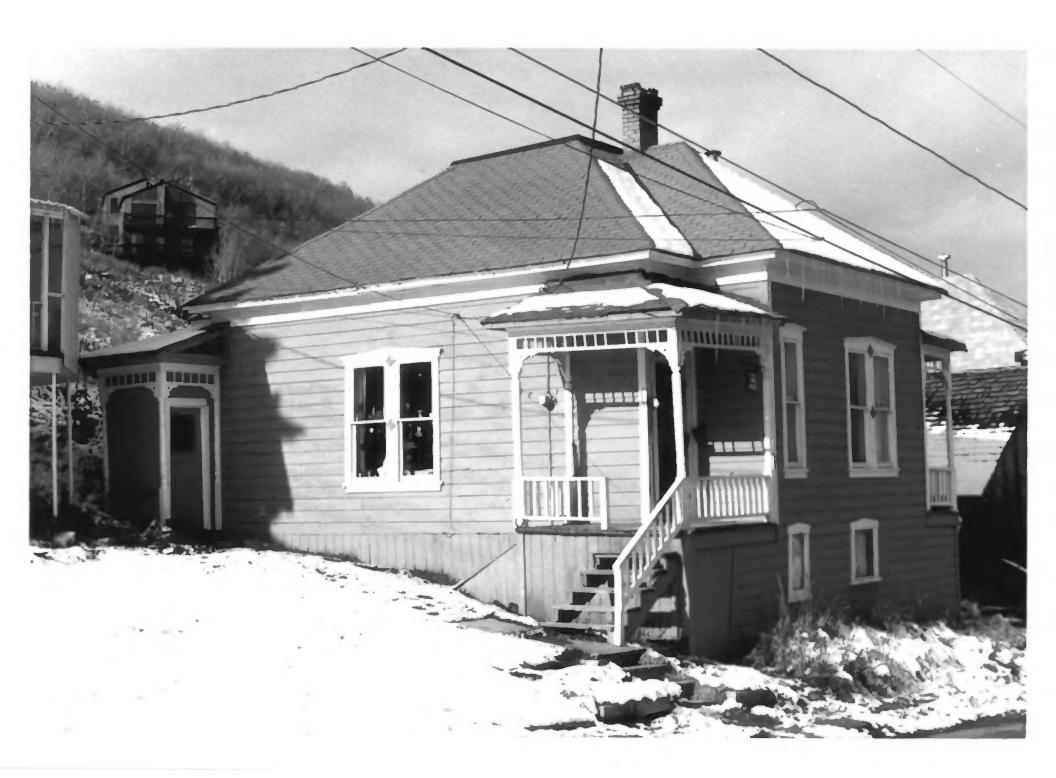
Southeast corner

Ernest Lynn Kimball House 911 Empire Park City, Summit County, Utah

Photo by Debbie Temme, October 1983 Negative: Utah State Historical Society

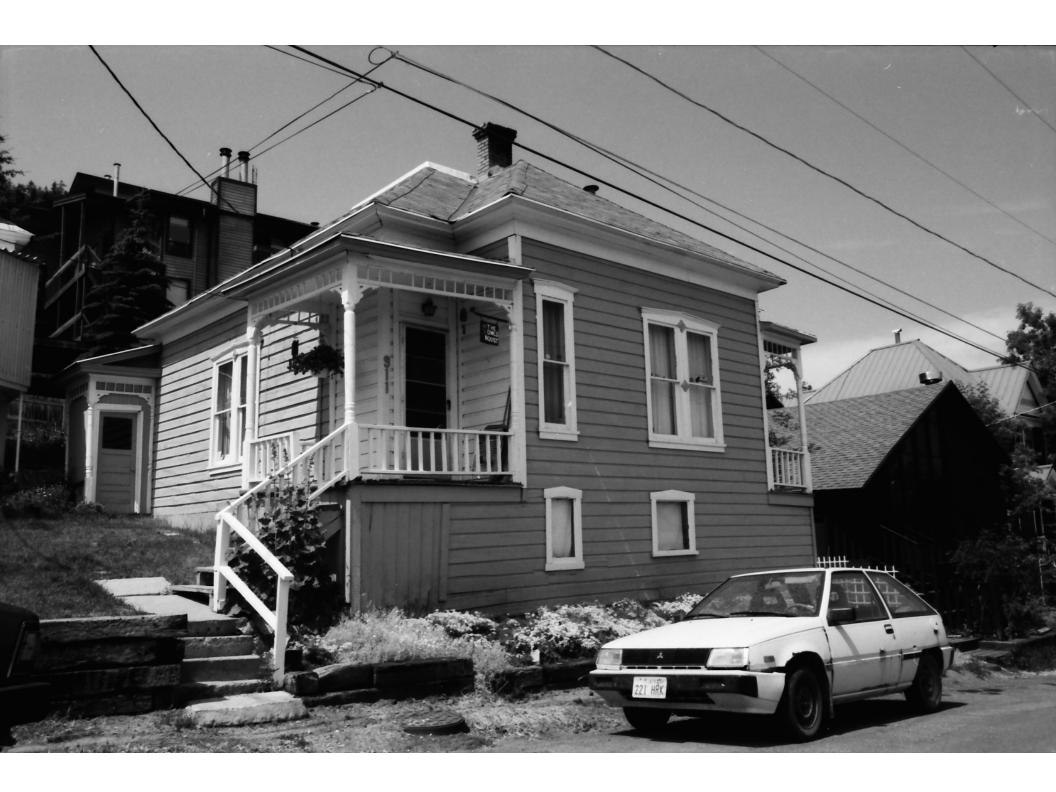
porches have straight post balustrades. The house is in excellent condition, and is unaltered, except for the enclosing of the rear porch. That type of change was common in Park City, and is unobtrusive. The house maintains its original integrity.
